Board of Supervisors Memorandum

**Canoa Hills Golf Course Donation Acceptance Final Two Reports
for Addendum Items Number 8 and Number 12**

RE: Asbestos inspection – Canoa Hills Golf Course

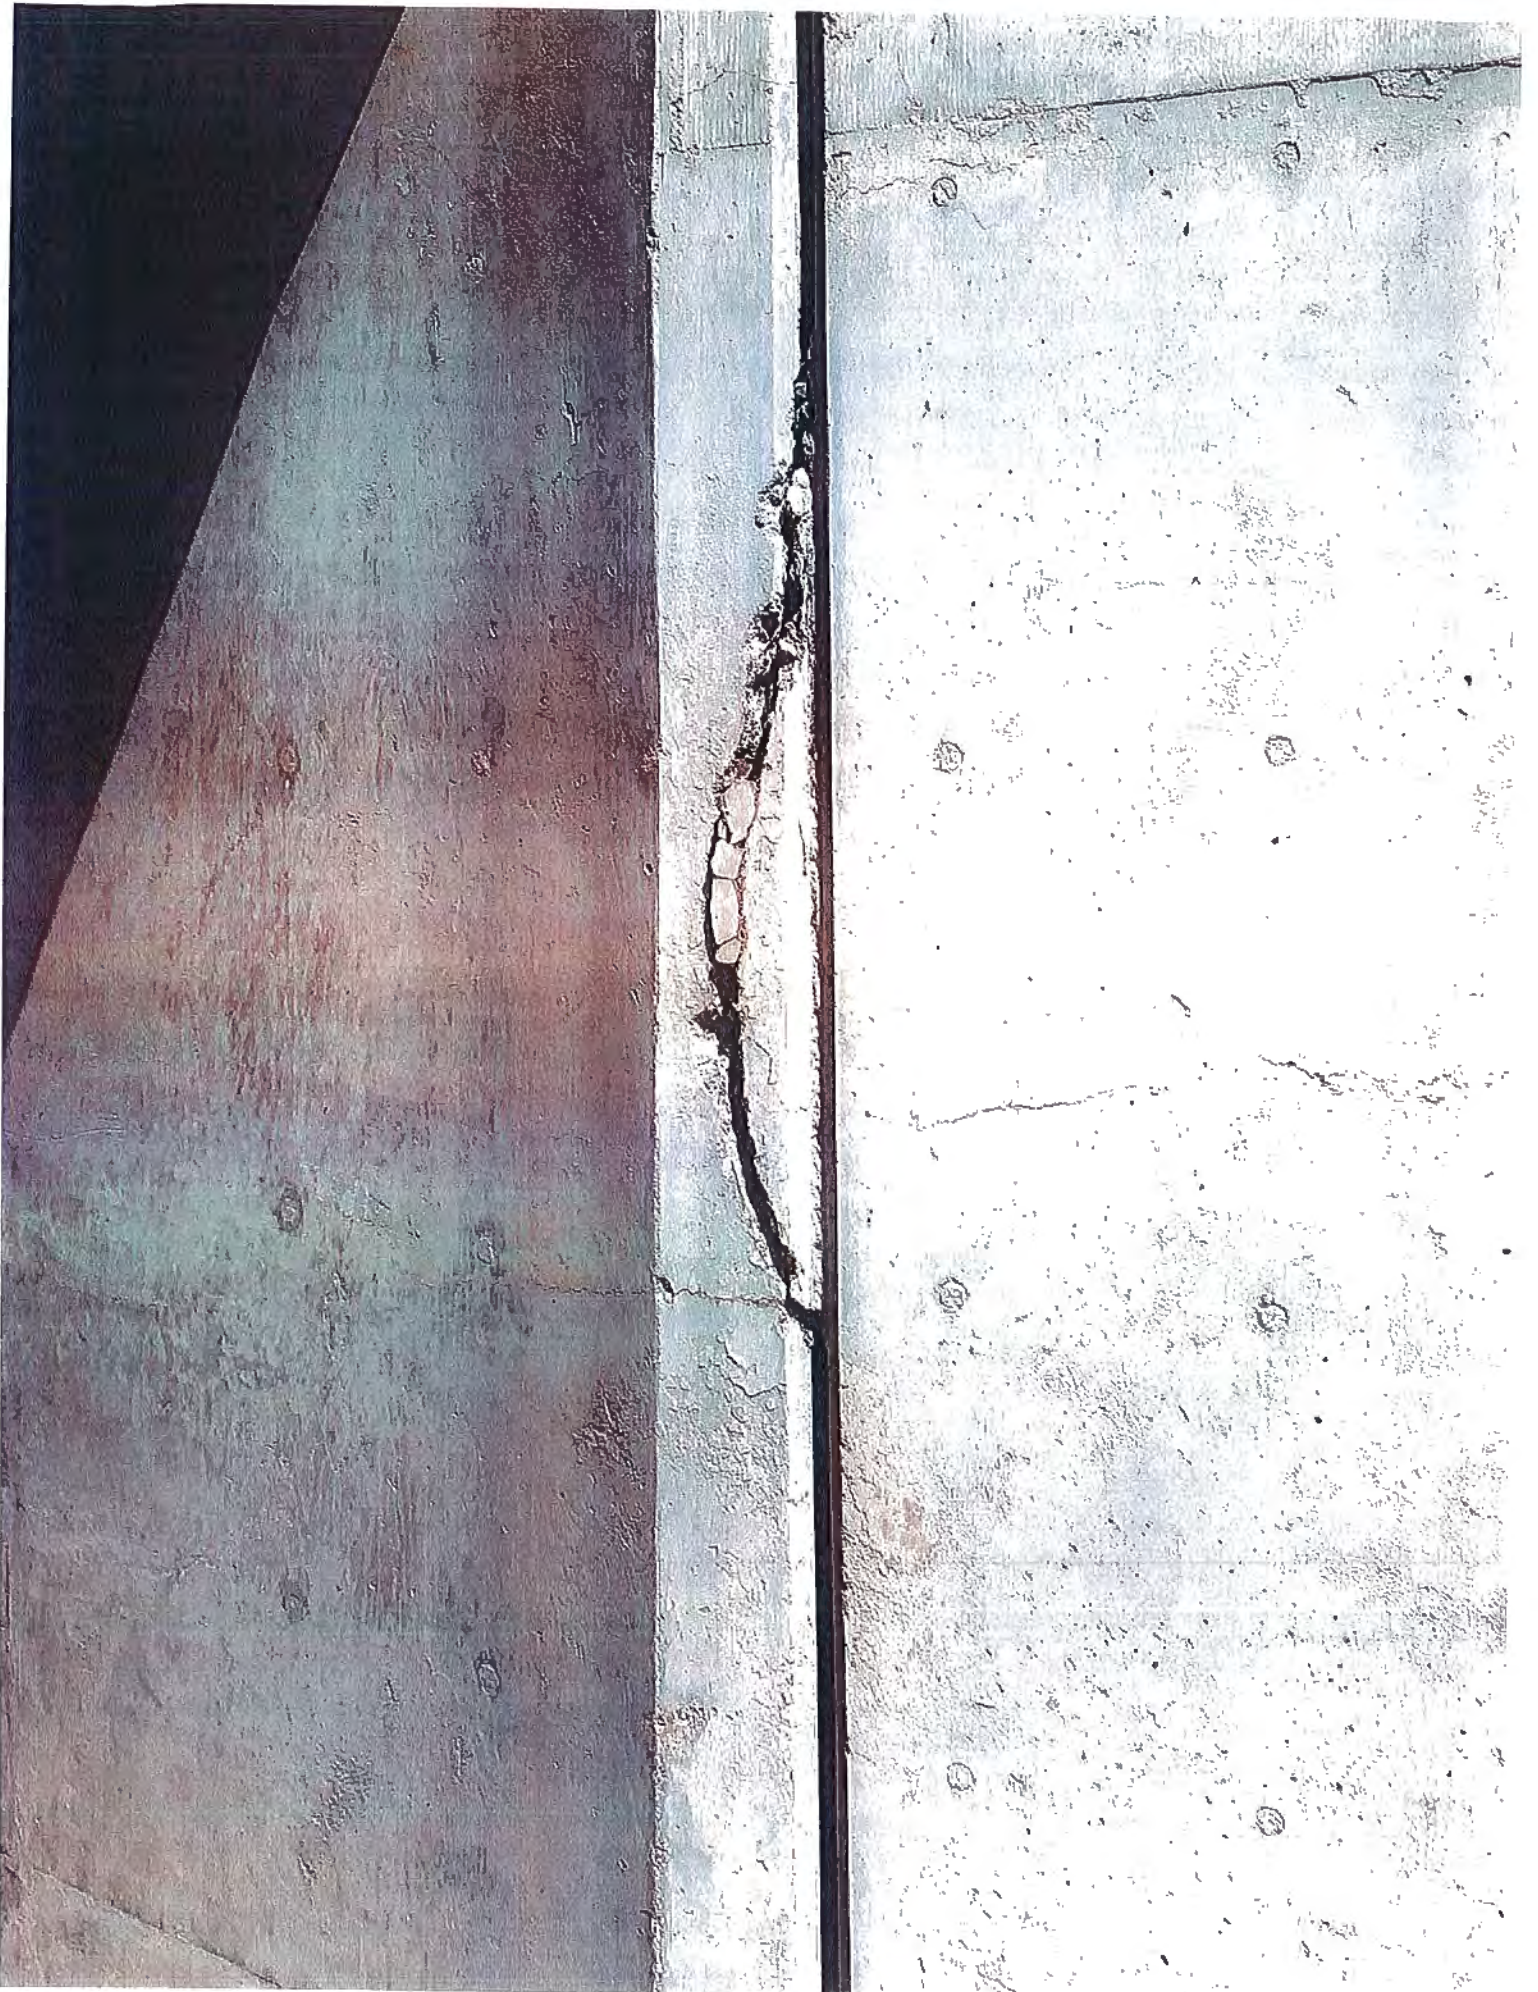
The structure to the northern area of the golf course is a 10x10 reinforced concrete box culvert. There are some cracks with small sections of exposed steel reinforcing at the interface between the headwall and wingwalls. This defect occurs at one location on the west side and one on the east side of the structure. There are also some minor horizontal cracks in a wingwall at the east end of the structure. There are very few, minor vertical shrinkage cracks in the walls of the culvert, and many scattered shrinkage cracks in the floor of the structure. The construction joints are in good condition with no signs of water seepage, efflorescence or corrosion passing through the joints. There is a metal conduit at the top of the interior wall and passes through the entire structure. The structure overall is in good condition and requires little or no repairs or maintenance at this time, except for patching the cracks and exposed reinforcing by the wingwall/headwall interface.

The structure located to the south along Camino del Sol is a two barrel, 10x10 reinforced concrete box culvert. This structure has a couple vertical cracks in the wingwalls on the west entrance, and has very few vertical shrinkage cracks in the walls or cracks in the floor. There is some efflorescence and corrosion present at the construction joints throughout the structure, but there is not active water seepage at this time. The structure overall is in good condition and requires little or no repairs or maintenance at this time. However, the entrance at the west side of this structure has wood planking embedded into earthen areas (fills) with a maximum height of about five feet, and the wooden planks are splitting and many sections have broken and have failed allowing earthen fills to drop out. Additionally, the concrete cart path has many large, scattered cracks, and there is some sediment buildup in the barrels from local drainage activity. These wooden earth retention planks will need to be replaced with some type of soil retention system, and the cart path may require replacement to remove these cracks which could create tripping hazards.

One other general observation is that the asphaltic concrete cart paths at both locations have many scattered, large cracks and potholes. An assessment of the total path system in the golf course would be required to ascertain corrective work. Inspection of the asphalt paving for Camino del Sol above both of these structures show no signs of settlement and that paving is in good condition.

Overall, these two structures are in good condition and will require very little repairs initially, and should not require any longterm maintenance. Please see the attached photos and let me know if you require further action on my part at this time.
