# Board of Supervisors Memorandum

April 17, 2018

**Canoa Hills Golf Course Donation Acceptance Final Two Reports  
for Addendum Items Number 8 and Number 12**

RE: Asbestos inspection – Canoa Hills Golf Course

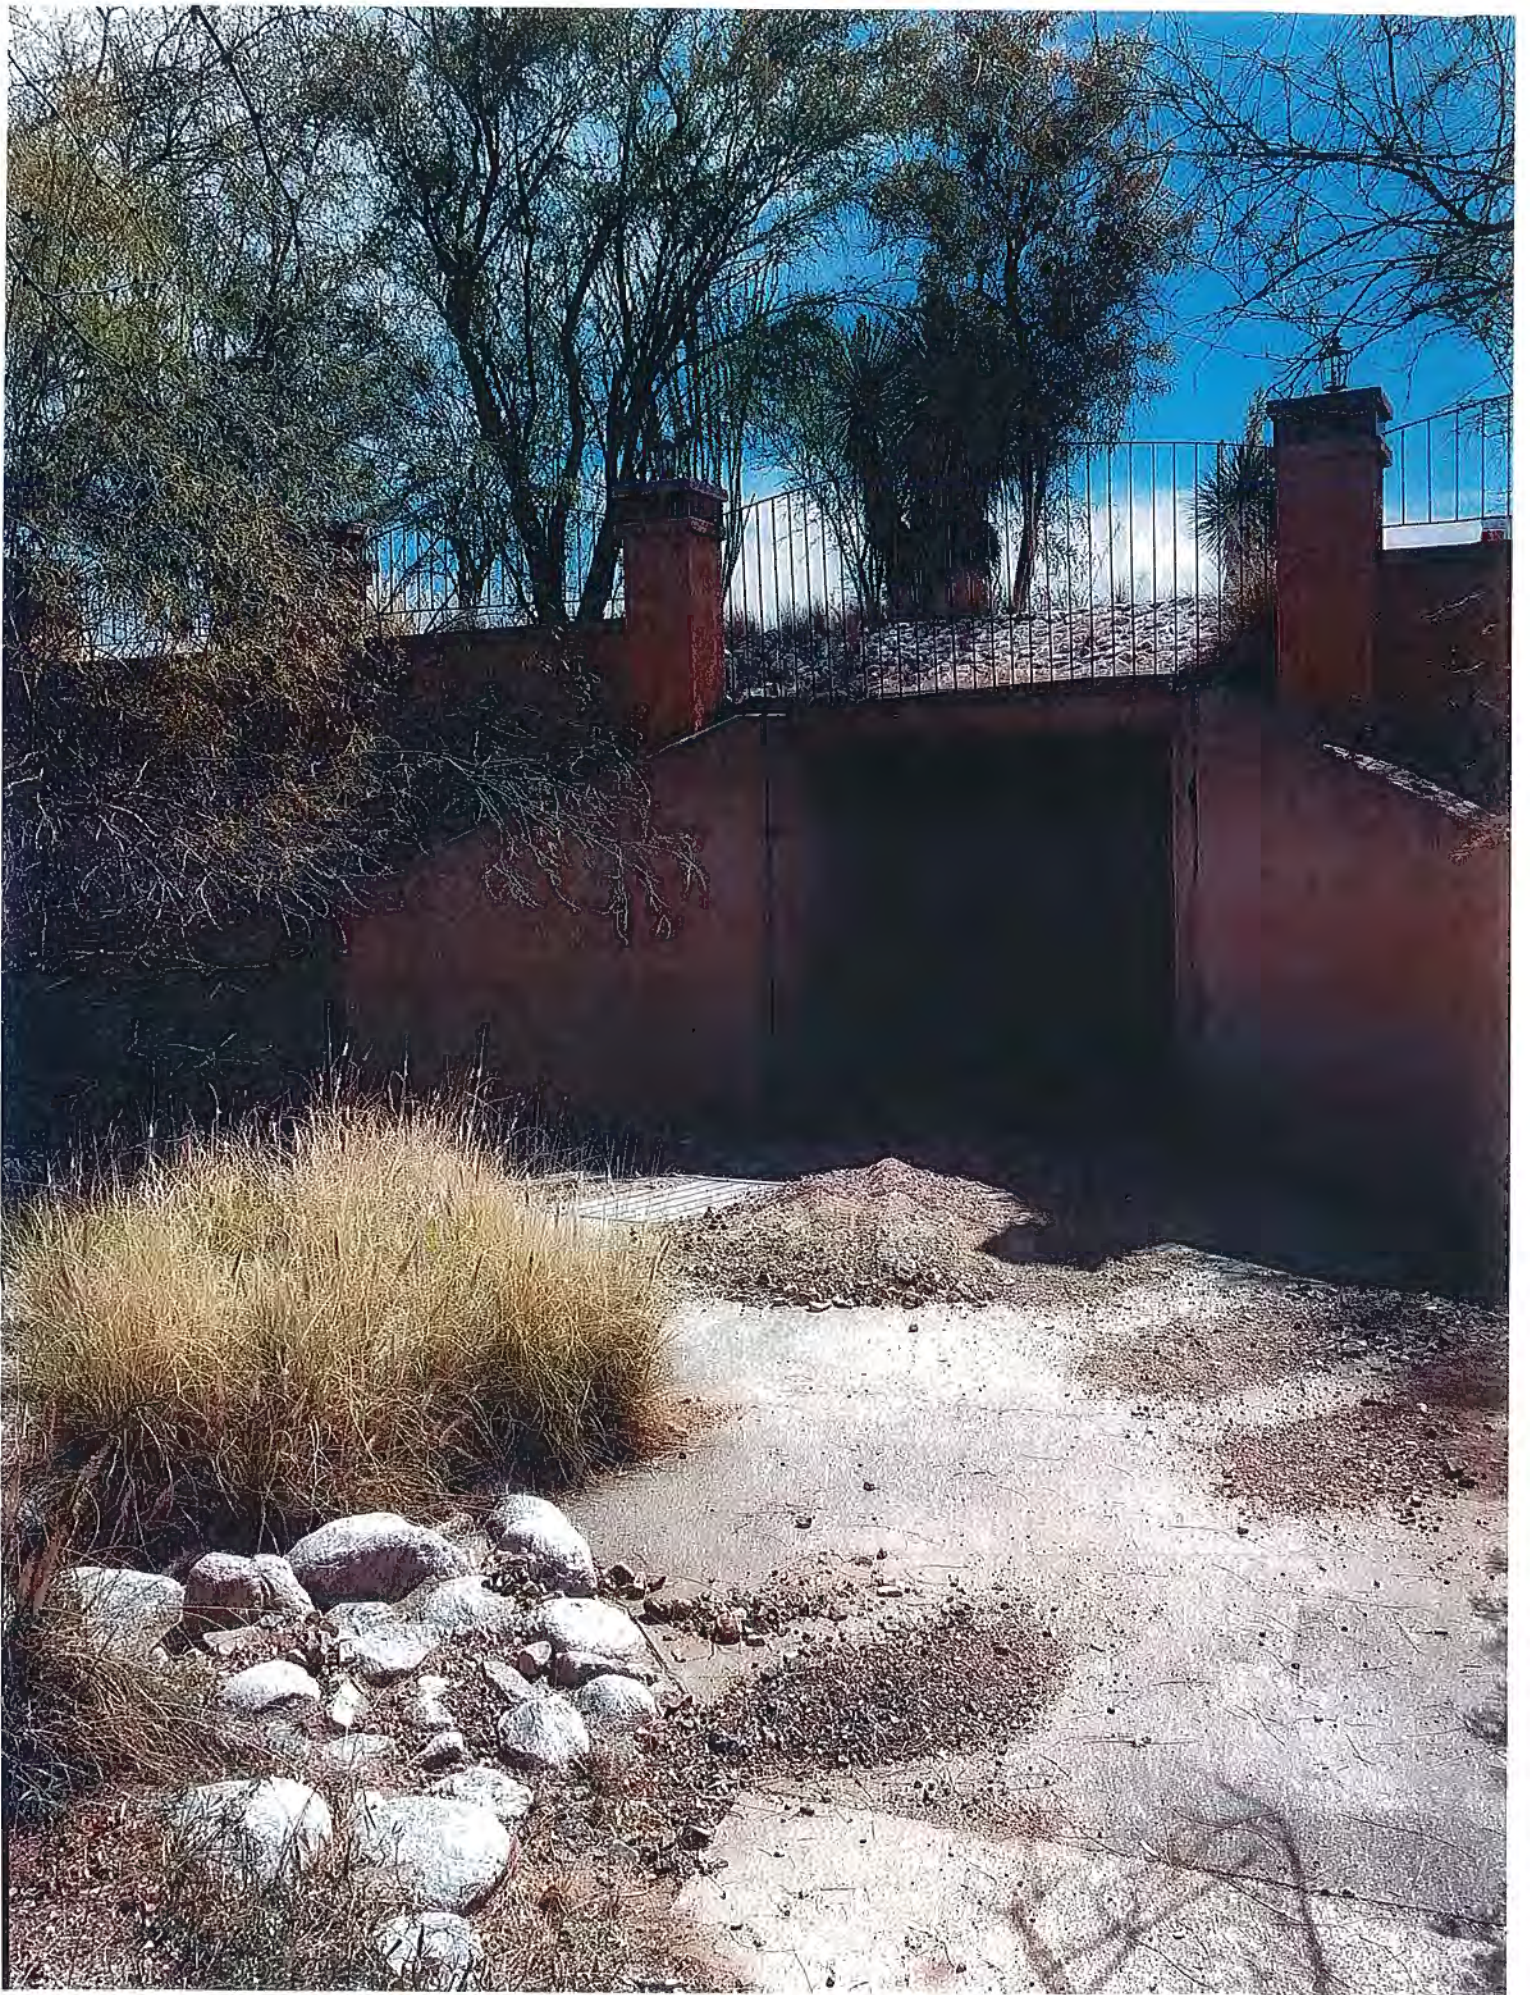
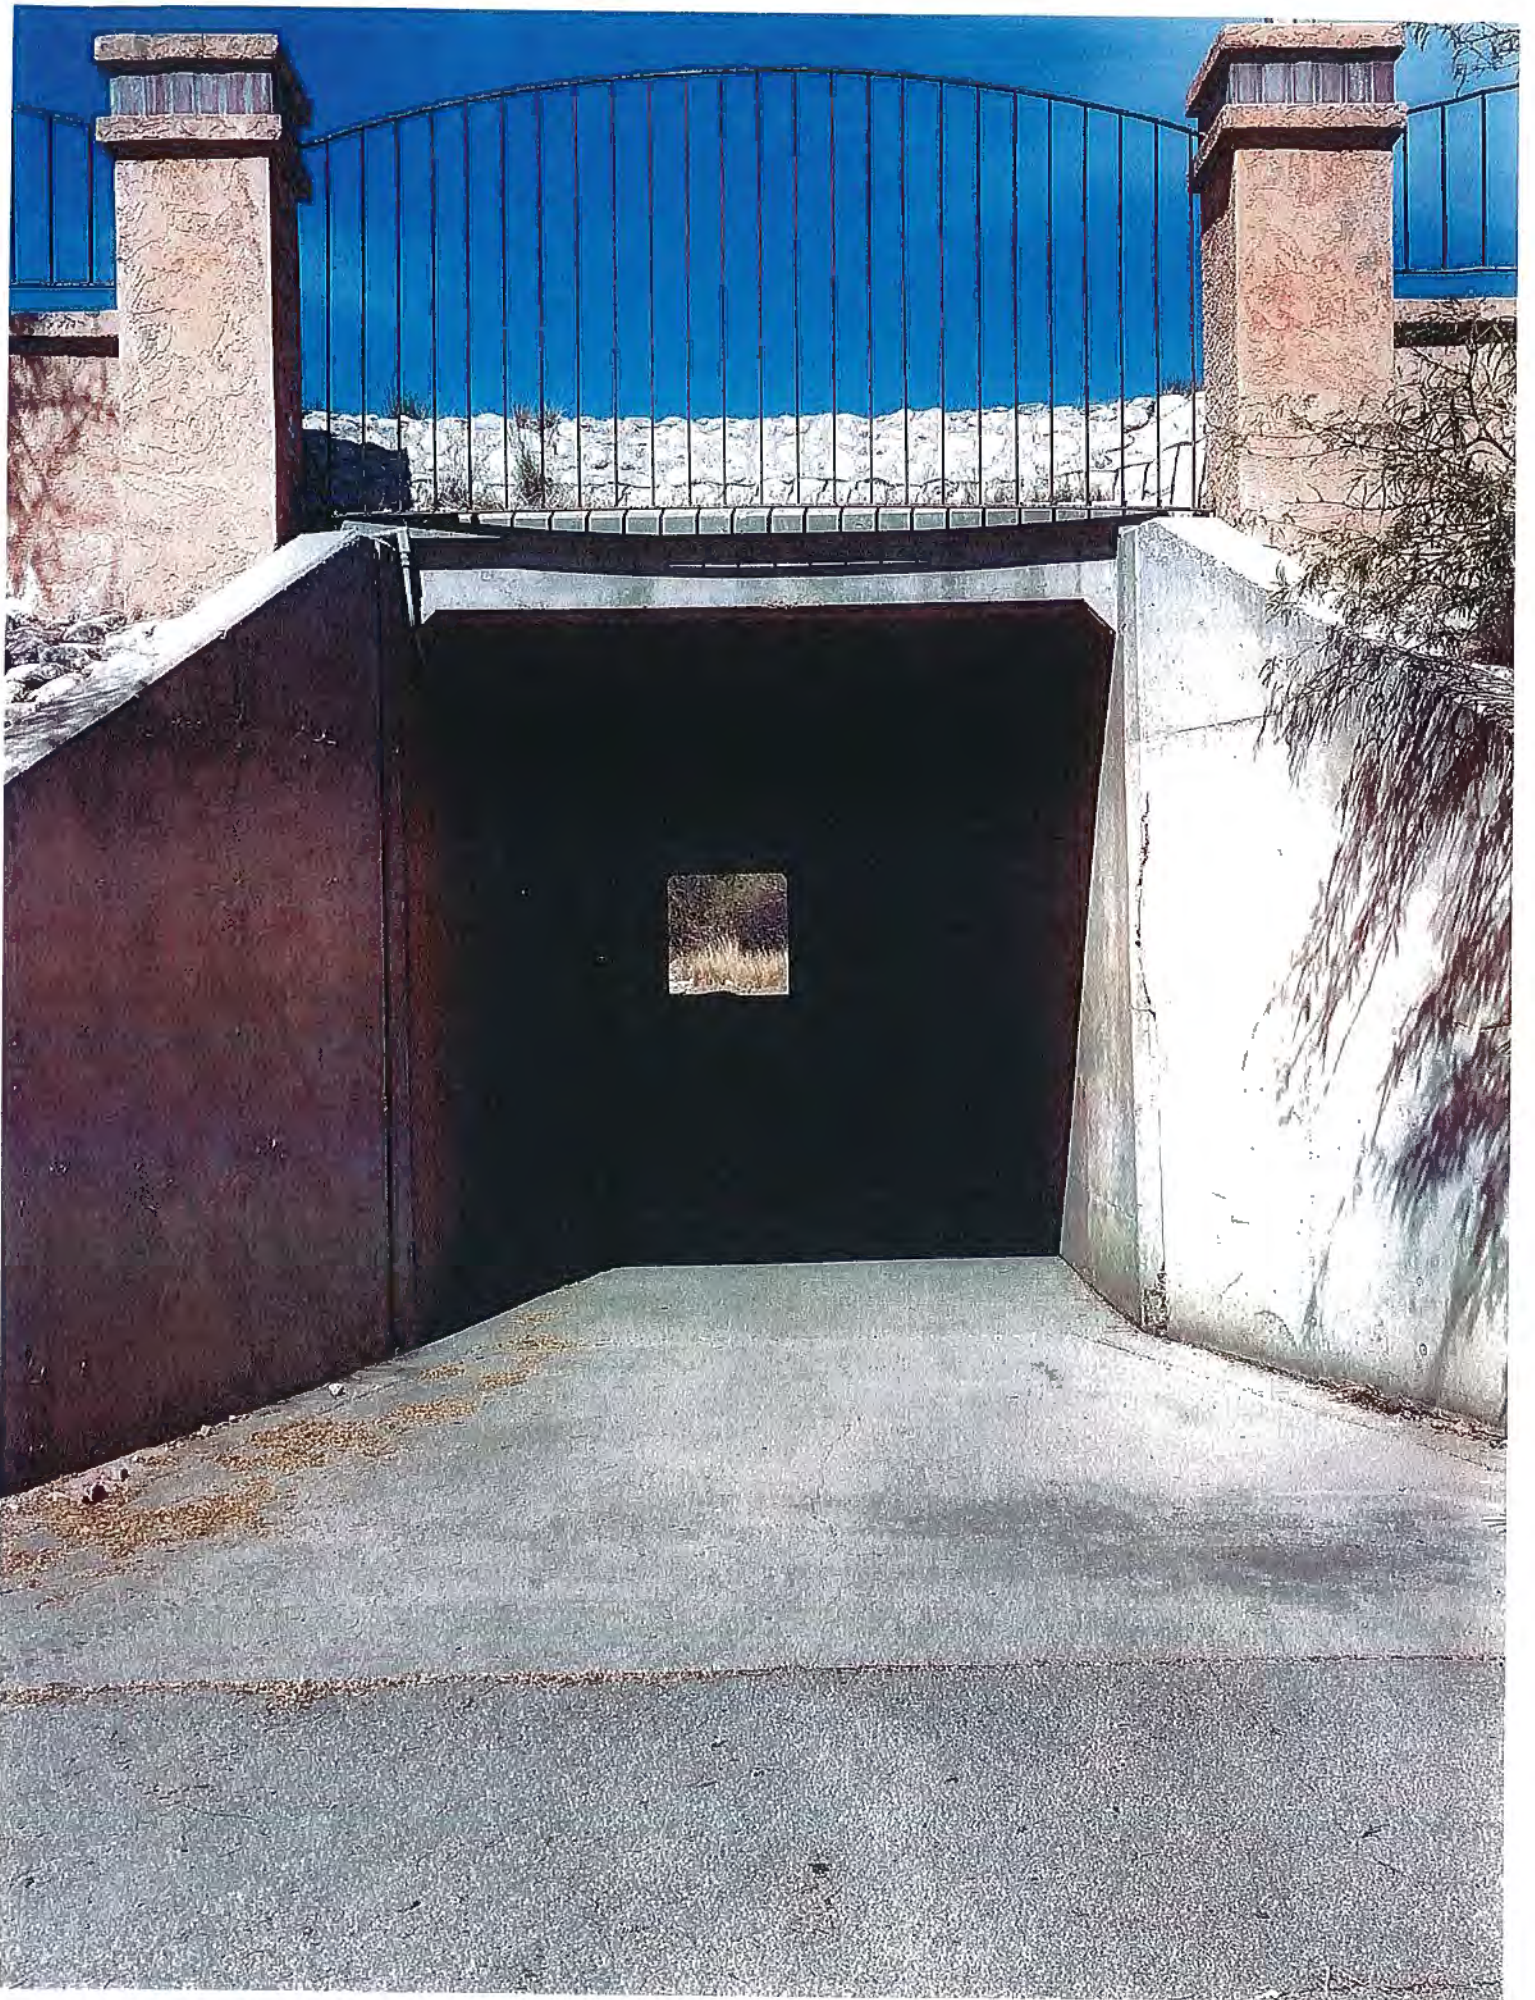
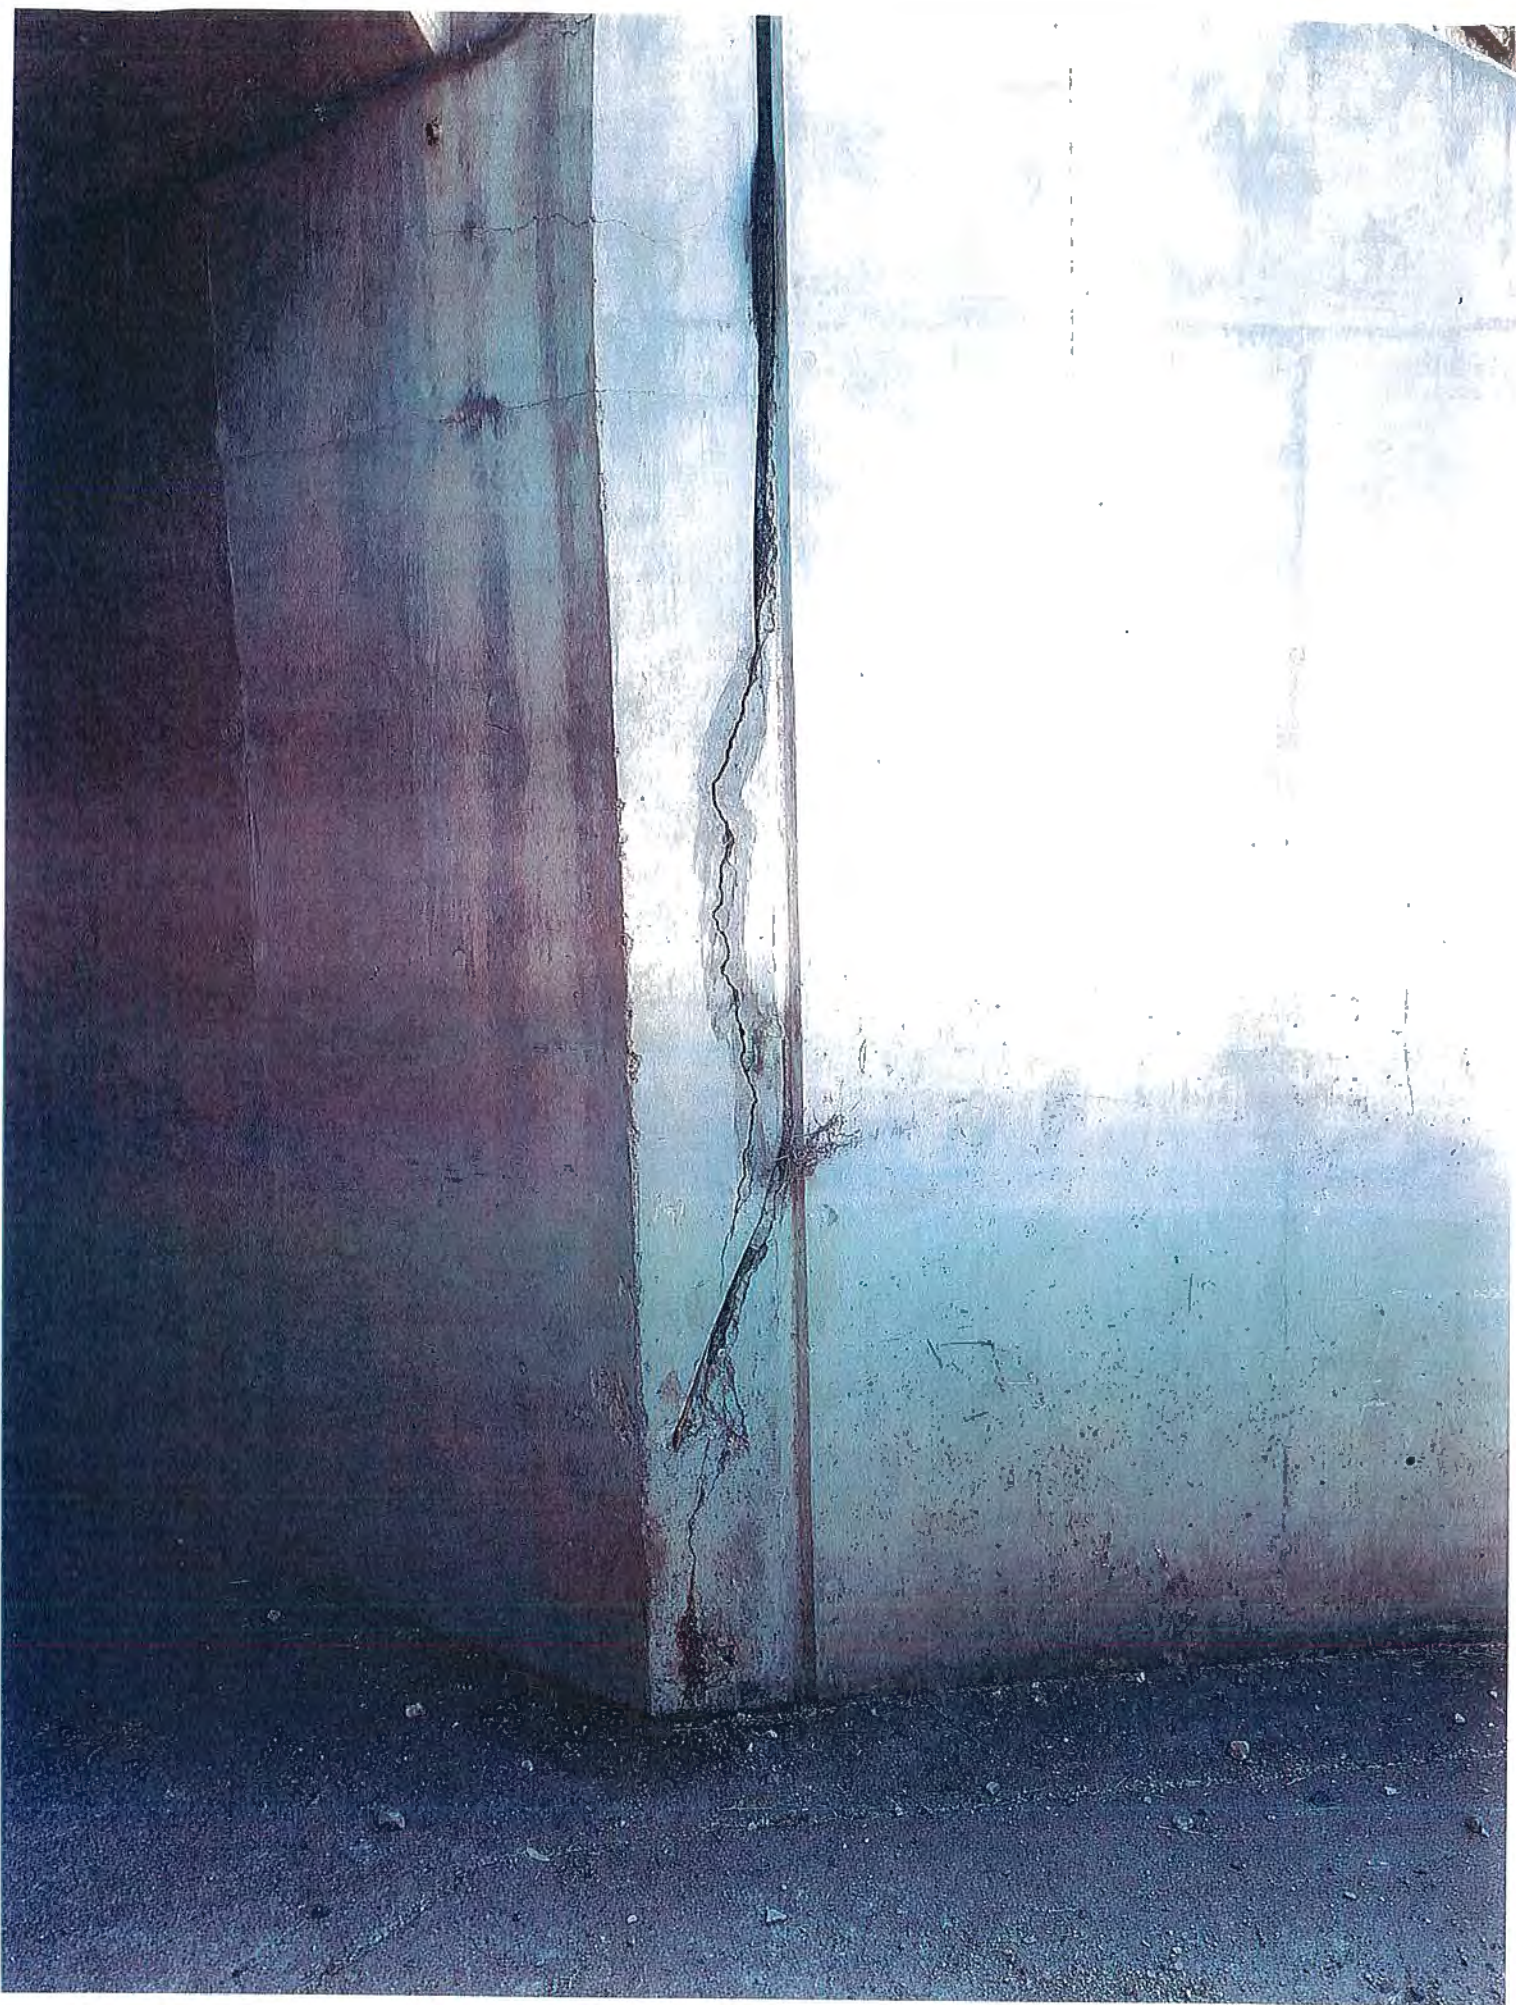
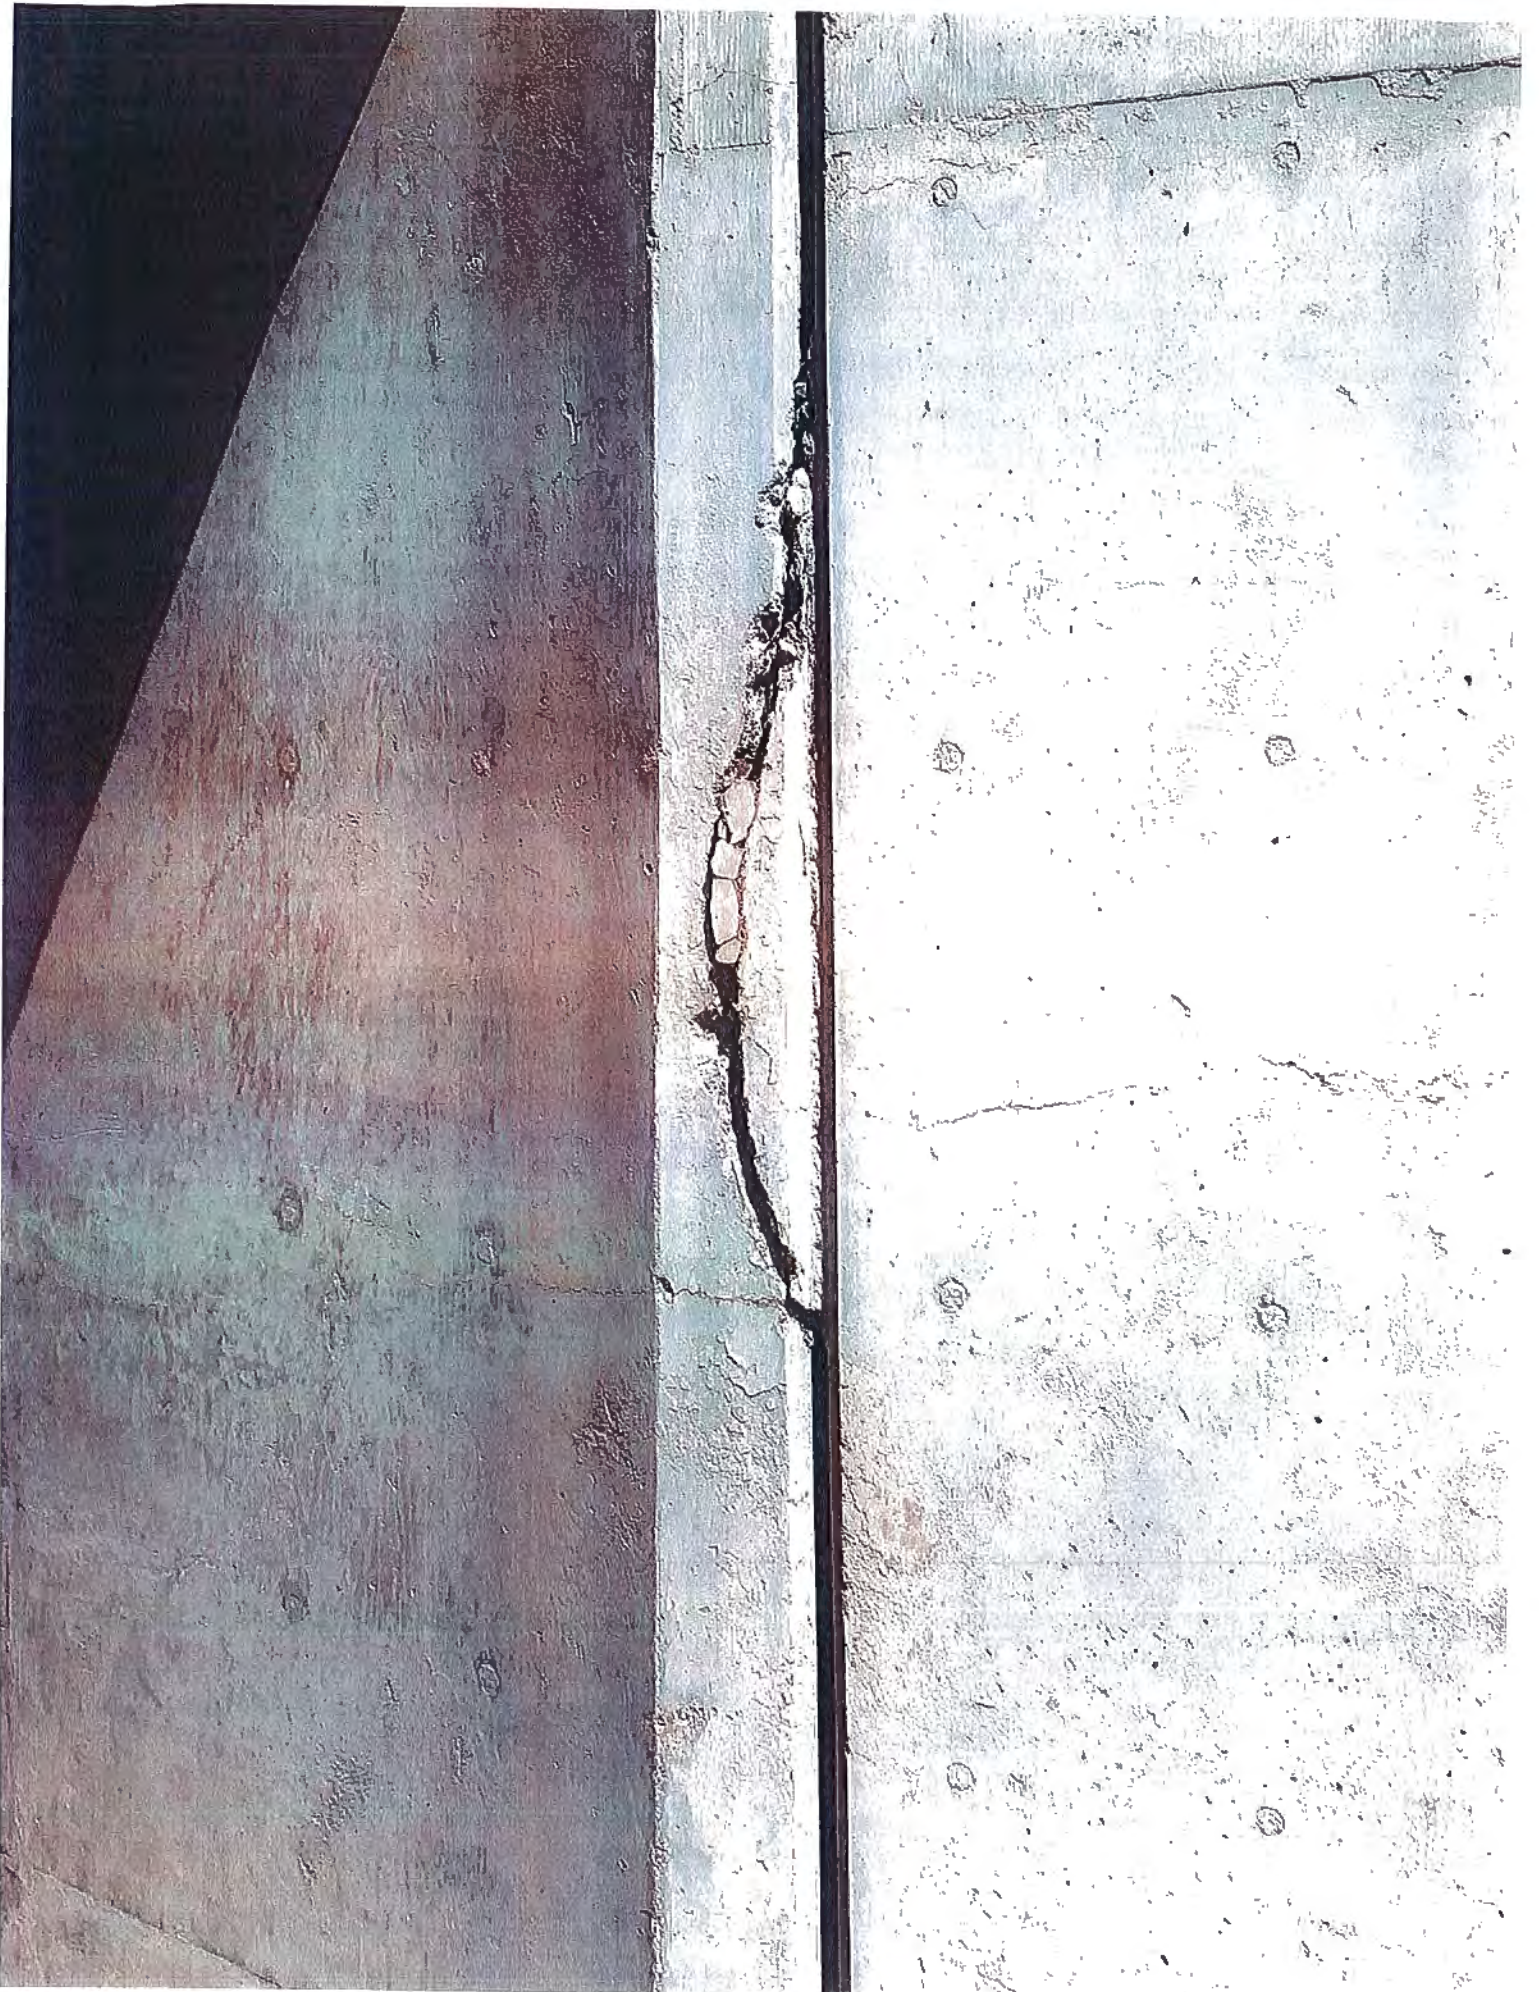
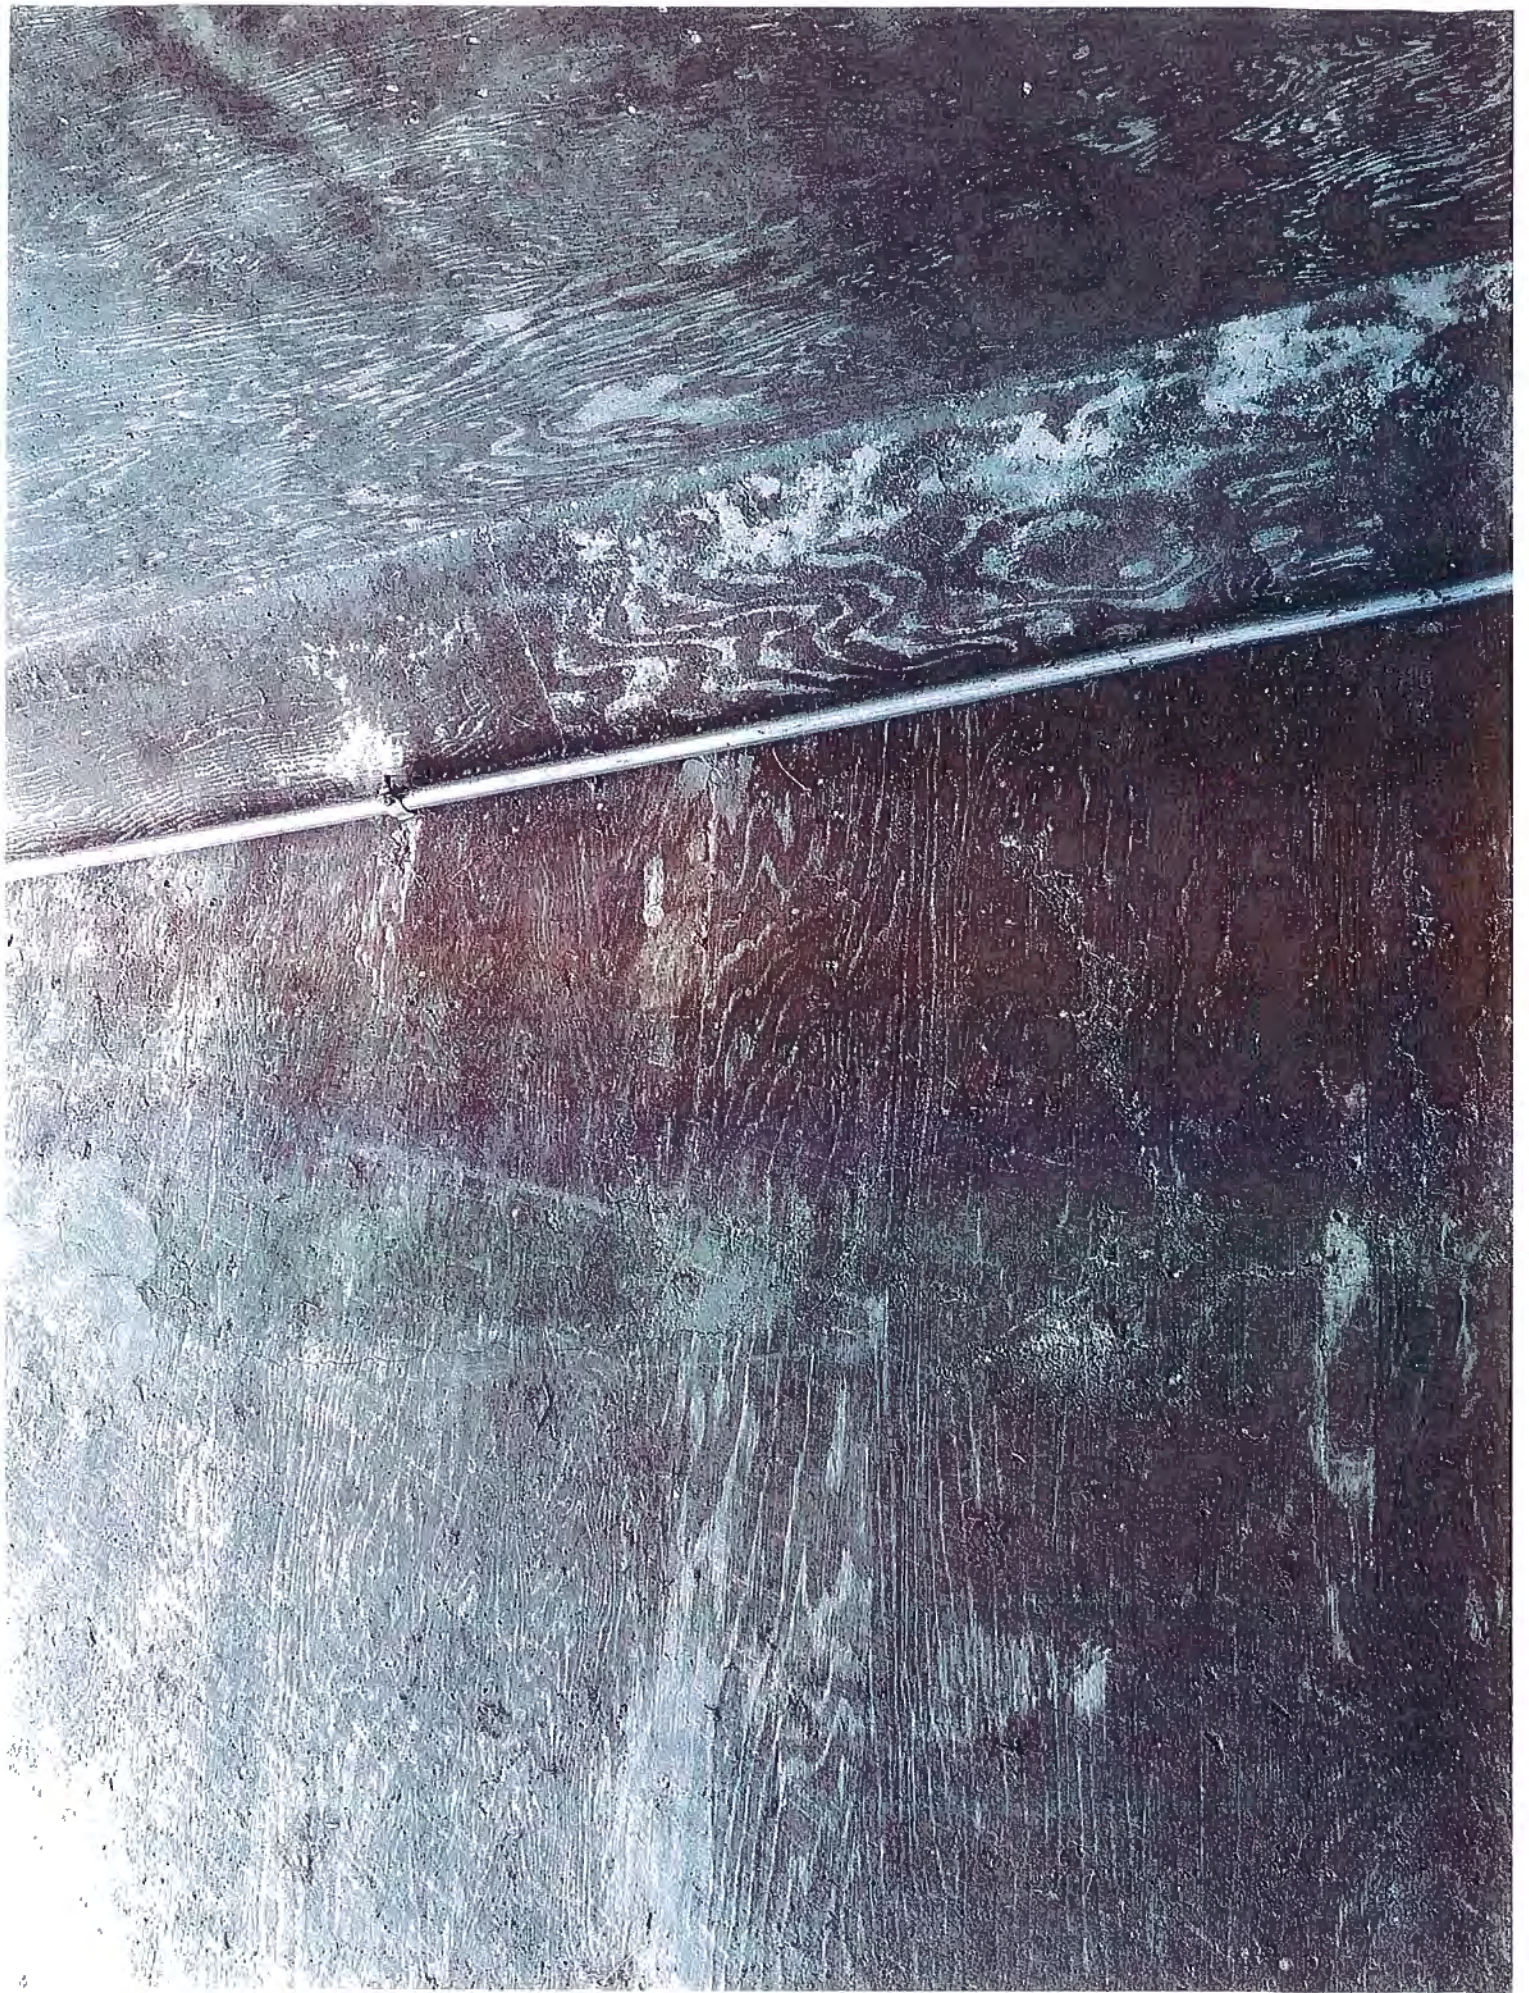
The structure to the northern area of the golf course is a 10x10 reinforced concrete box culvert. There are some cracks with small sections of exposed steel reinforcing at the interface between the headwall and wingwalls. This defect occurs at one location on the west side and one on the east side of the structure. There are also some minor horizontal cracks in a wingwall at the east end of the structure. There are very few, minor vertical shrinkage cracks in the walls of the culvert, and many scattered shrinkage cracks in the floor of the structure. The construction joints are in good condition with no signs of water seepage, efflorescence or corrosion passing through the joints. There is a metal conduit at the top of the interior wall and passes through the entire structure. The structure overall is in good condition and requires little or no repairs or maintenance at this time, except for patching the cracks and exposed reinforcing by the wingwall/headwall interface.
