# Board of Supervisors Memorandum

April 17, 2018

**Canoa Hills Golf Course Donation Acceptance Final Two Reports  
for Addendum Items Number 8 and Number 12**

RE: Asbestos inspection – Canoa Hills Golf Course

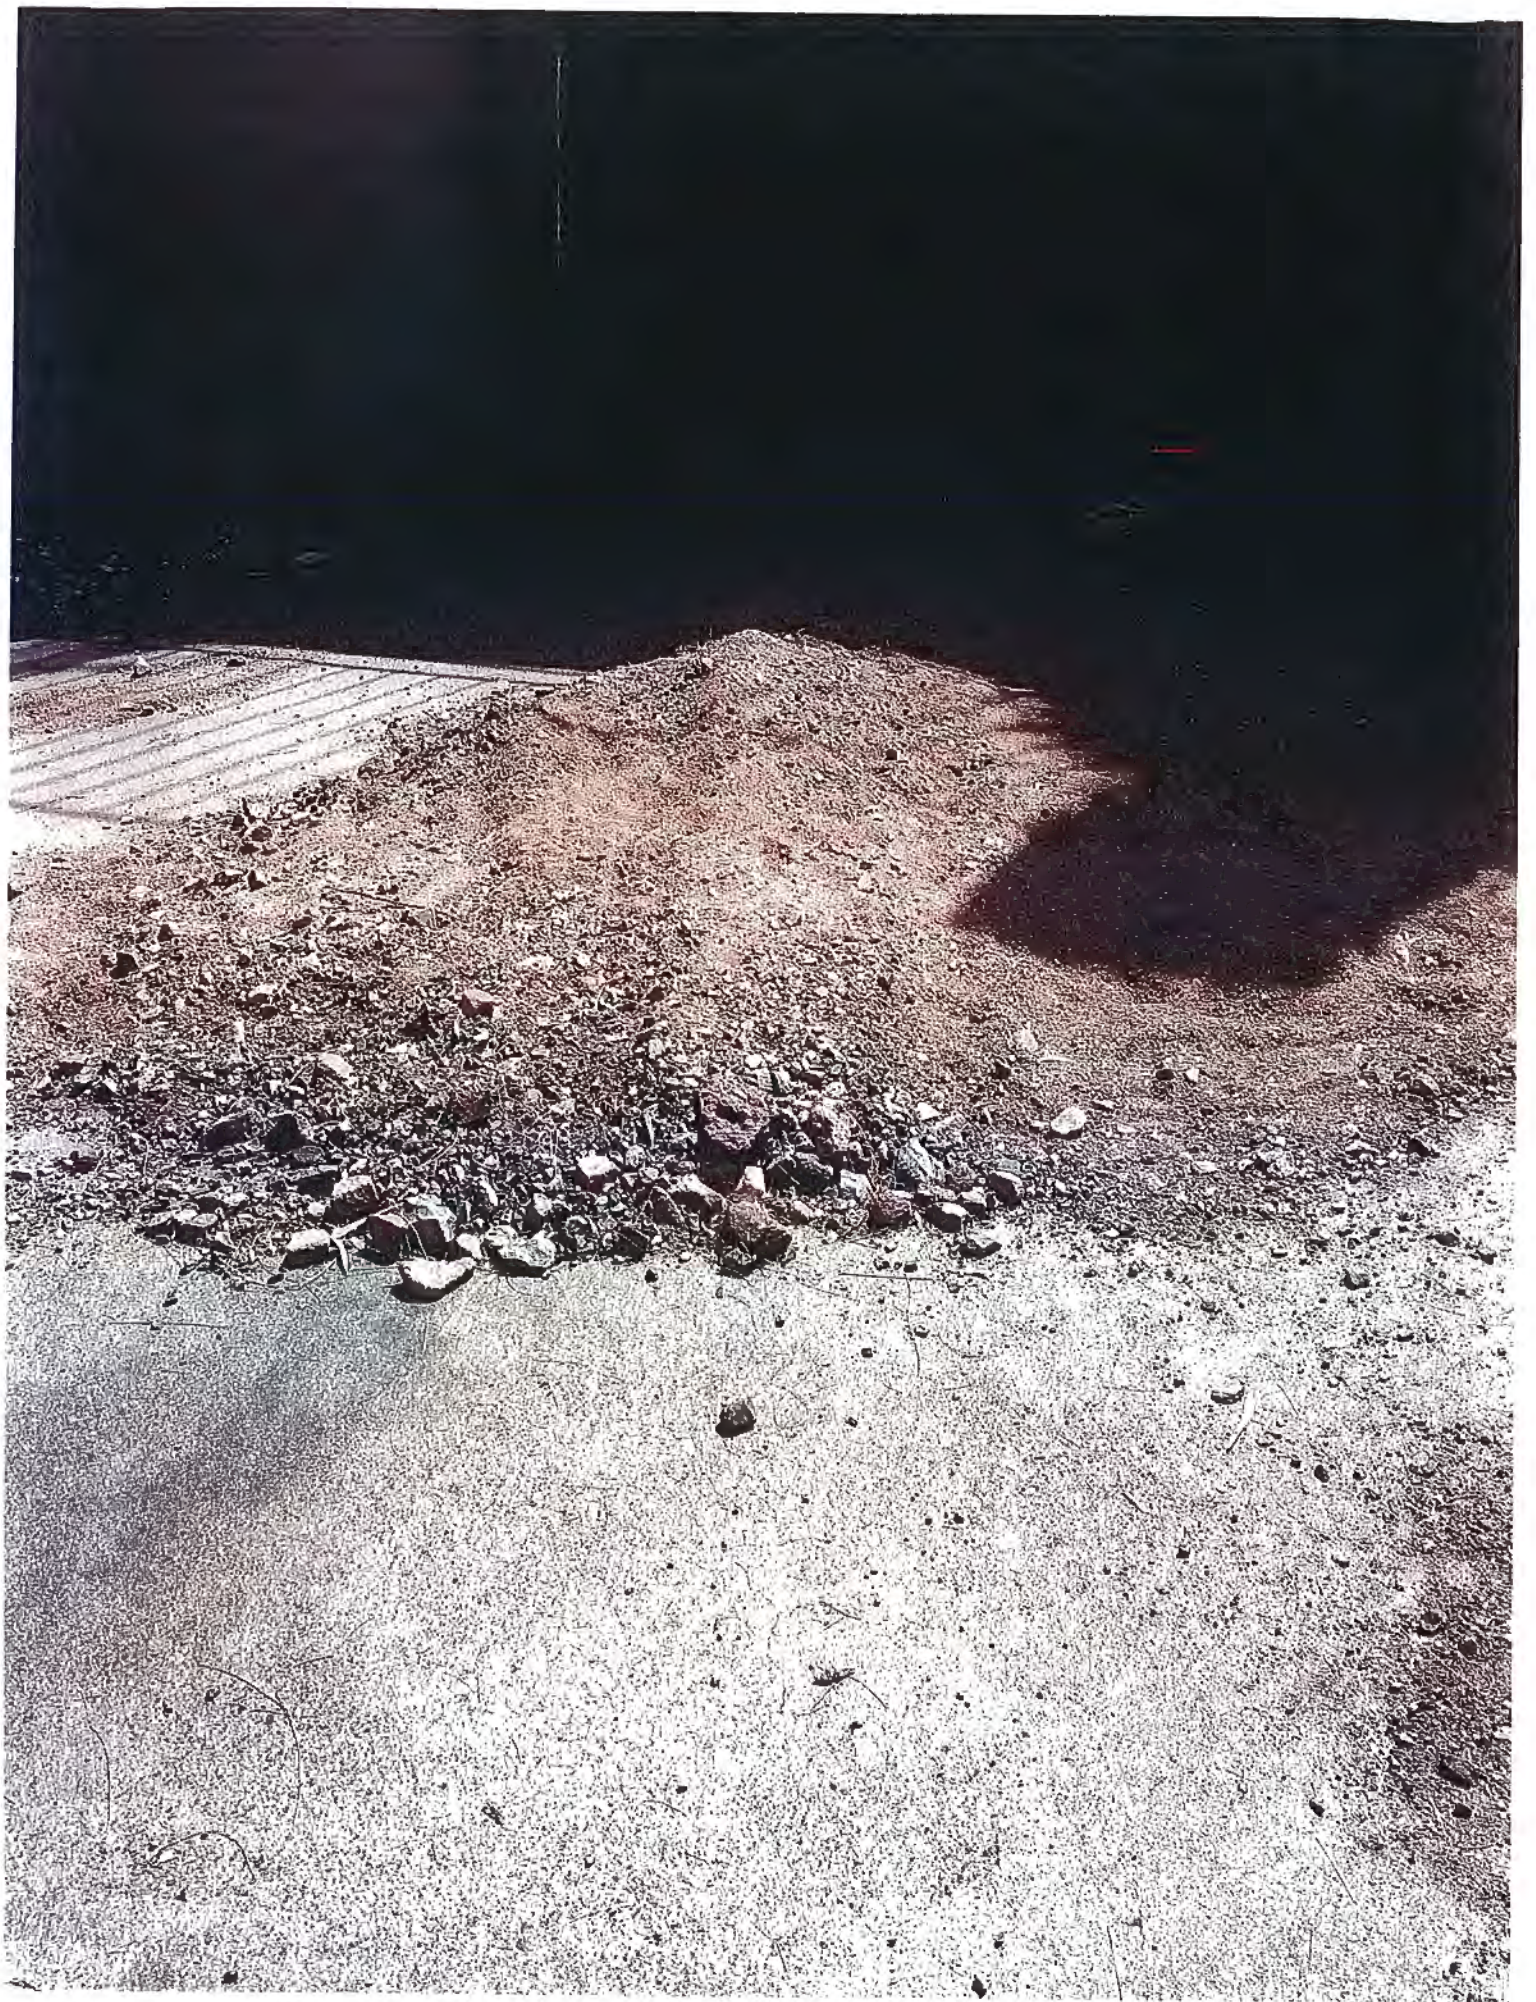
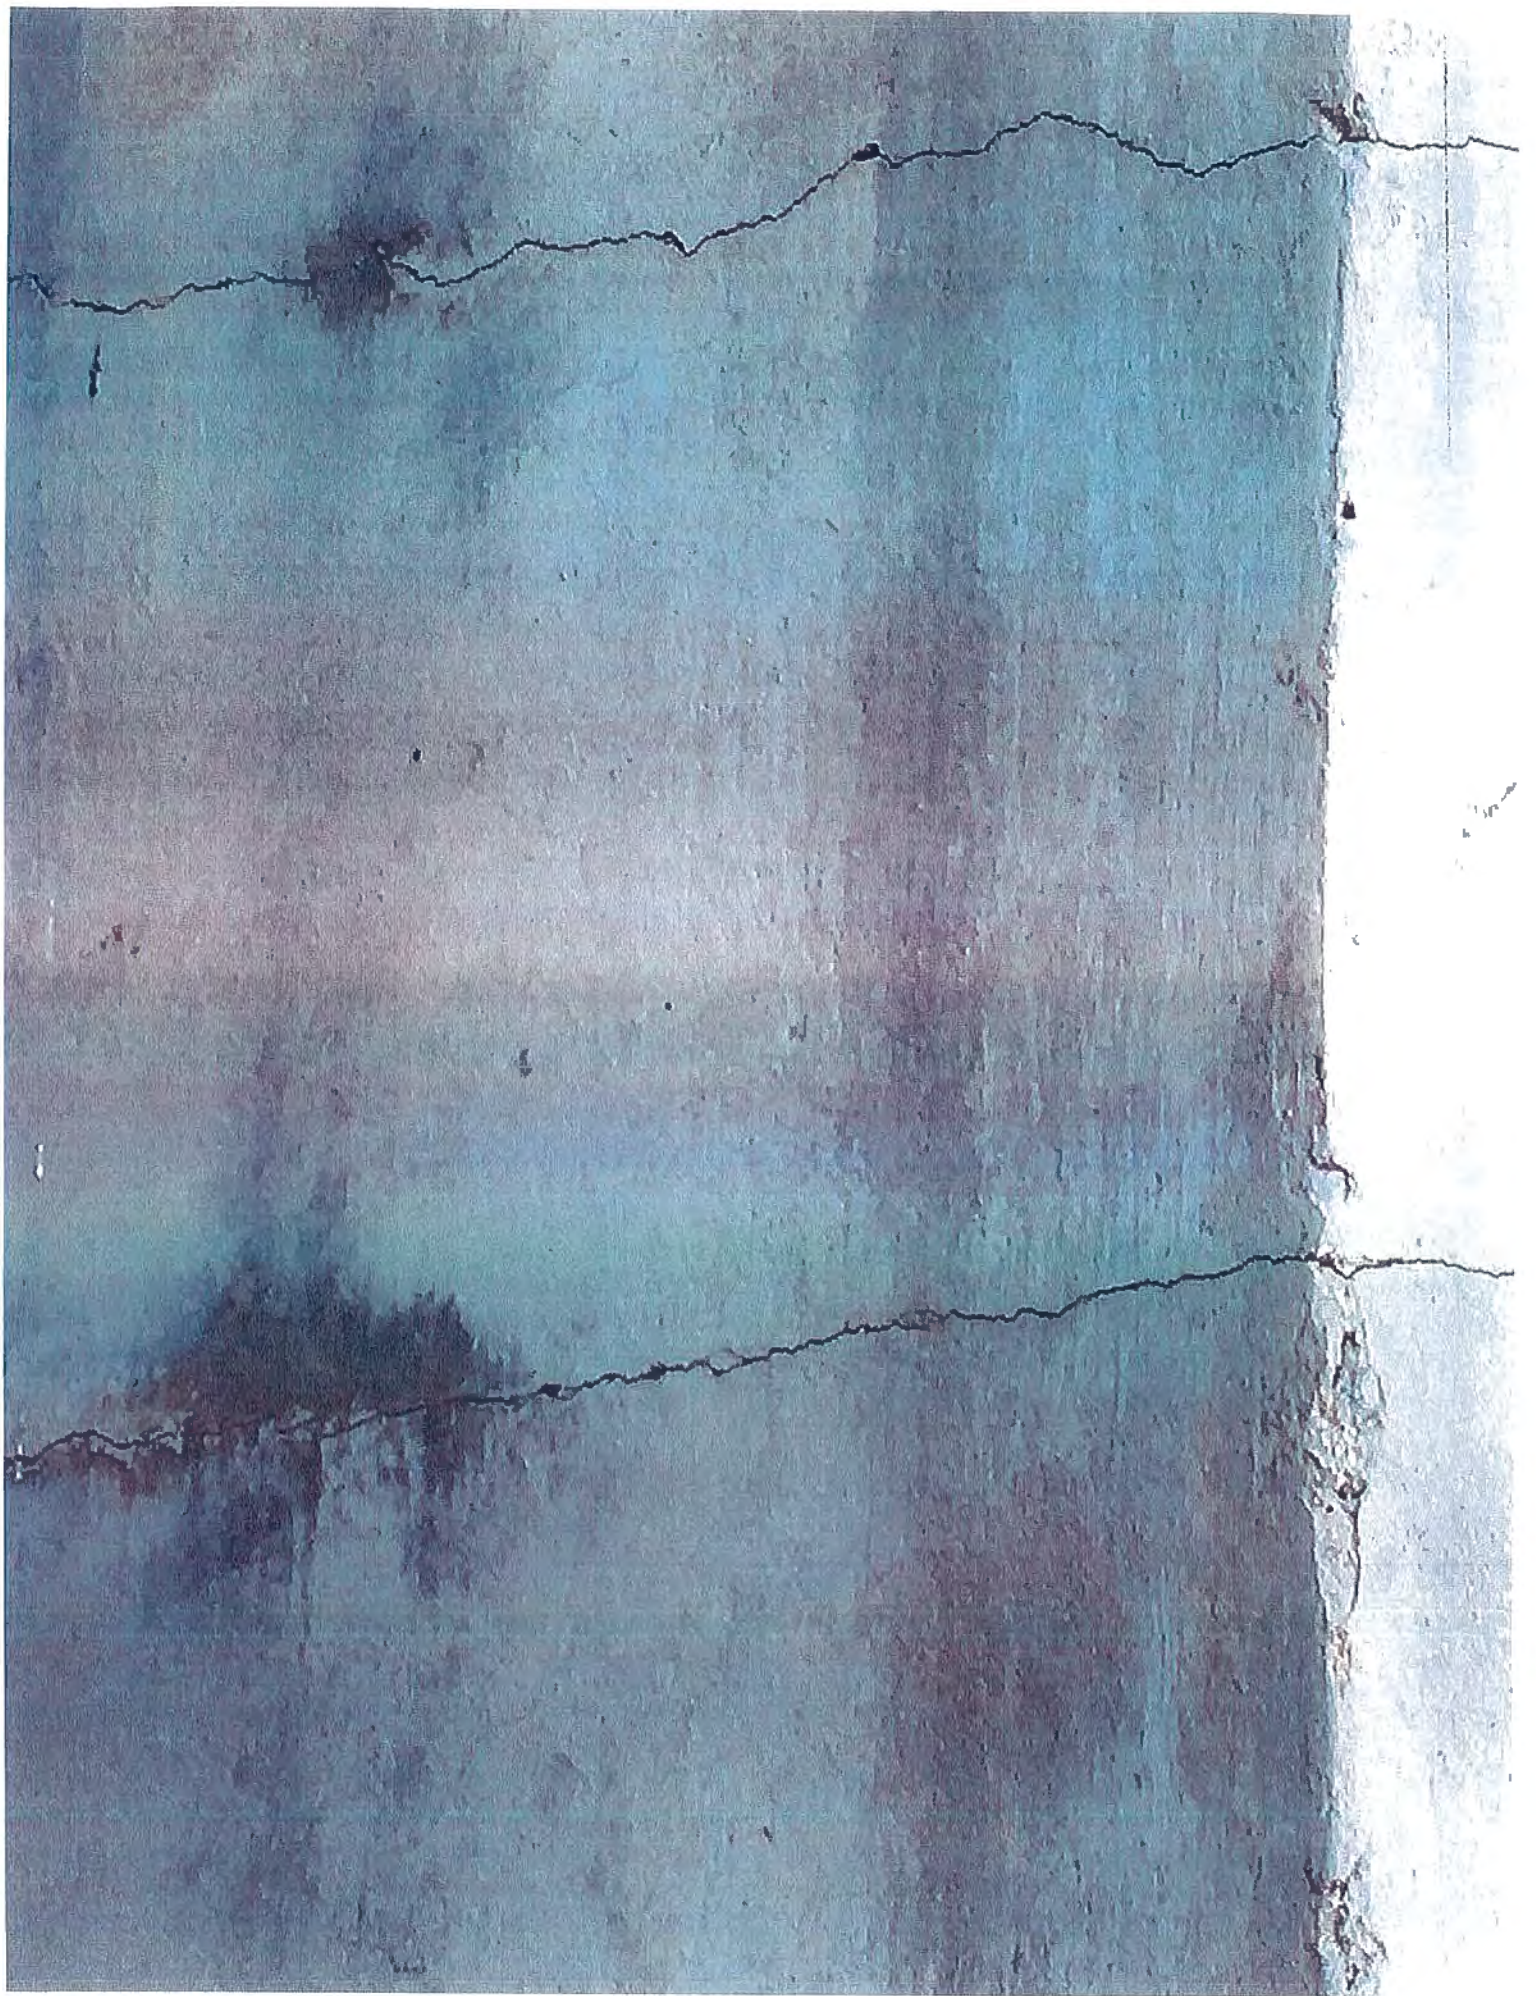
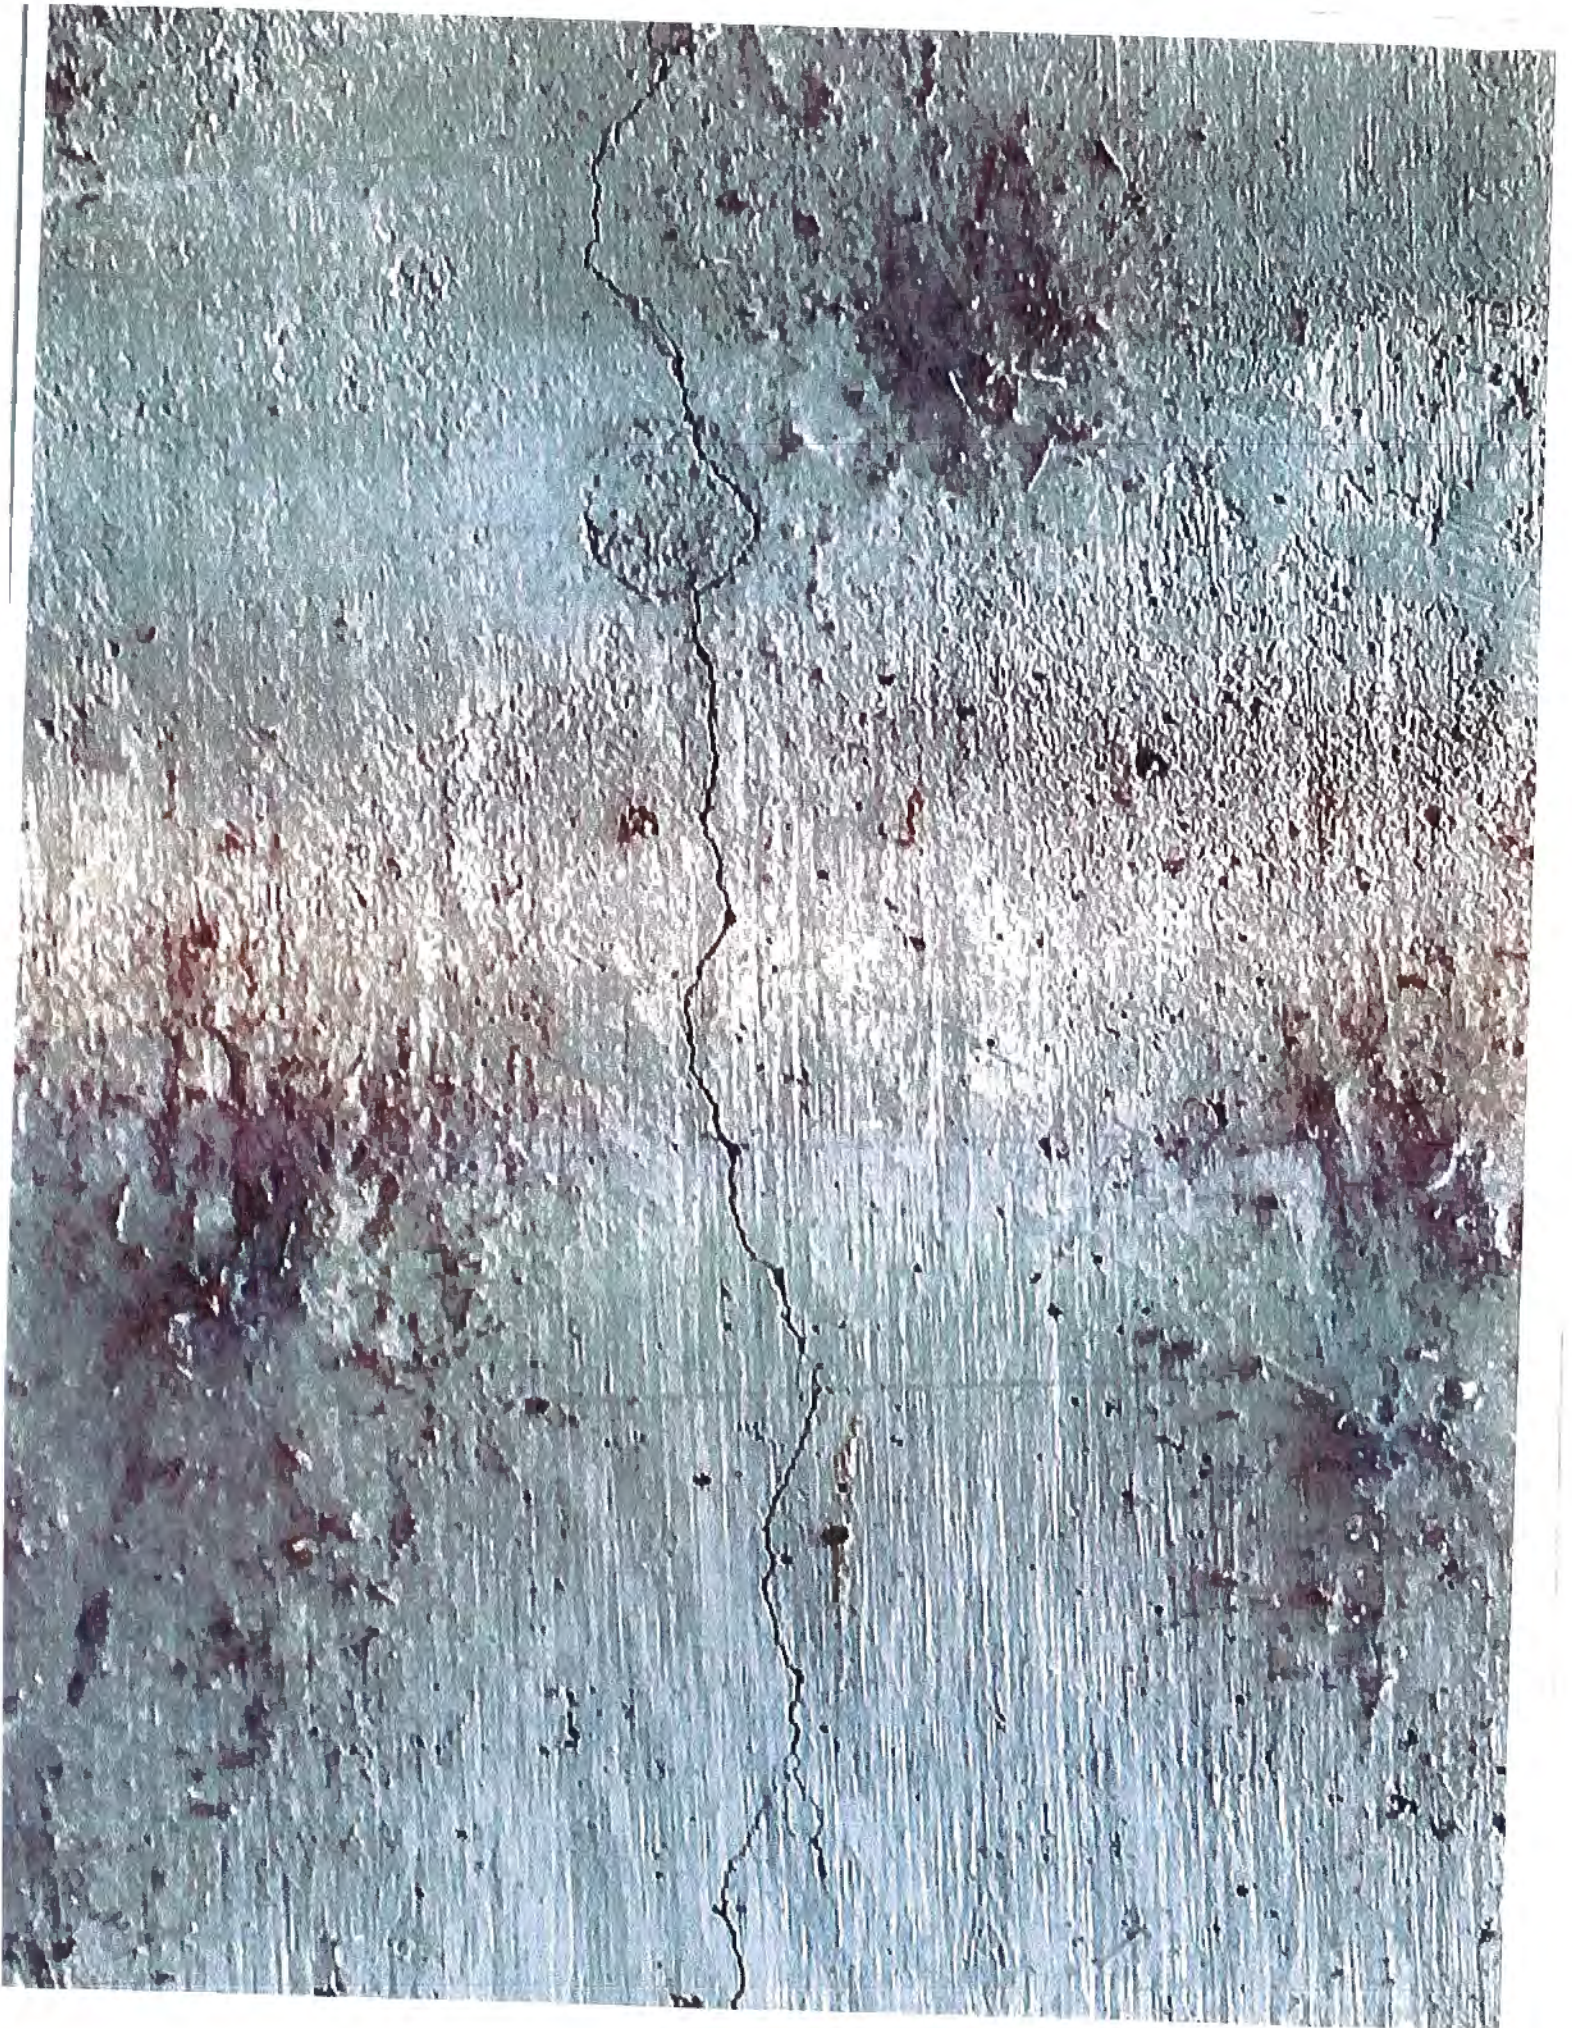
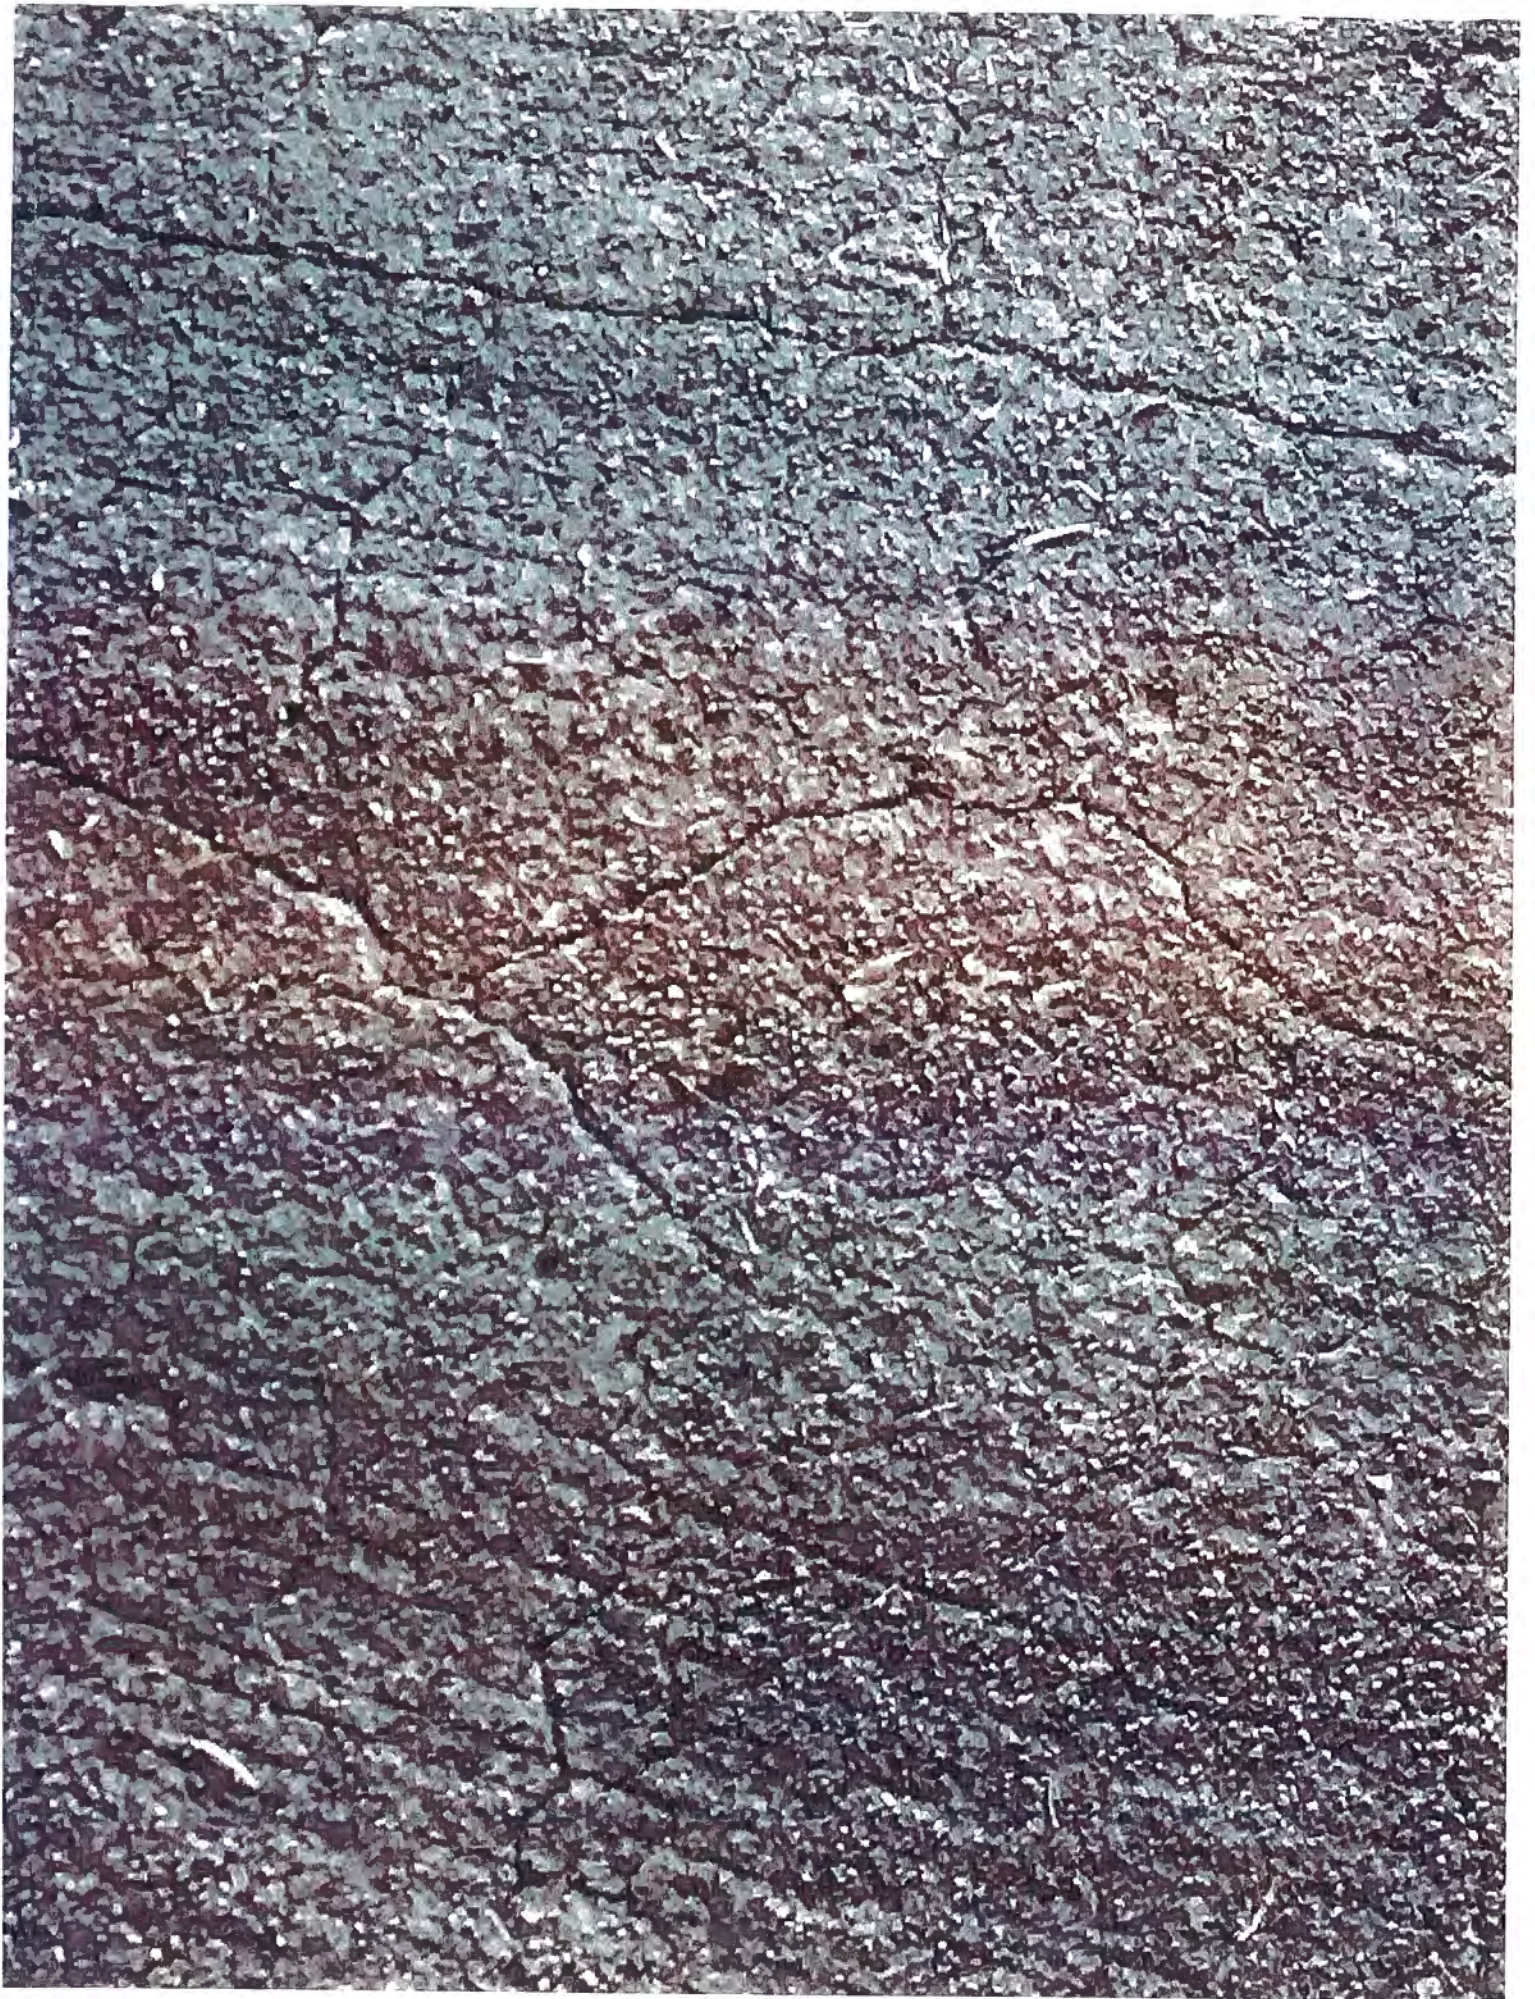
The structure located to the south along Camino del Sol is a two barrel, 10x10 reinforced concrete box culvert. This structure has a couple vertical cracks in the wingwalls on the west entrance, and has very few vertical shrinkage cracks in the walls or cracks in the floor. There is some efflorescence and corrosion present at the construction joints throughout the structure, but there is not active water seepage at this time. The structure overall is in good condition and requires little or no repairs or maintenance at this time. However, the entrance at the west side of this structure has wood planking embedded into earthen areas (fills) with a maximum height of about five feet, and the wooden planks are splitting and many sections have broken and have failed allowing earthen fills to drop out. Additionally, the concrete cart path has many large, scattered cracks, and there is some sediment buildup in the barrels from local drainage activity. These wooden earth retention planks will need to be replaced with some type of soil retention system, and the cart path may require replacement to remove these cracks which could create tripping hazards.
