West Speedway 46kV Distribution Line Emergency Repair Stabilization

Site Location:

3651 West Speedway Blvd/Gates Pass Road

Oct/Dec 2021

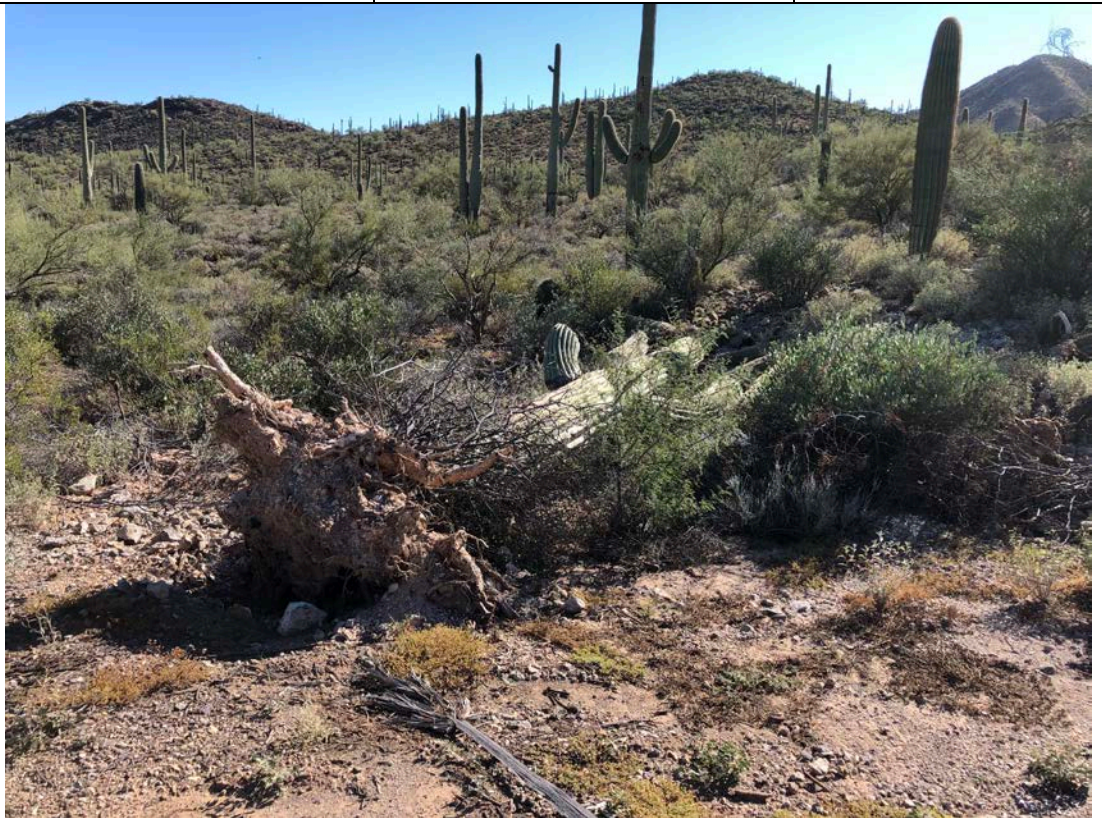
Photo No. 1**Photo Description:**

Multi-armed saguaro that was blown down with the three poles including the communication lines and the electrical conductor.

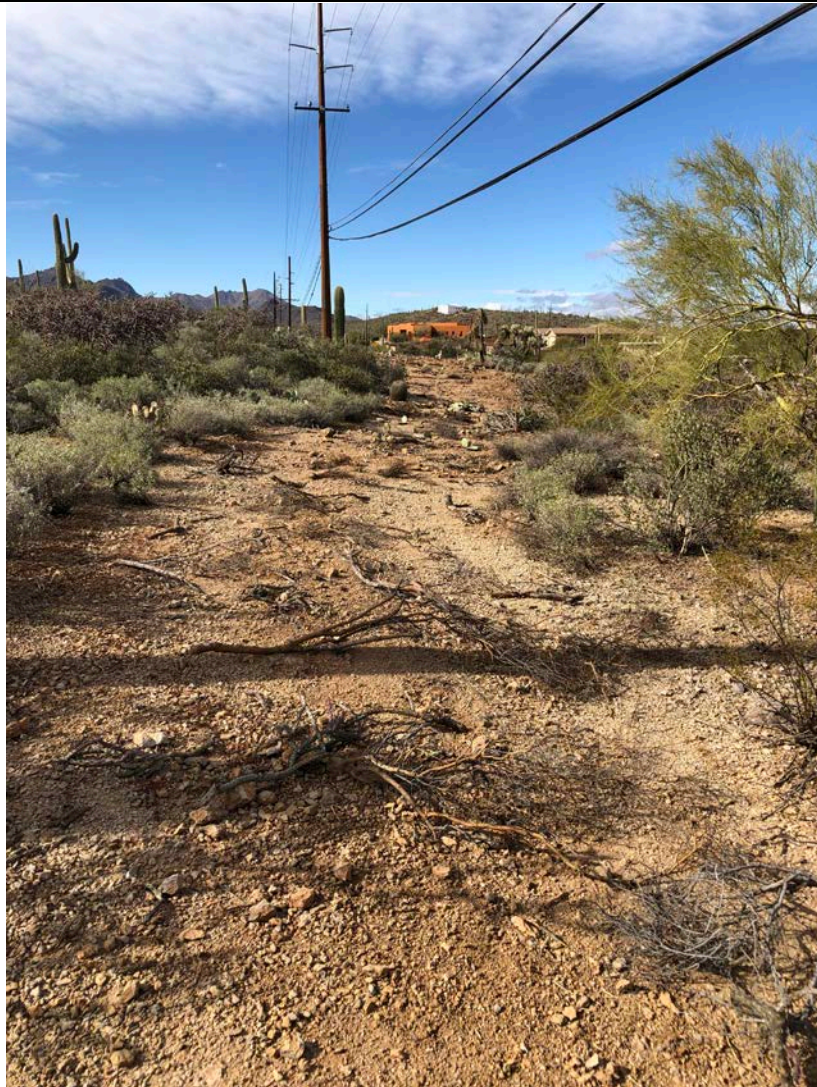
Photo No. 2

After stabilization.
Saguaro was removed
from the access road as
requested by the County
ROW inspector.

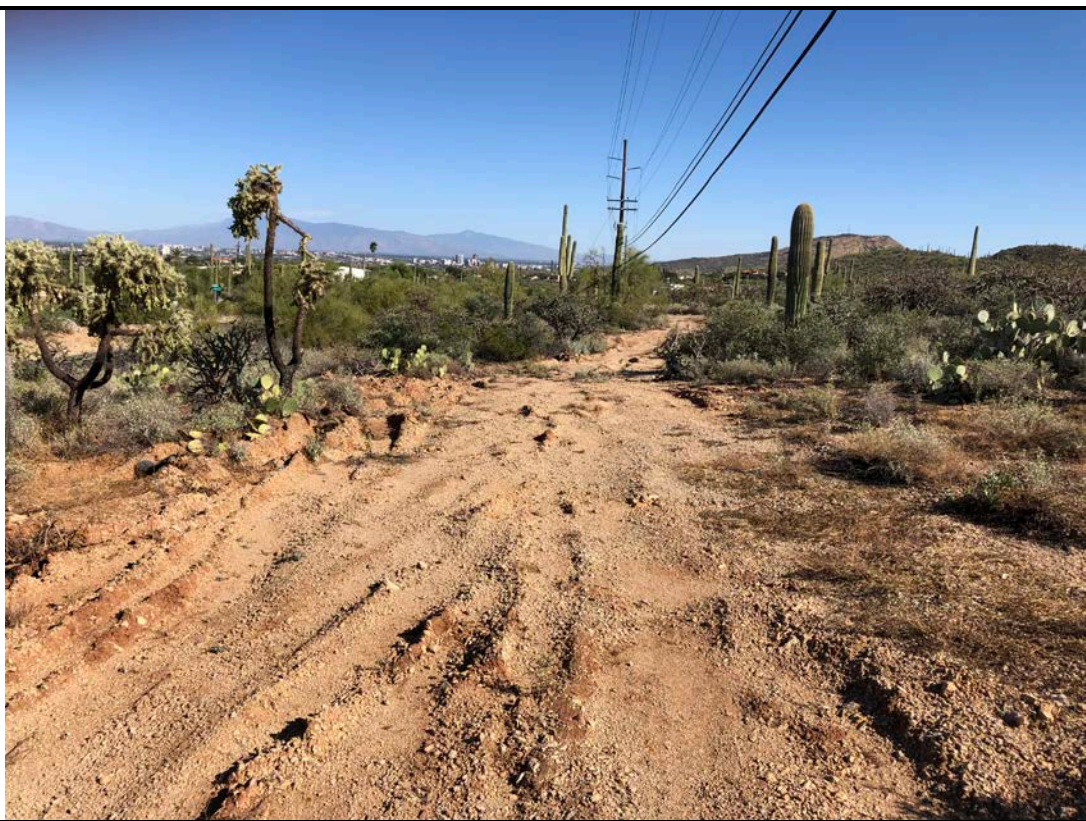
Photo No. 3

Photo Description:
Central access road
after emergency repair
looking east.

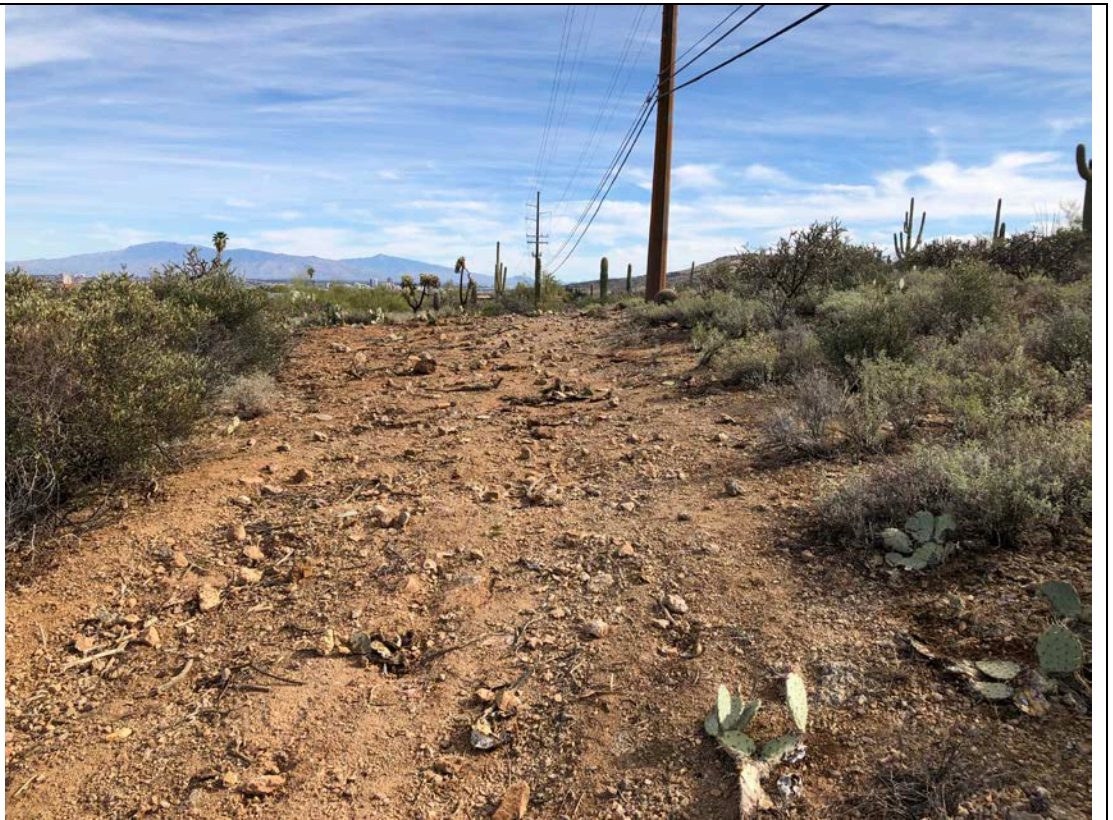
Photo No. 4

Photo Description:
Central access road
after stabilization
looking east.

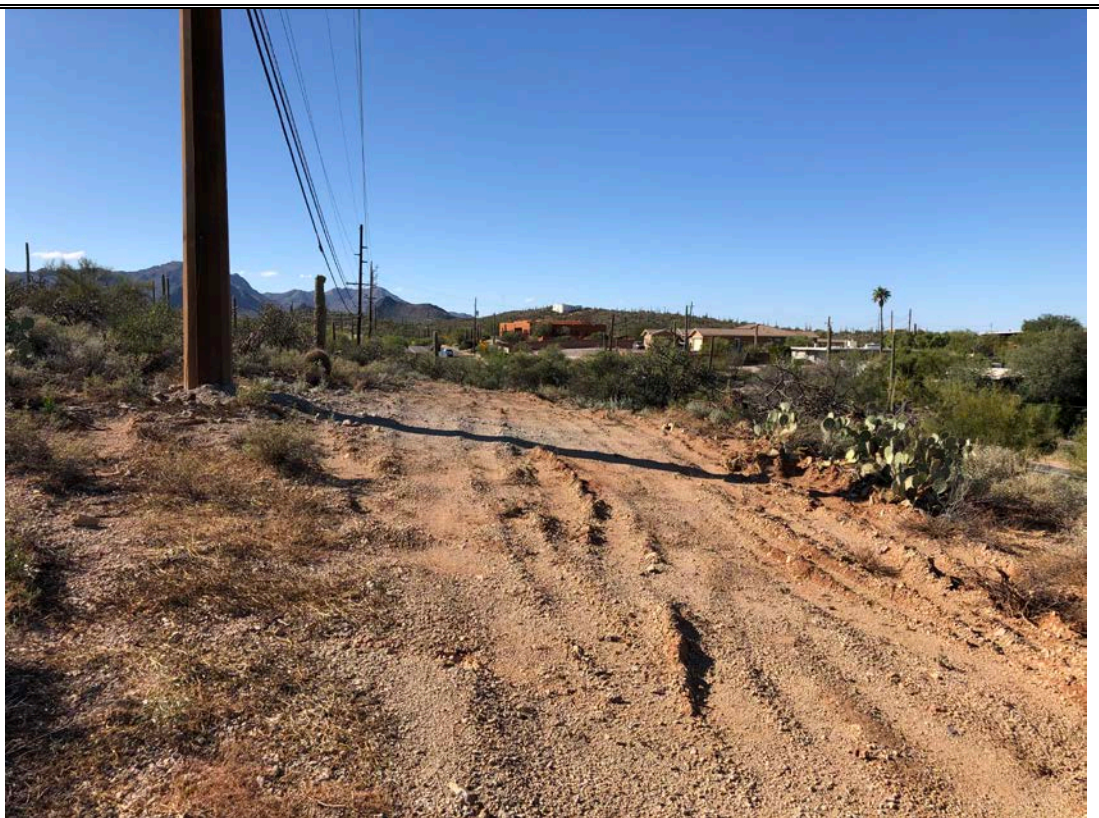
Photo No. 5

Photo Description:
Central access road
after emergency repair
looking west.

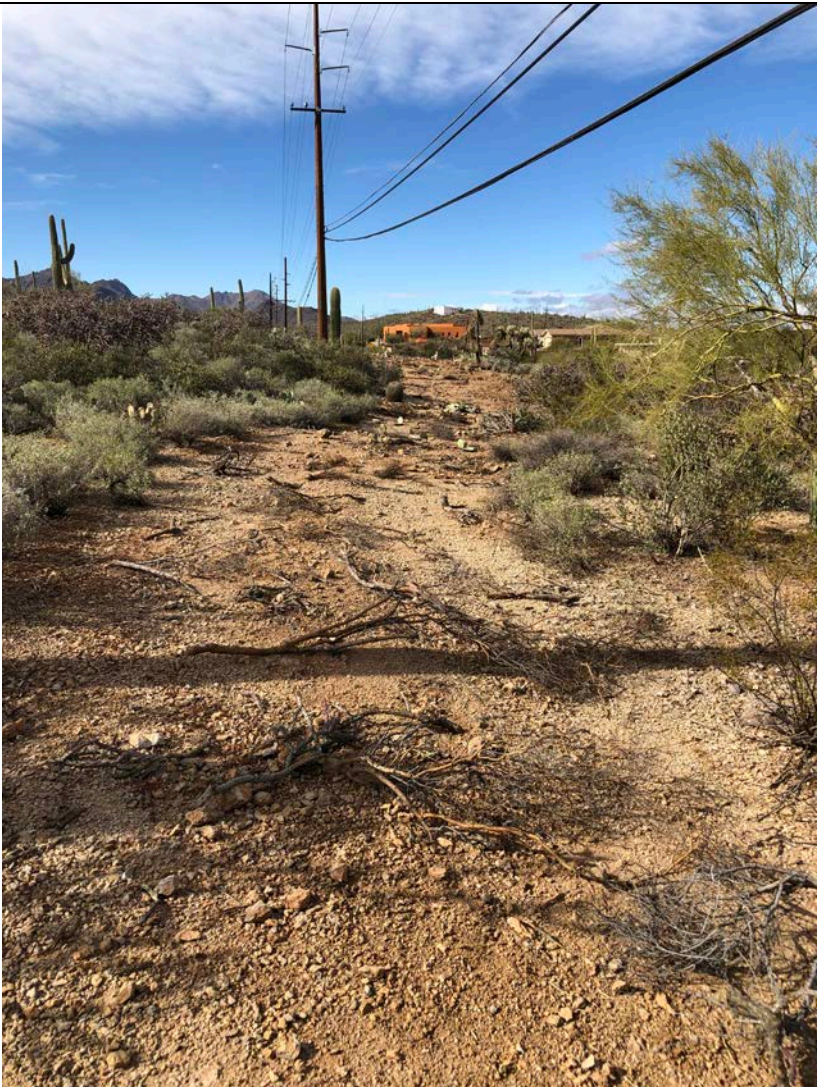
Photo No. 6

Photo Description: Central access road after stabilization looking west.

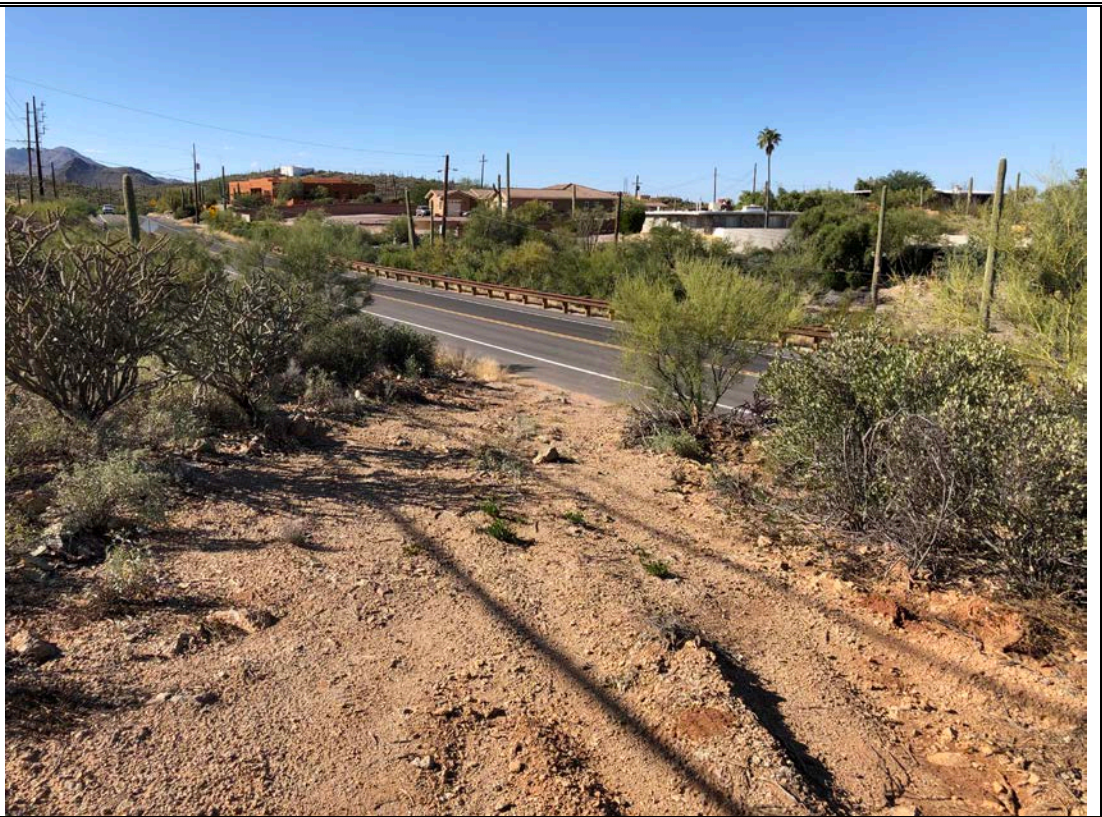
Photo No. 7

East access road after
emergency repair
looking west.

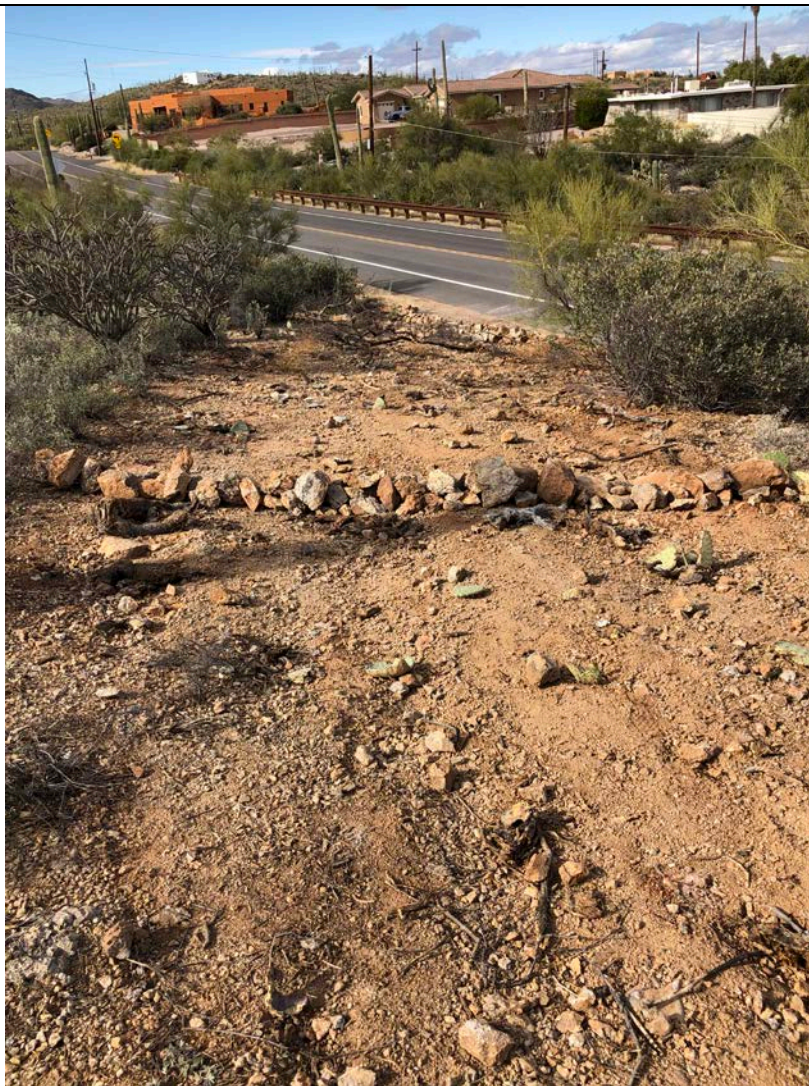
Photo No. 8

East access road after stabilization looking west.

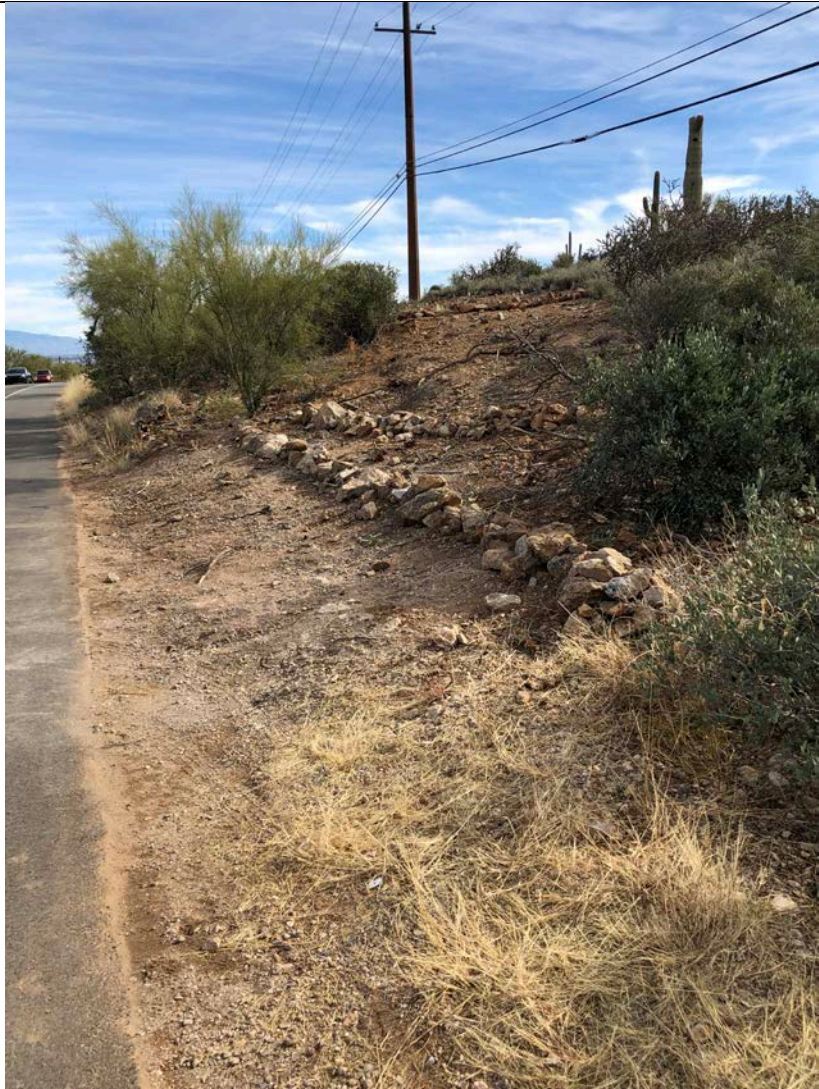
Photo No. 9

East access road after
access control looking
east.
