Red Point Development, Inc.
 SOUTH SIDE HARDY RD, EAST OF THORNYDALE RD
 (Ownership Entities: Hardy-Thornydale I Associates, Fidelity National Title Trust #10760)
 REZONING: SR to CR-5

EXHIBIT I-C.4a-e
 ONSITE HYDROLOGY
 PAGE 15

EXHIBIT I-D.3,7-10
 VEGETATIVE COMMUNITIES
 PAGE 20

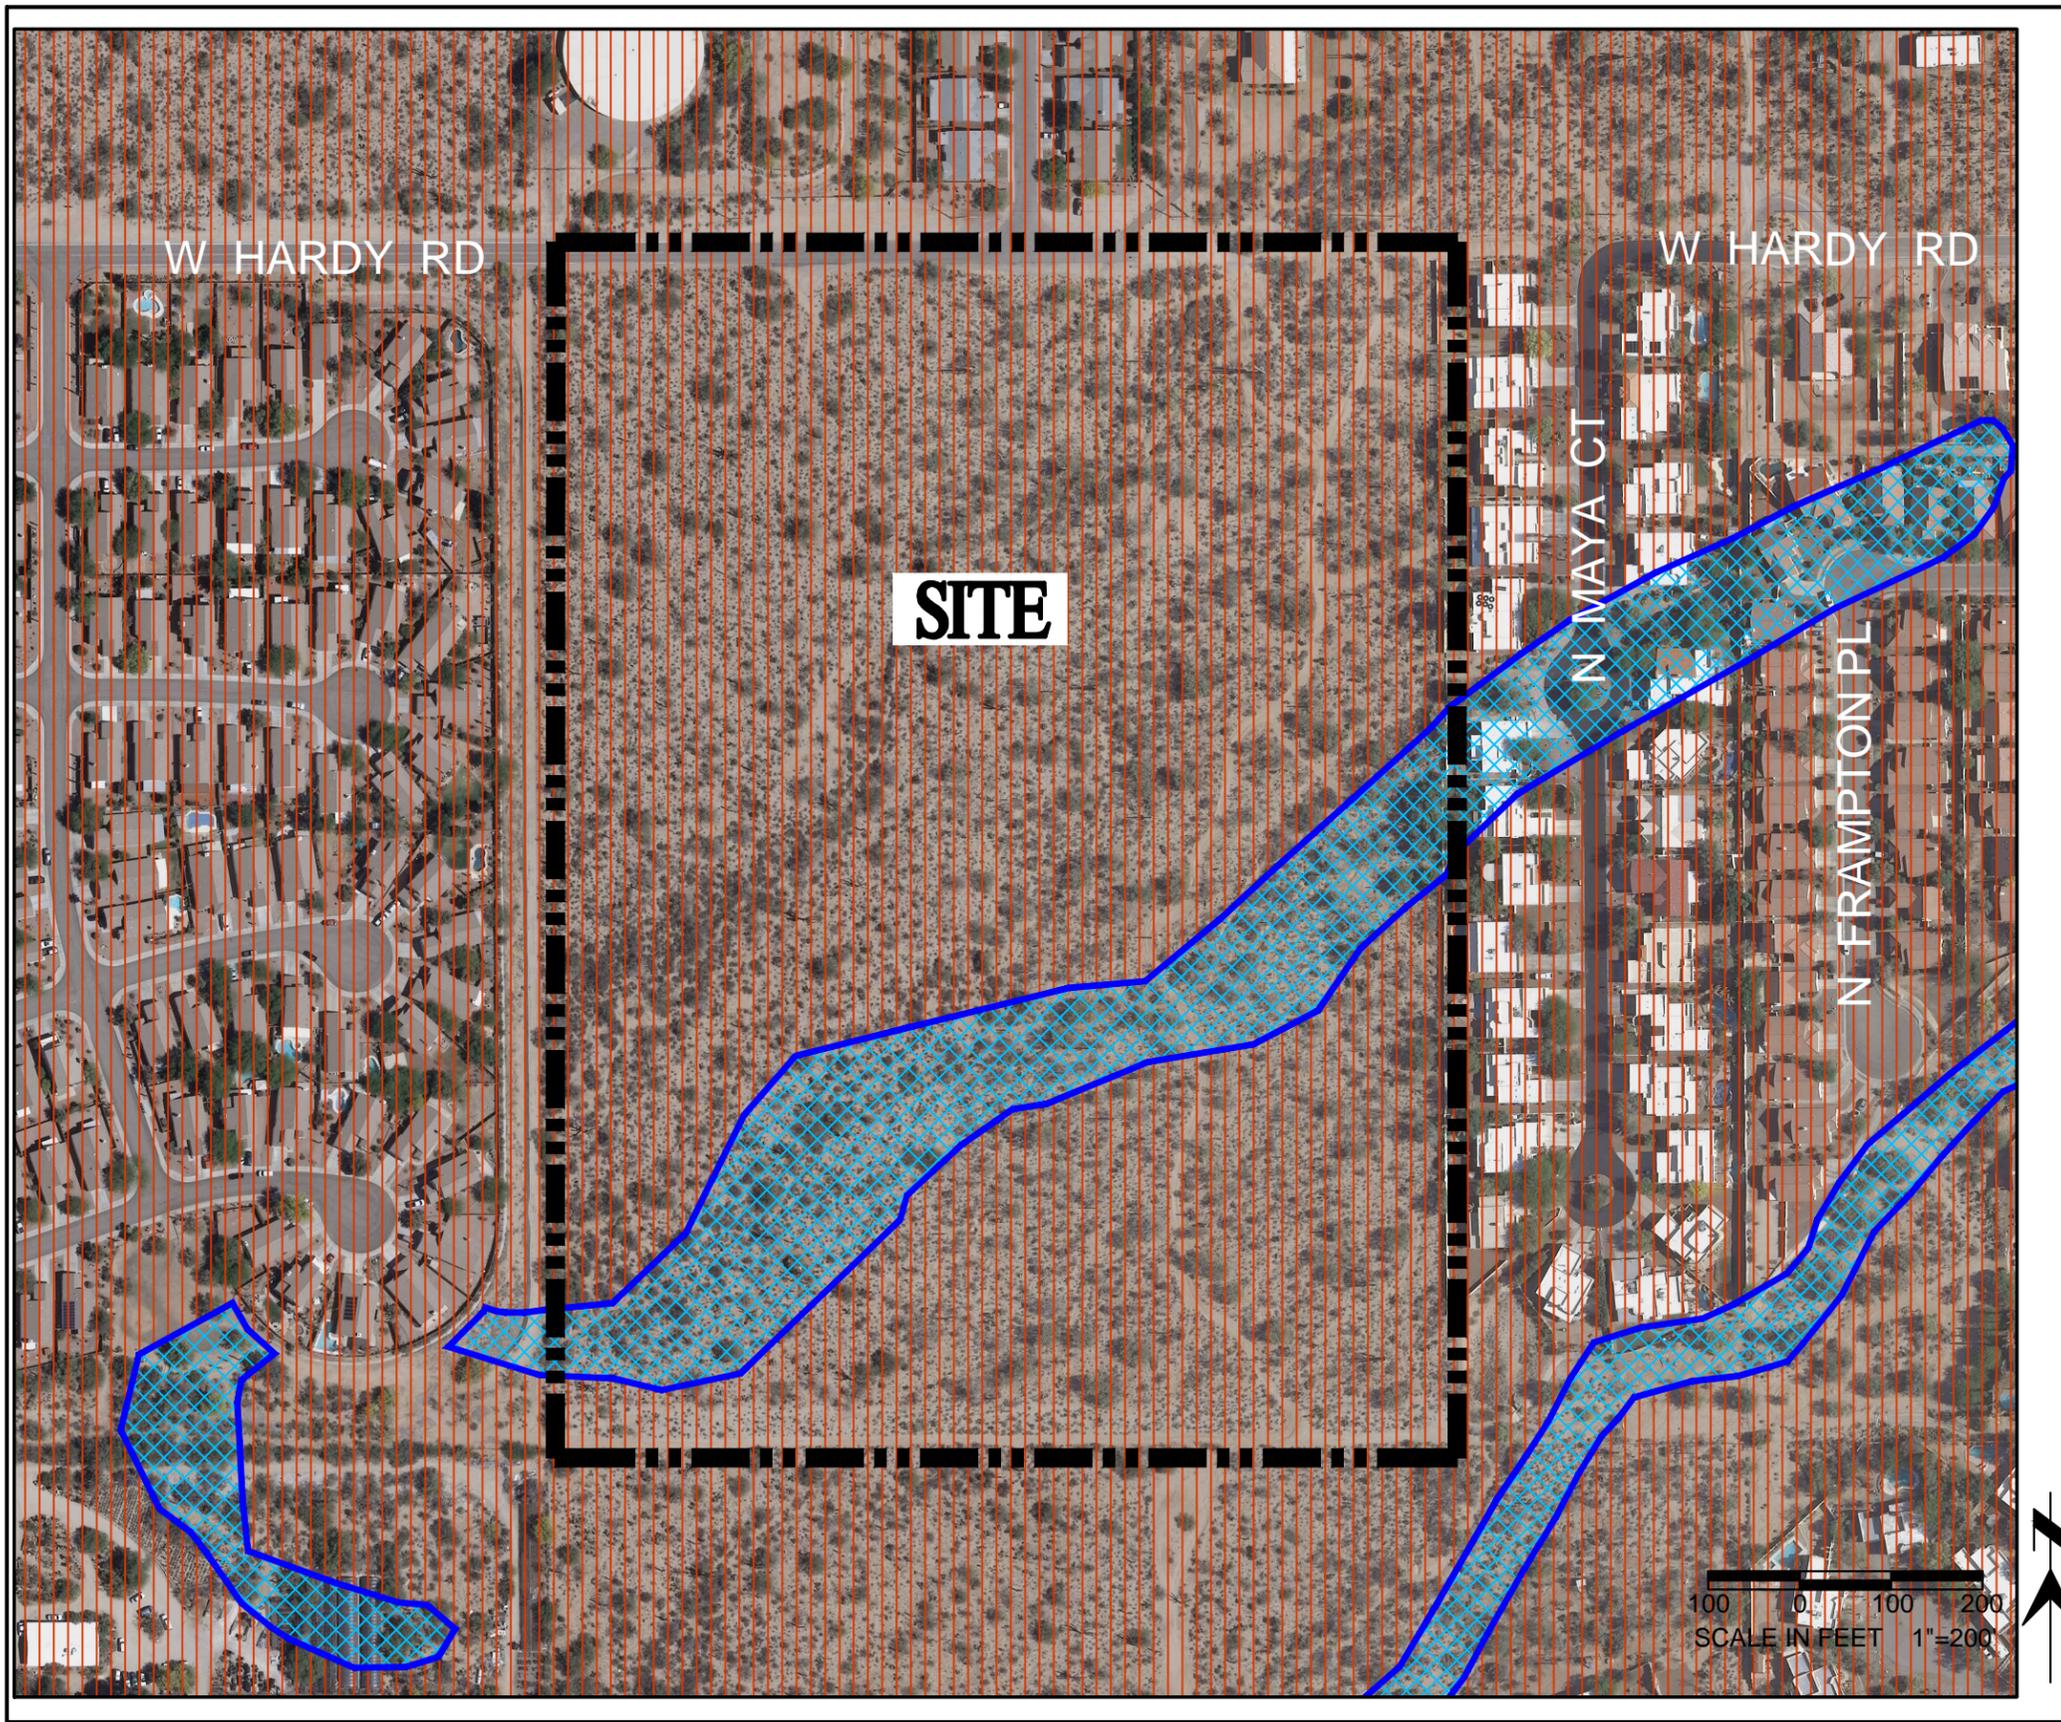
Rezoning Site
 Entire site and surrounding area falls within
 Multiple Use Management Area (MUMA) and
 Special Species Management Area (SSMA)
 CLS Designation.
 (Approximately 29.8 AC prior to Dedications.)

Multiple Use Management Area (MUMA) and
 Special Species Management Area (SSMA) with
 underlying Xeroriparian "C" Riparian Area
 Approx 3.7 AC

Multiple Use Management Area (MUMA)
 and Special Species Management Area (SSMA)
 Approx 26.1 AC

Entire Rezoning Site falls within
 MUMA and SSMA CLS Designation

The entire site falls within the Maeveen Marie Behan Conservation Lands System (MMBCLS), being classified as CLS *Multiple Use Management Area* and *Special Species Management Area (SSMA)*. While not a CLS category, the site also has underlying *Xeroriparian "C"* regulated riparian habitat. Exhibit I-D.1.2 shows the limits of these areas within the property.

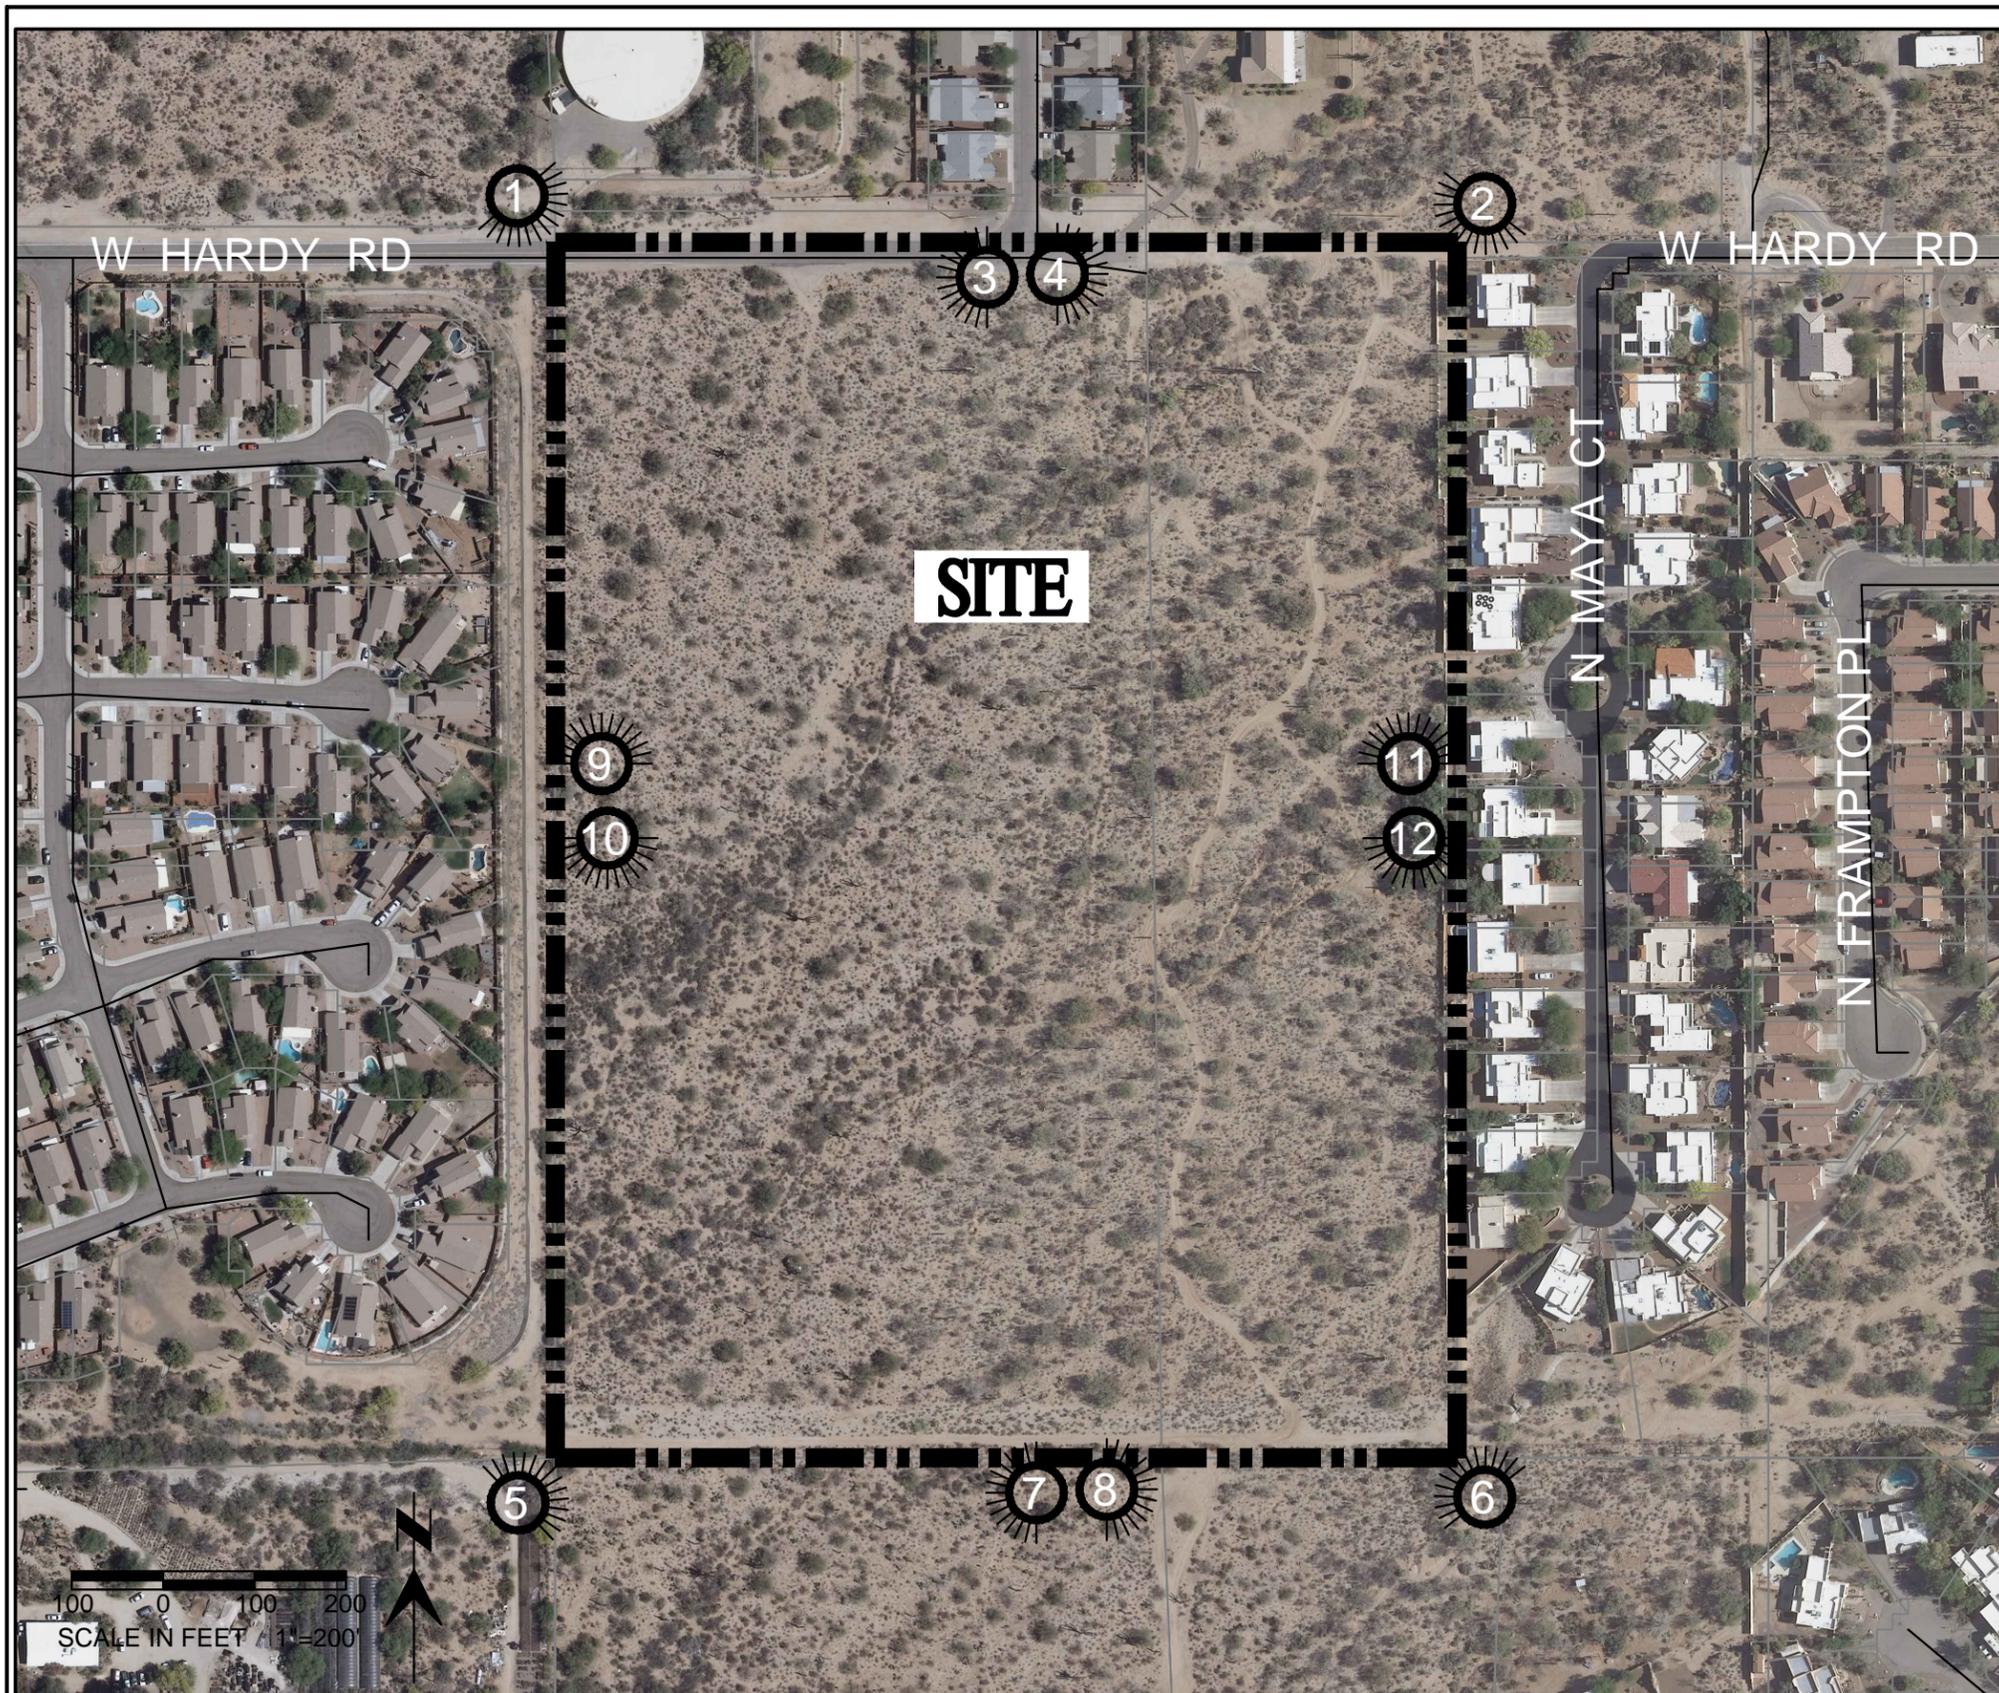
1. Looking southeast.
2. Looking southwest.
3. Looking west.
4. Looking east.
5. Looking northeast.
6. Looking northwest.
7. Looking west.
8. Looking east.
9. Looking north.
10. Looking south.
11. Looking north.
12. Looking south.

Radial Lines indicate Direction and Extent of Photo View; see subsequent exhibits for pictorial survey.

Ground level photographic mosaics have been provided at pertinent boundary locations surrounding the subject property. The photo location points are depicted on Exhibit I-E.2a. The photographic mosaics are depicted on Exhibits I-E.2b through I-E.2g. In general, the views across the site are unremarkable in the foreground and mid-ground ranges. The most notable and high-quality views are northward in the direction of the distant Tortolita Mountains, westward toward the distant Tucson Mountains, eastward in the direction of the distant Santa Catalina Mountains.

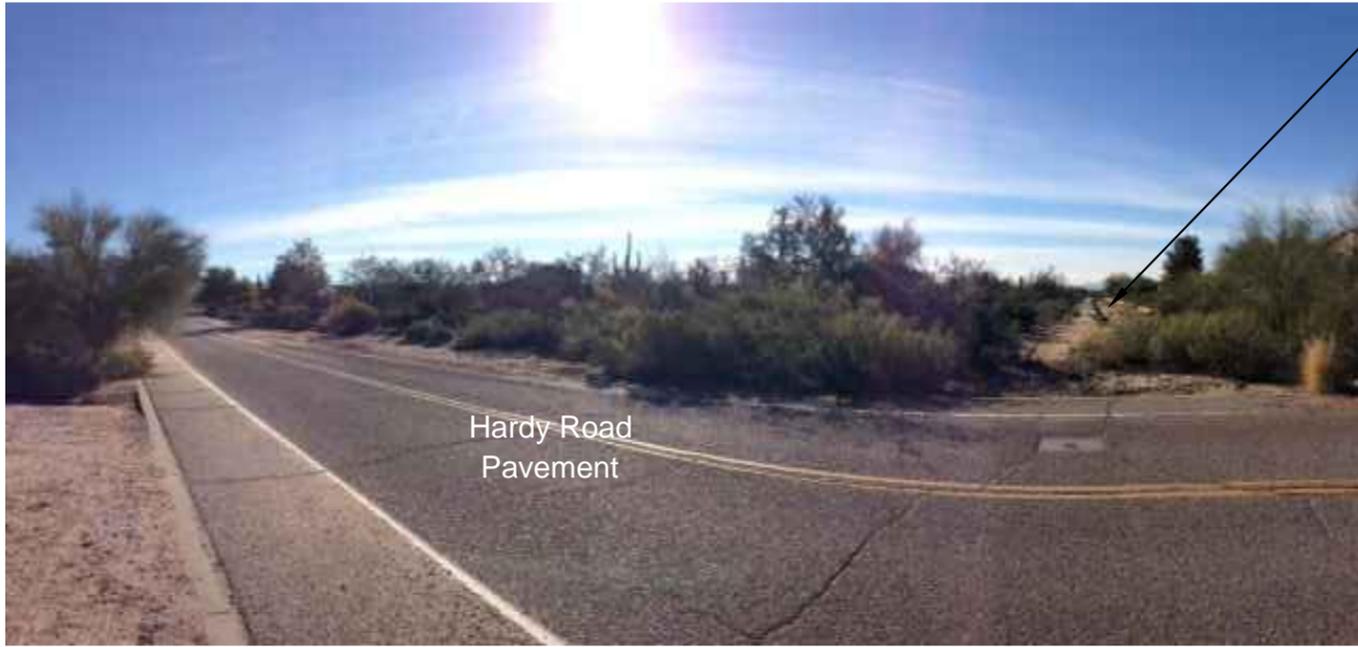
PHOTO LOCATION 1: View from northwest corner of the project, looking southeast at the property.

Existing Concrete-Lined Drainage Channel within existing/adjacent Sunnyvale Subdivision.

Hardy Road
Pavement

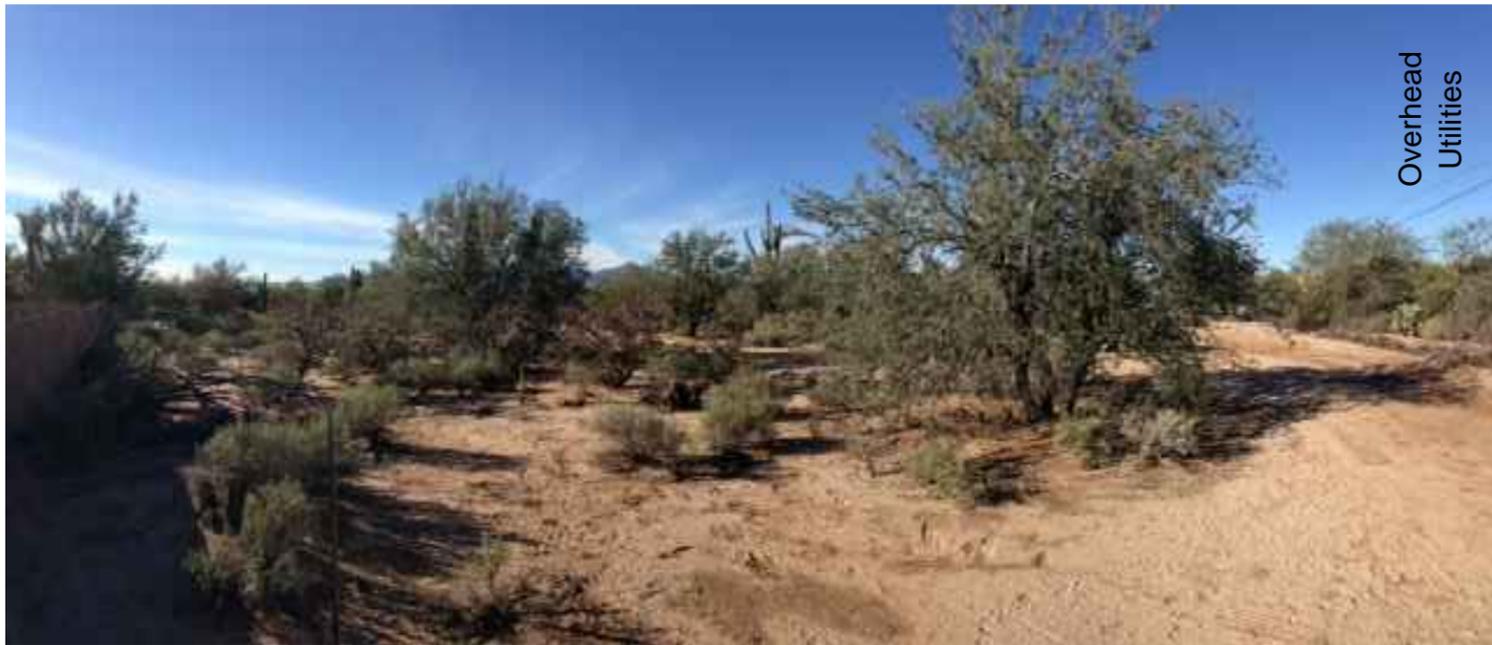
PHOTO LOCATION 2: View from northeast corner of the project, looking southwest at the property.

Overhead
Utilities

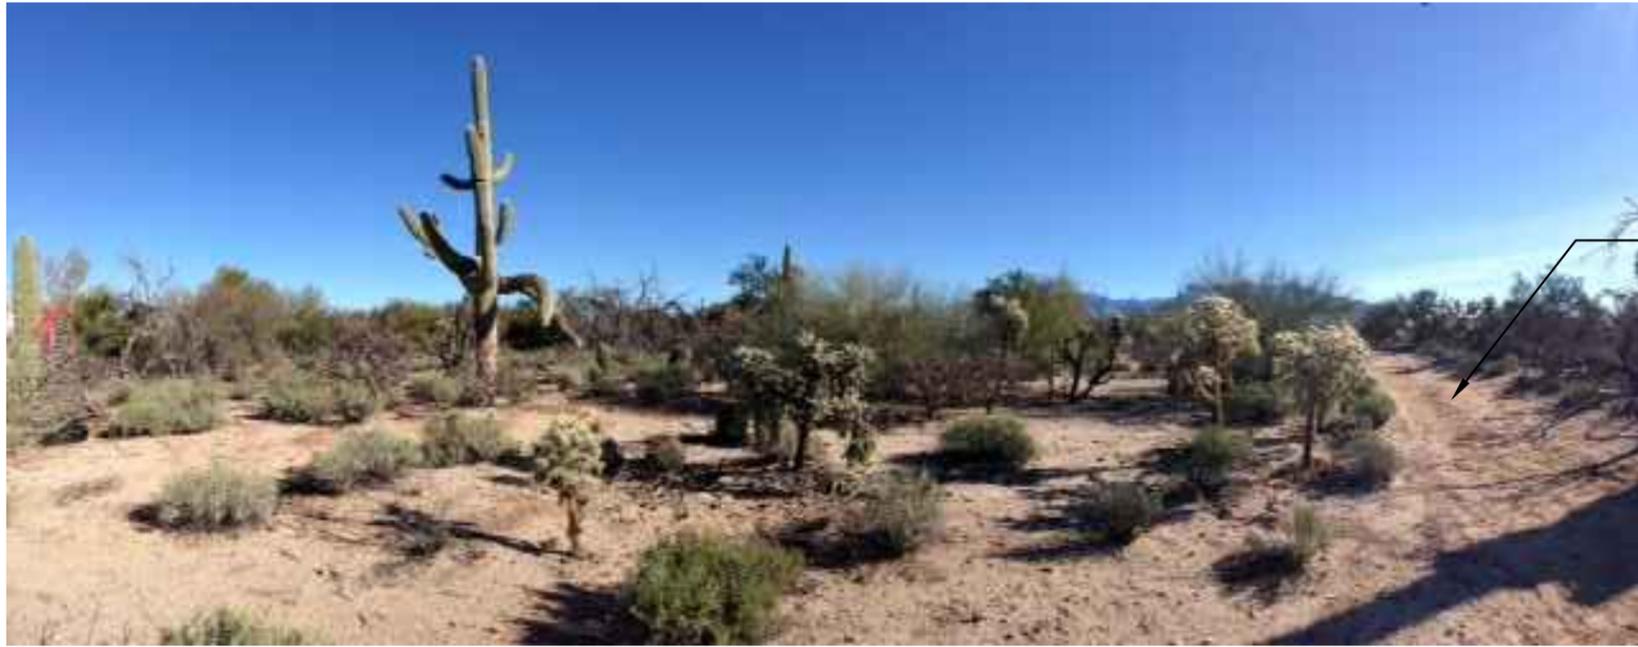
PHOTO LOCATION 5: View from southwest corner of the project, looking northeast at the property.

Existing dirt road along Site's south boundary.

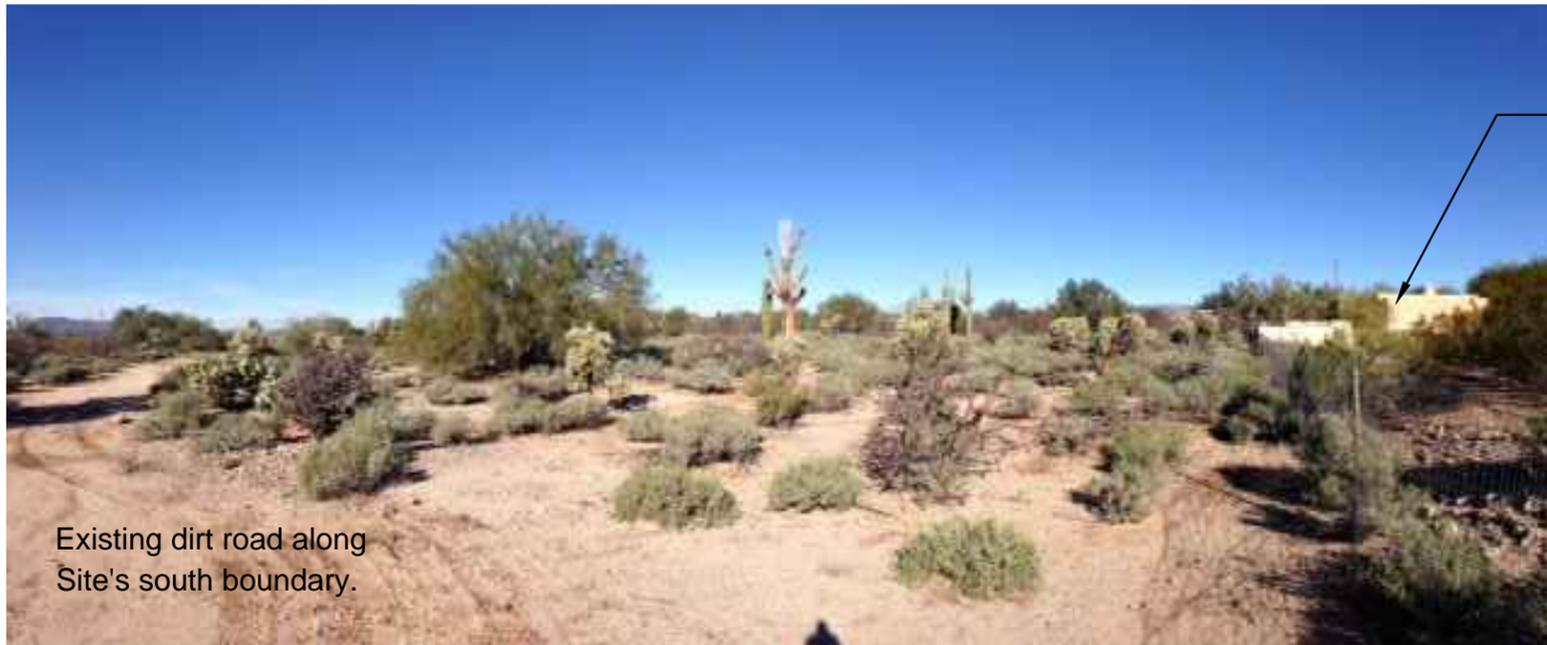
PHOTO LOCATION 6: View from southeast corner of the project, looking northwest at the property.

Existing/adjacent Maya Court Subdivision

Existing dirt road along Site's south boundary.
