NWC MAGEE & THORNYDALE ROADS  
 (Ownership Entity: Mandarin Associates)  
 REZONING: SR to CR-5

EXHIBIT I-B.1a-e  
 TOPOGRAPHIC  
 CHARACTERISTICS  
 PAGE 11

**Red Point Development, Inc.**  
 NWC MAGEE & THORNYDALE ROADS  
 (Ownership Entity: Mandarin Associates)  
 REZONING: SR to CR-5

**EXHIBIT I-C.4a-e**  
 ONSITE HYDROLOGY  
 PAGE 16

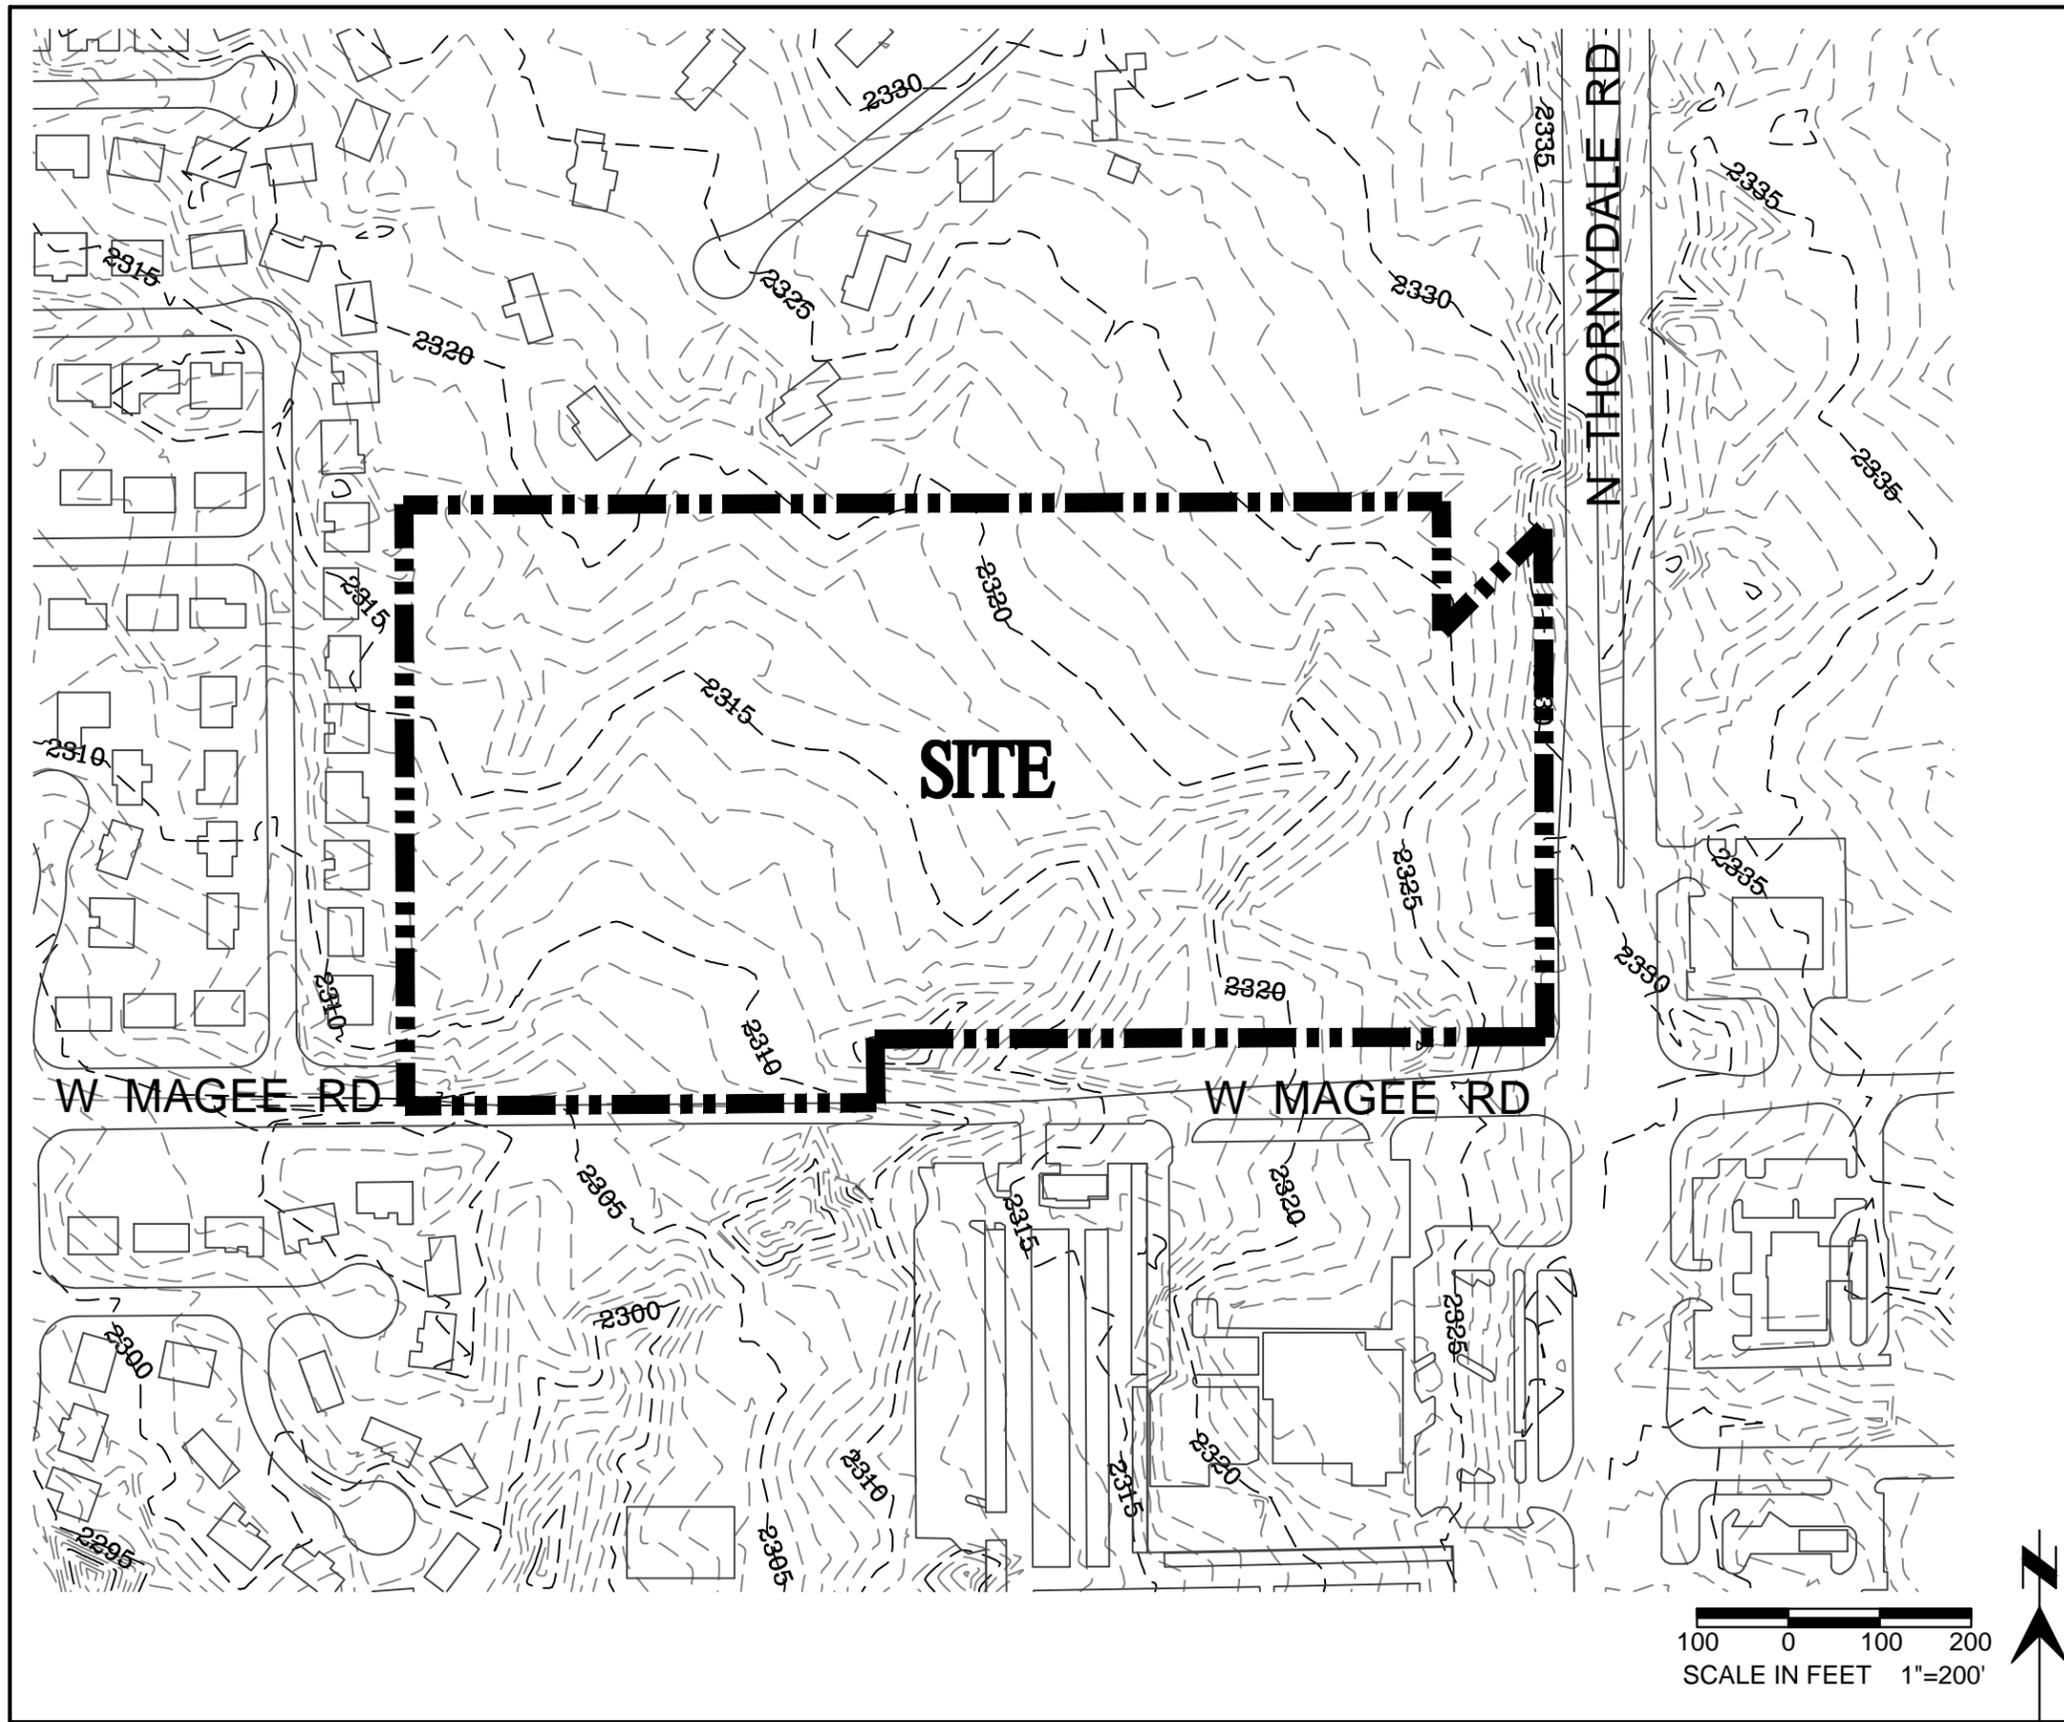
Existing Condition Topographic Contour (1' Interval)

Average Cross Slope = 2.15%

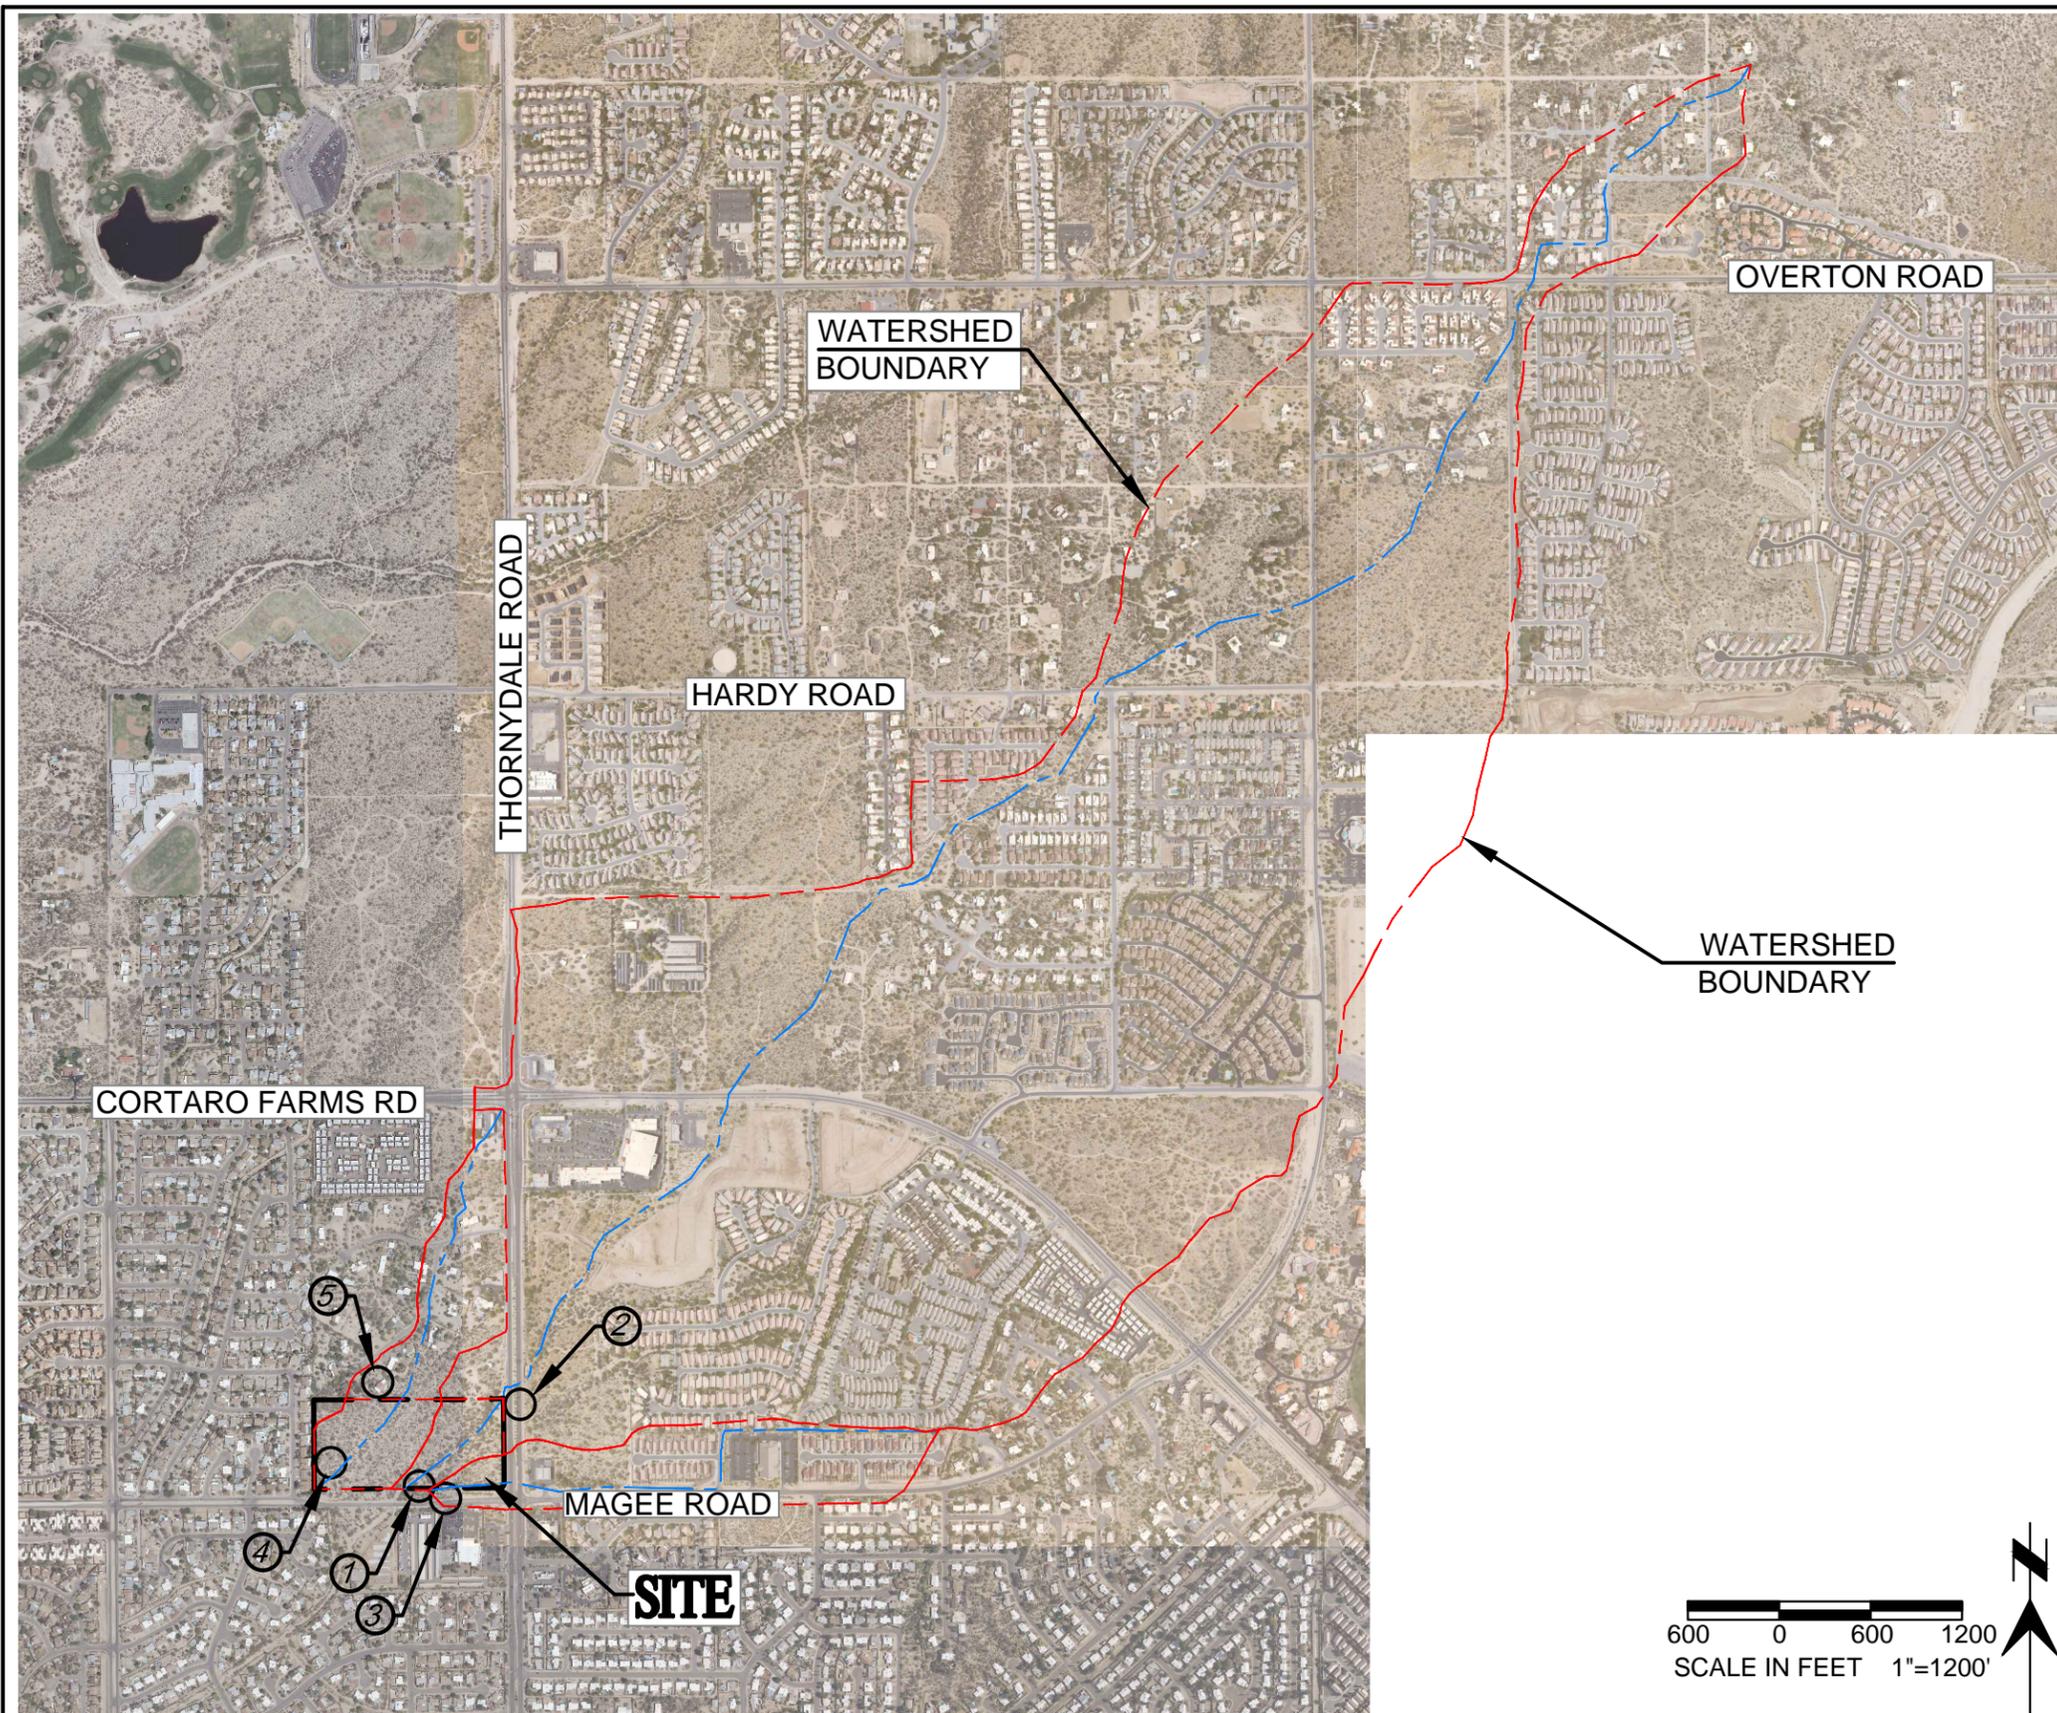
The boundary of the off-site watersheds contributing stormwater to the subject Magee Road property are shown on Exhibit I-C.1. Four (4) specific offsite watersheds were delineated for this property, all of which emanate from the northeast and enter the property along its north or east boundary.

All of the washes exist in a natural condition and all can be characterized as sheet flow, except between CP-1 and CP-2, which is fairly well channelized.

CP-2 is the location where the largest off-site flow enters the site by way of a large box culvert located beneath Thornydale Road. This flow subsequently exits the site at CP-1 along its south property boundary. The drainage areas at CP-1 and CP-2 are 648.6 acres and 654.4 acres, respectively.

CP-3 impacts the site at its extreme southeast corner, near the intersection of Magee Road and Thornydale Road. It flows westward, primarily within the public street right-of-way, ultimately draining to CP-1. The drainage area at CP-3 is 33.2 acres.

CP-5 enters the property along the north boundary, traversing the site in sheet flow, and then exits at CP-4 near the property's southwest corner. The drainage area at CP-4 and CP-5 are 19.9 acres and 28.9 acres, respectively.

CONCENTRATION POINT ID	Q100 (CFS)	DA (AC)
1 (incl. CP-2)	2022	654.4
2	2011	648.6
3	203	33.2
4 (incl CP-5)	131	28.9
5	107	19.9

The upstream areas of the offsite watersheds contributing to this parcel were described above in Item 1. They are summarized in the following Table, along with their existing (pre-development) 100-year peak discharges.

Summary of 100-Year Peak Discharges		
Concentration Point Number	Q <sub>100</sub> (cfs)	Drainage Area (Acres)
1	2022	654.4
2	2011	648.6
3	203	33.2
4	131	28.9
5	107	19.9

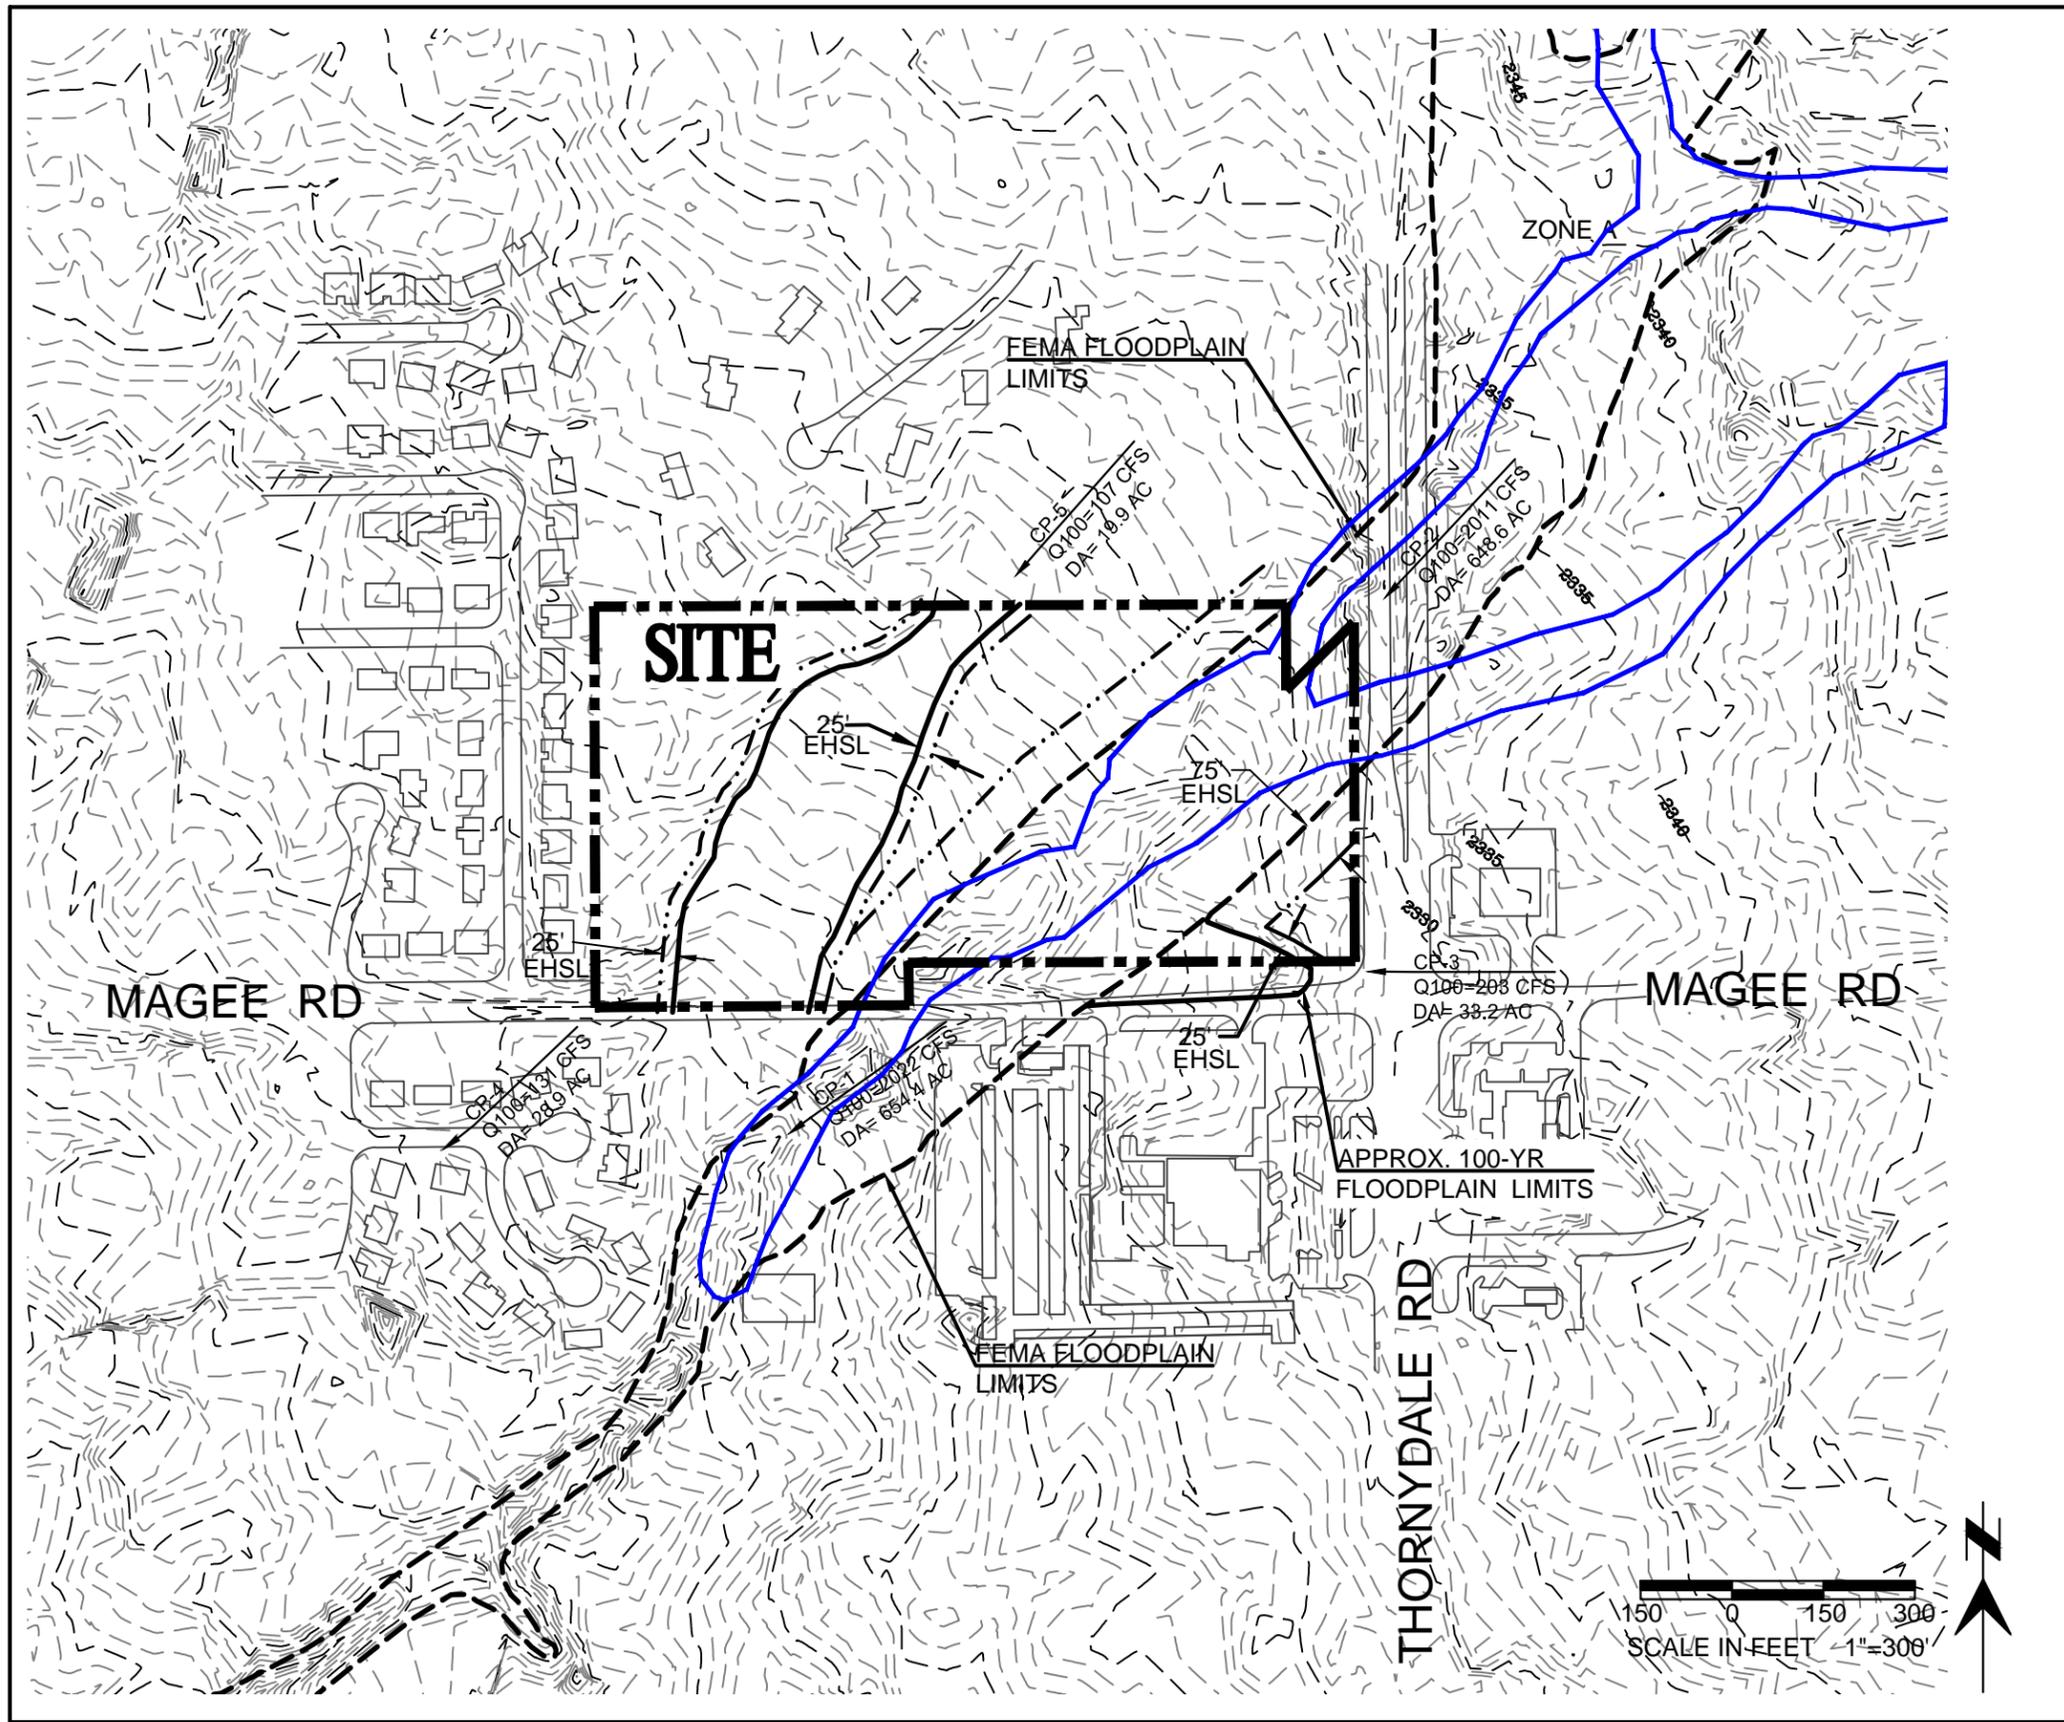
- a. The approximate 100-year regulatory floodplains have been delineated on the Exhibit for the washes in excess of 100 cfs traversing the site.
- b. Most of the rezoning site falls within Zone X (unshaded) on FEMA FIRM Panel #04019C1070L dated June 16, 2011. However, the defined wash diagonally traversing the eastern portion of the property (between CP-1 and CP-2) is mapped by FEMA as Zone A.

- c. The site includes three (3) concentration points (CP-2, 3 & 5) with peak discharges in excess of 100 cfs entering the site. Peak discharges were determined by the Pima County Regional Flood Control District (PCRFCDD) hydrology methods and the PC-Hydro computer program.

- d. The existing washes traversing the site exit the property in their natural state.
- e. The site contains riparian habitat area regulated per the Pima County RFCD Flood Hazard Map; same is delineated on Exhibit I-C.2.

- h. According to Pima County Ordinance No. 2010 FC-5, 16.28.030, erosion hazard and building setback distances are required for the above-described watercourses traversing the property. Erosion Hazard Setbacks for each respective wash have been delineated on Exhibit I-C.2.

The rezoning site is vacant and undeveloped in the existing condition. The project parcel consists of 100% pervious soils of hydrologic soil Types A, B & C. See Exhibit I.C.4a-g in support of the following:

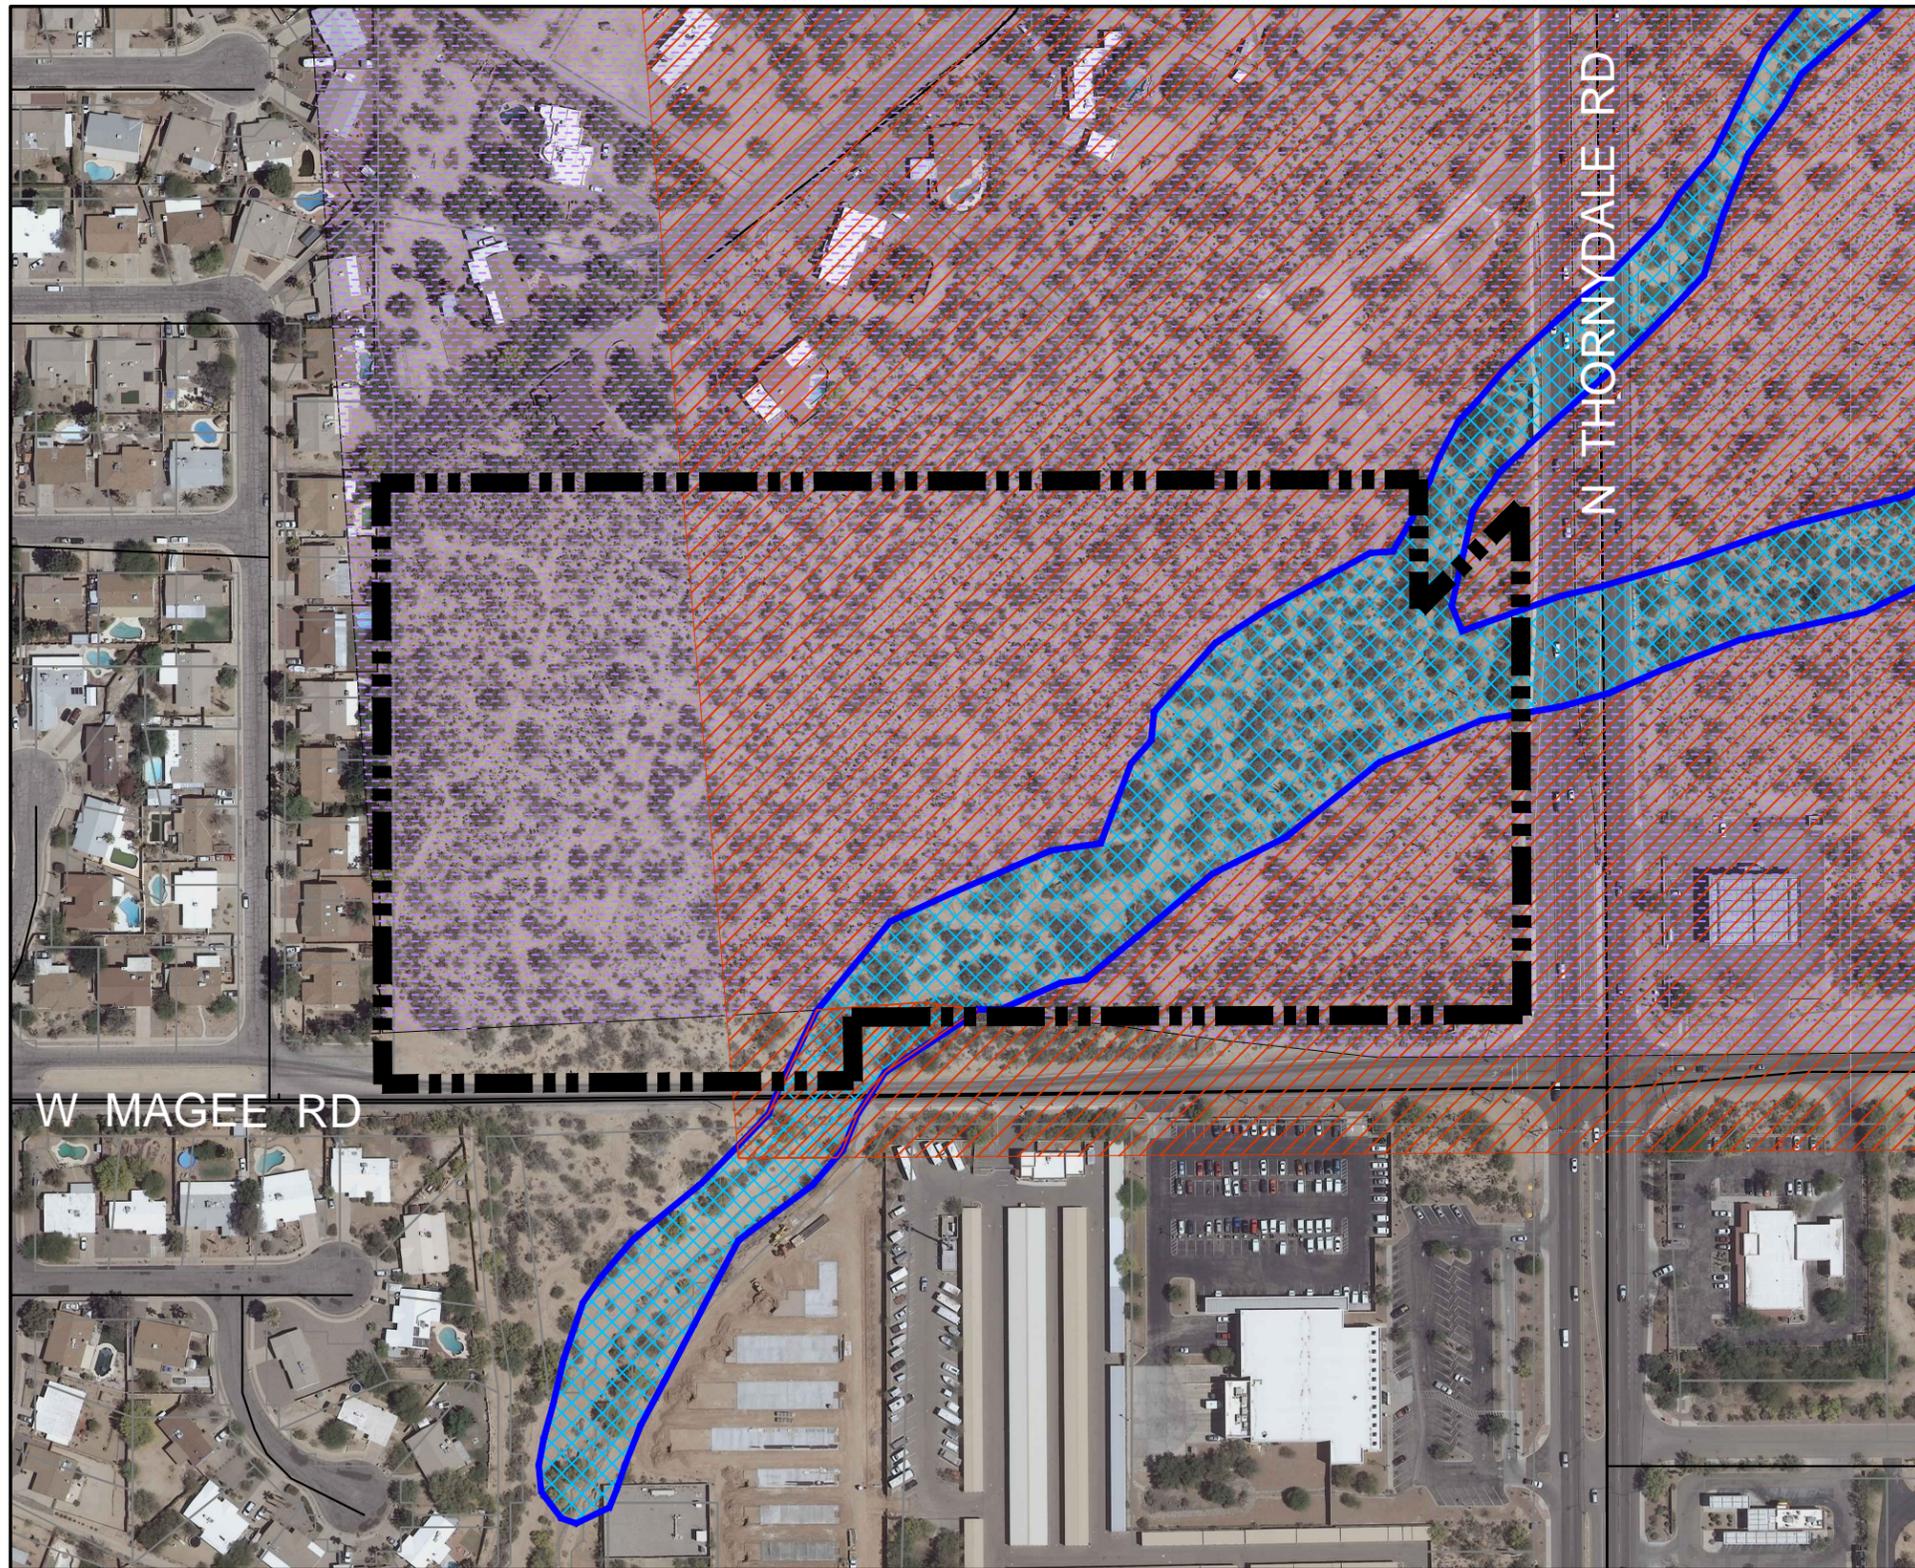
**EXHIBIT I-D.1,2**  
 PIMA COUNTY CONSERVATION  
 LANDS SYSTEM  
 PAGE 20

Approximately ninety-five percent (95%) of the site falls within the Maeveen Marie Behan Conservation Lands System (MMBCLS), being classified as CLS *Multiple Use Management Area (MUMA)* and containing 16.5 acres of this classification. Approximately 75% of the site within the *MUMA* classification is also designated as *Special Species Management Area (SSMA)*. While not a CLS category, the *MUMA/SSMA* area contains 3.1 acres of Xeroriparian Class “C” habitat. Exhibit I-D.1.2 shows the limits of these respective areas within the property.

Multiple Use Management Area (MUMA) and Special Species Management Area (SSMA) with underlying Xeroriparian "C" Riparian Area  
Approx. 3.1 AC

Multiple Use Management Area (MUMA) and Special Species Management Area (SSMA)  
Approx. 8.6 AC

Multiple Use Management Area (MUMA) with no Special Species Management Area (SSMA)  
Approx. 4.8 AC

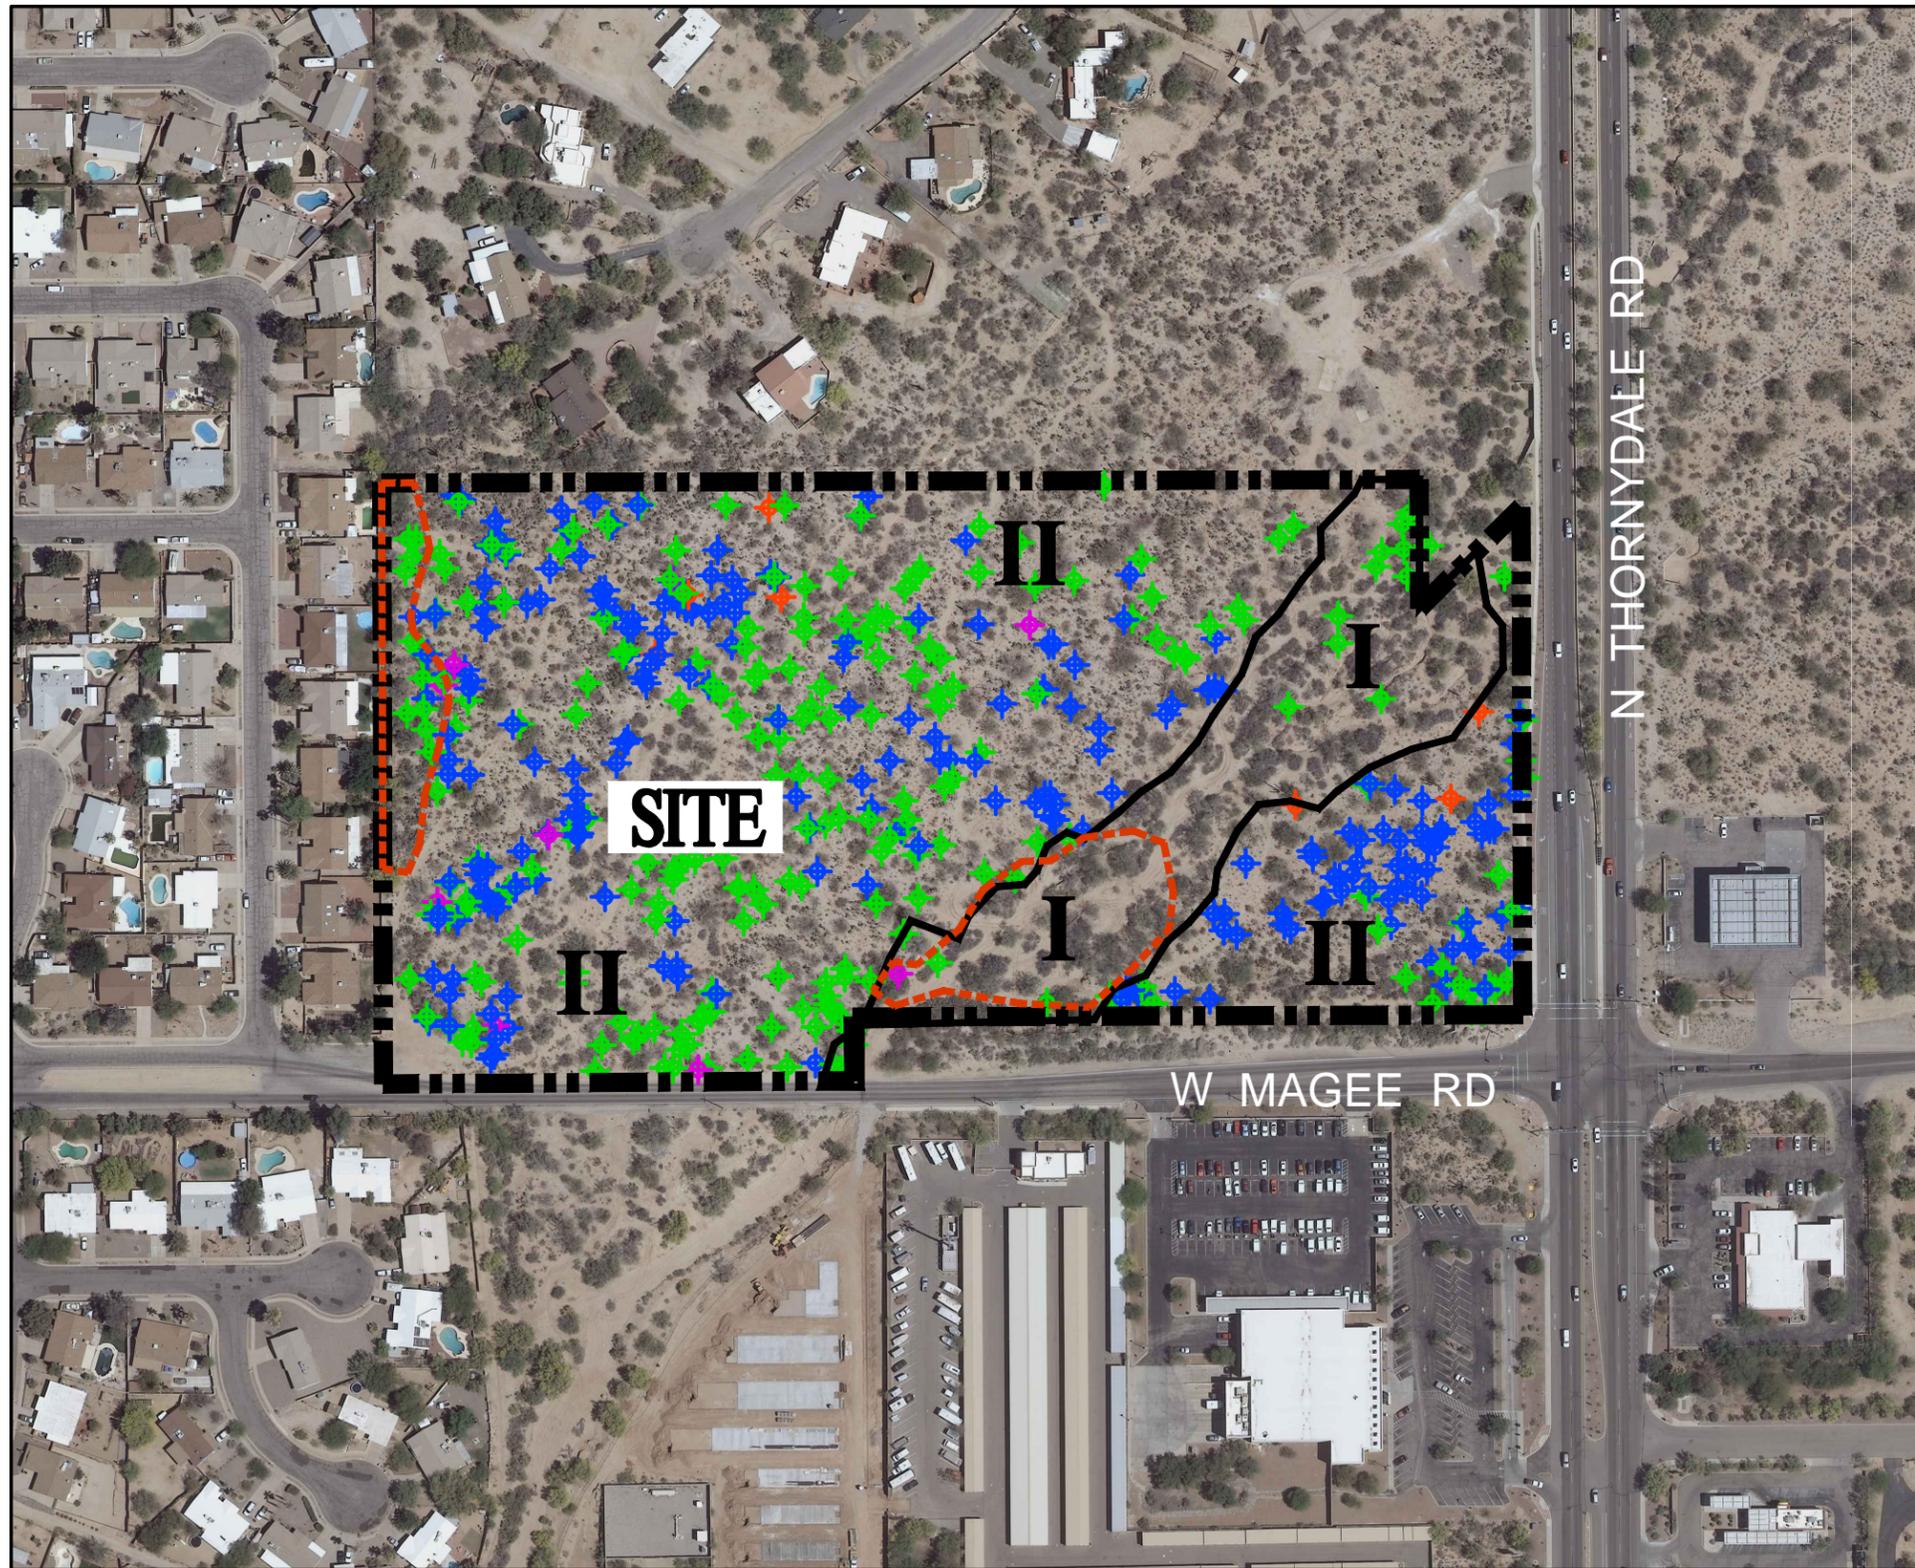
EXHIBIT I-D.3,7-10  
 VEGETATIVE COMMUNITIES

Saguaro Cactus (*Carnegie gigantea*) have been field surveyed and mapped on the subject rezoning site (See Exhibit I-D.3). A total of three hundred nine (309) saguaros were found on the property. One hundred thirty-nine (139) of these saguaros are six feet (6') tall or less, one hundred sixty-three (163) are greater than six feet (>6') up to eighteen feet (18') tall, and seven (7) are greater than eighteen feet (>18') tall.

Ironwood trees were also field survey and mapped on the rezoning site (see Exhibit I-D.3). Two hundred sixty-three (263) Ironwoods were found, some of which are non-viable.

Vegetation on the property is in generally good condition, with the exception of that near the northeast corner of the property, which is impacted by concentrated incoming drainage from culverts beneath Thornydale Road. Channel erosion near these outlets has created vertical earthen cuts upwards of six feet (6') tall, with an associated destruction of vegetation. The following two (2) vegetative zones have been mapped on the subject site (see Exhibit I-D.3,7-10).

**Zone I: Riparian Vegetation - 129,990 SF (approximately 17.2% of the Site)**

**Zone II: Upland Vegetation & Ironwood/Saguaro Association - 625,391 SF  
(approximately 82.8% of the Site)**

There are areas on the site with vegetation of generally good quality and aesthetic value; these areas are mapped on Exhibit I.D.3. Substantial portions of the property have been devoted (on the proposed PDP) to set-asides for screening and buffering the neighboring properties.

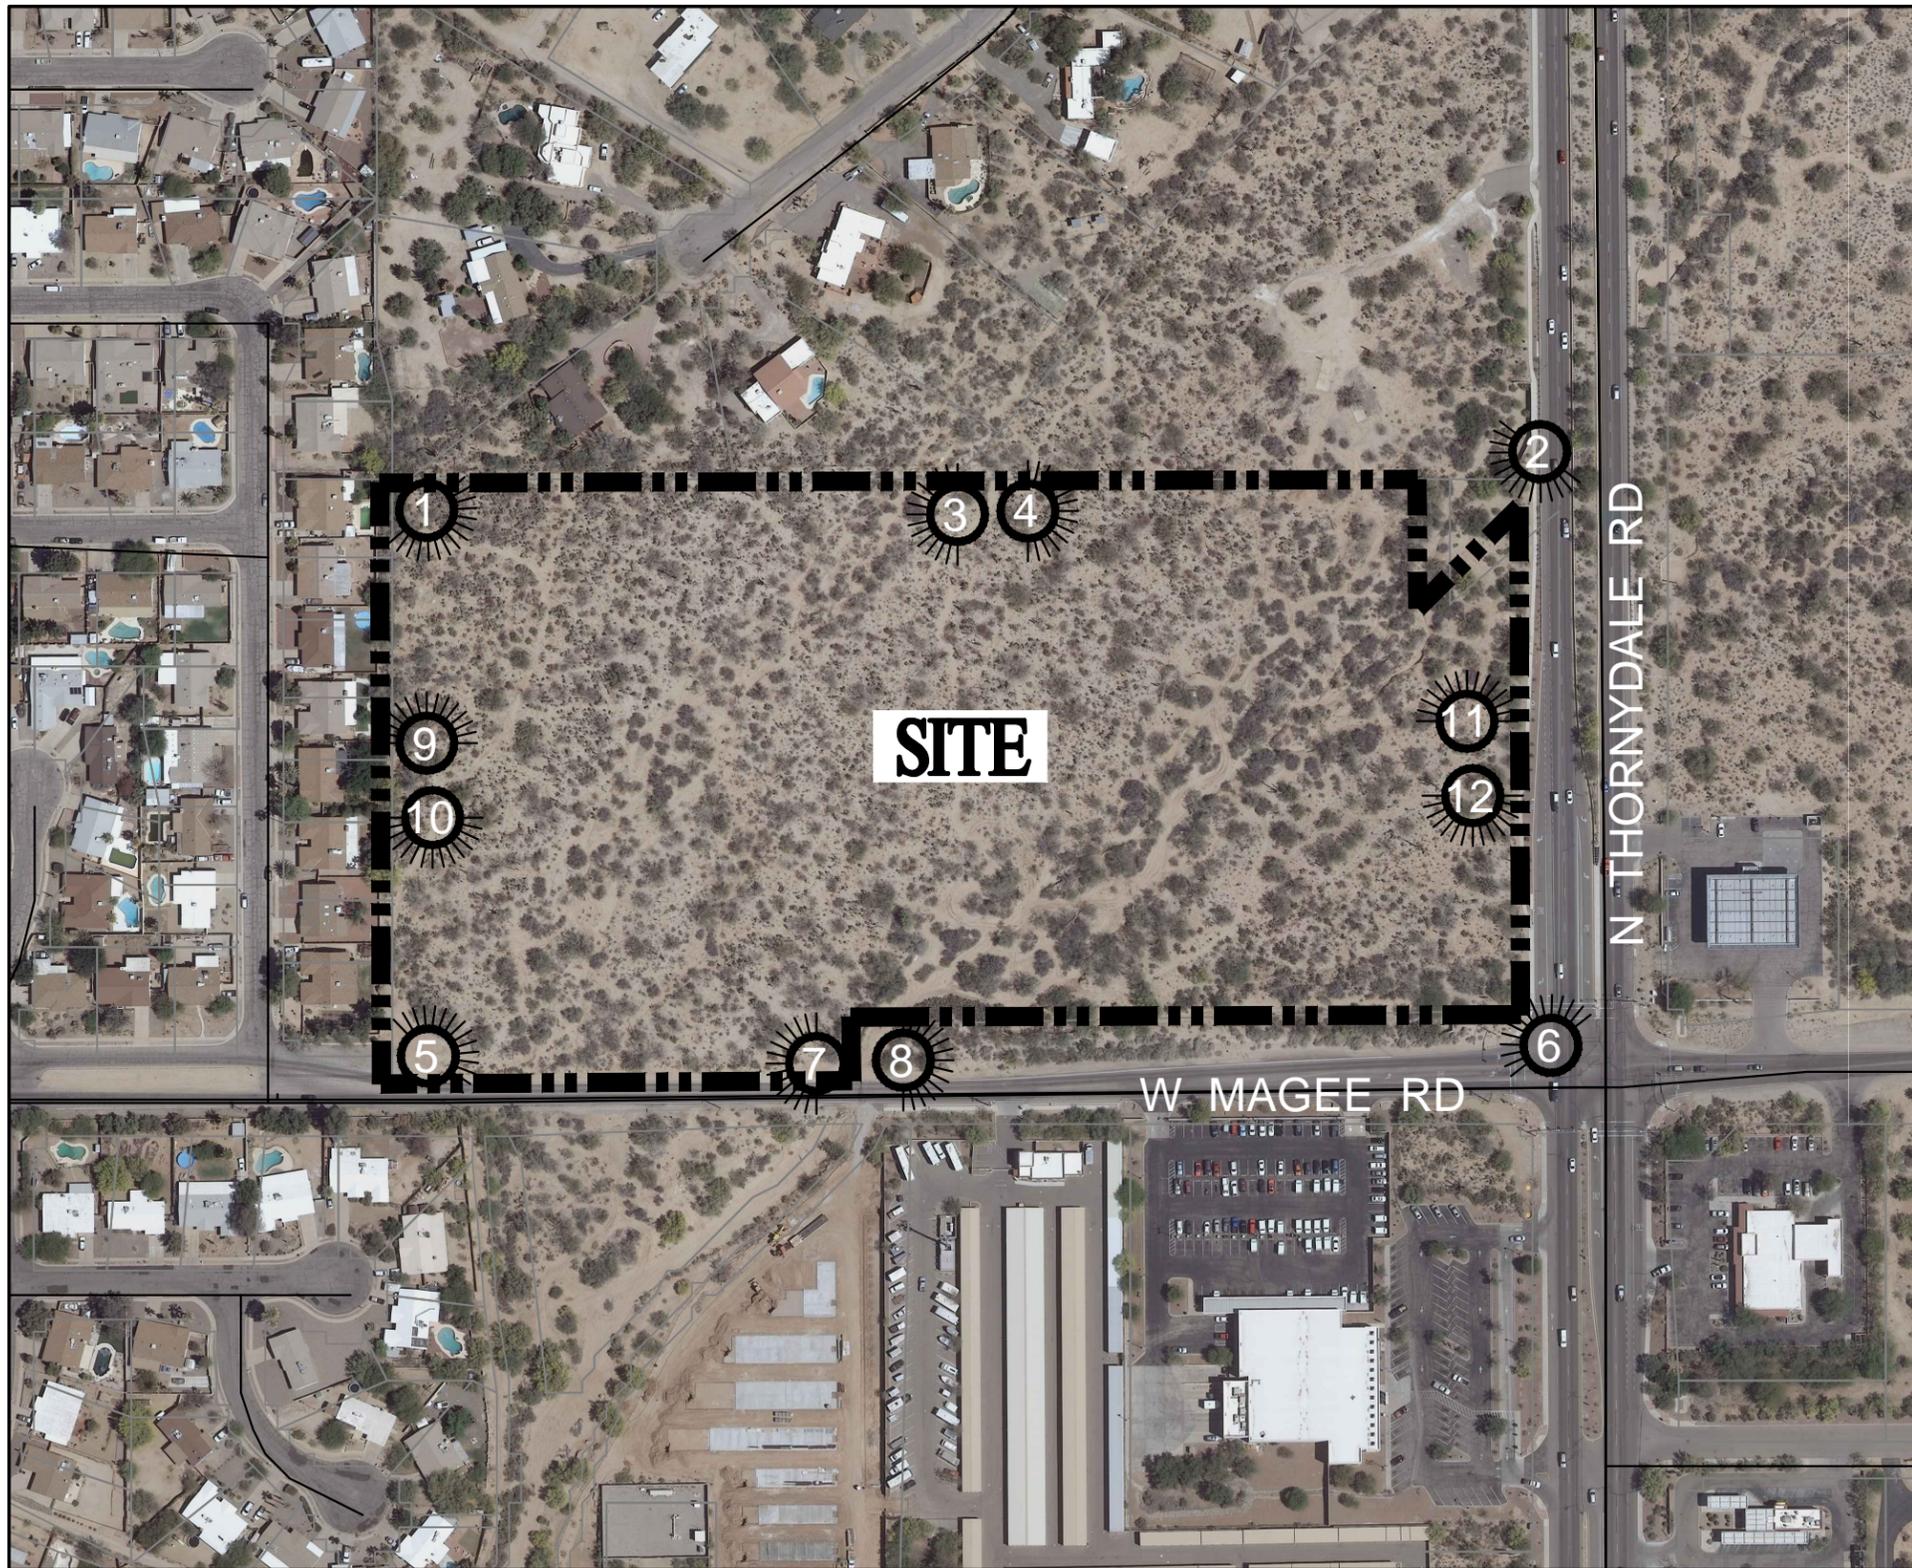
Ground level photographic mosaics have been provided at pertinent boundary locations surrounding the subject property. The photo location points are depicted on Exhibit I-E.2a. The photographic mosaics are depicted on Exhibits I-E.2b through I-E.2g. In general, the views across the site are unremarkable in the foreground and mid-ground ranges. The most notable and high-quality views are northward in the direction of the distant Tortolita Mountains, westward toward the distant Tucson Mountains, eastward in the direction of the distant Santa Catalina Mountains.
