# ***ADDENDA***

## Hydrology Report

**Existing Conditions Floodplain Modeling Report for  
Pima County Parcels 108-26-015D, 108-26-016A & 108-26-015B**

**AN 8.02-ACRE ARCHAEOLOGICAL SURVEY OF  
ST. DEMETRIOS GREEK ORTHODOX CHURCH PROPERTY AT  
3232 EAST RIVER ROAD, TUCSON, PIMA COUNTY, ARIZONA**

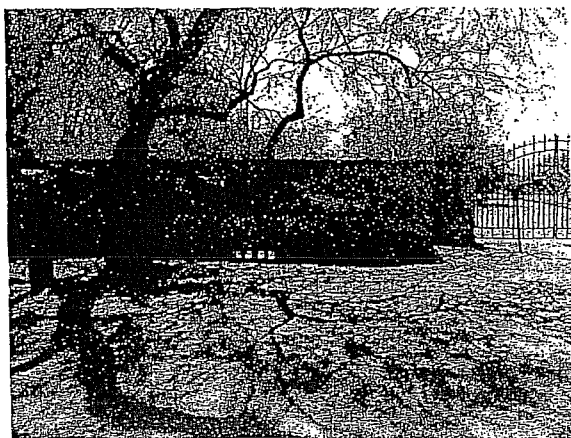
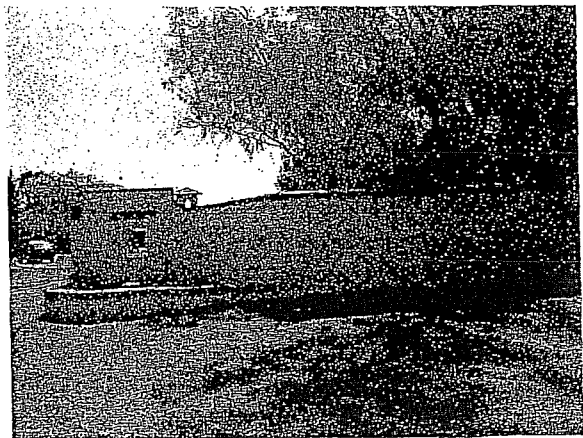
The photos above show walls along the west side of the River Road frontage. These walls were included in the model.

7. Significant buildings located within the valley were identified and included in the model as obstructions. In addition, the existing wall along the River Road frontage, south of Roger Road, was modeled using an assume width reduction (blockage to flow) of 95%.

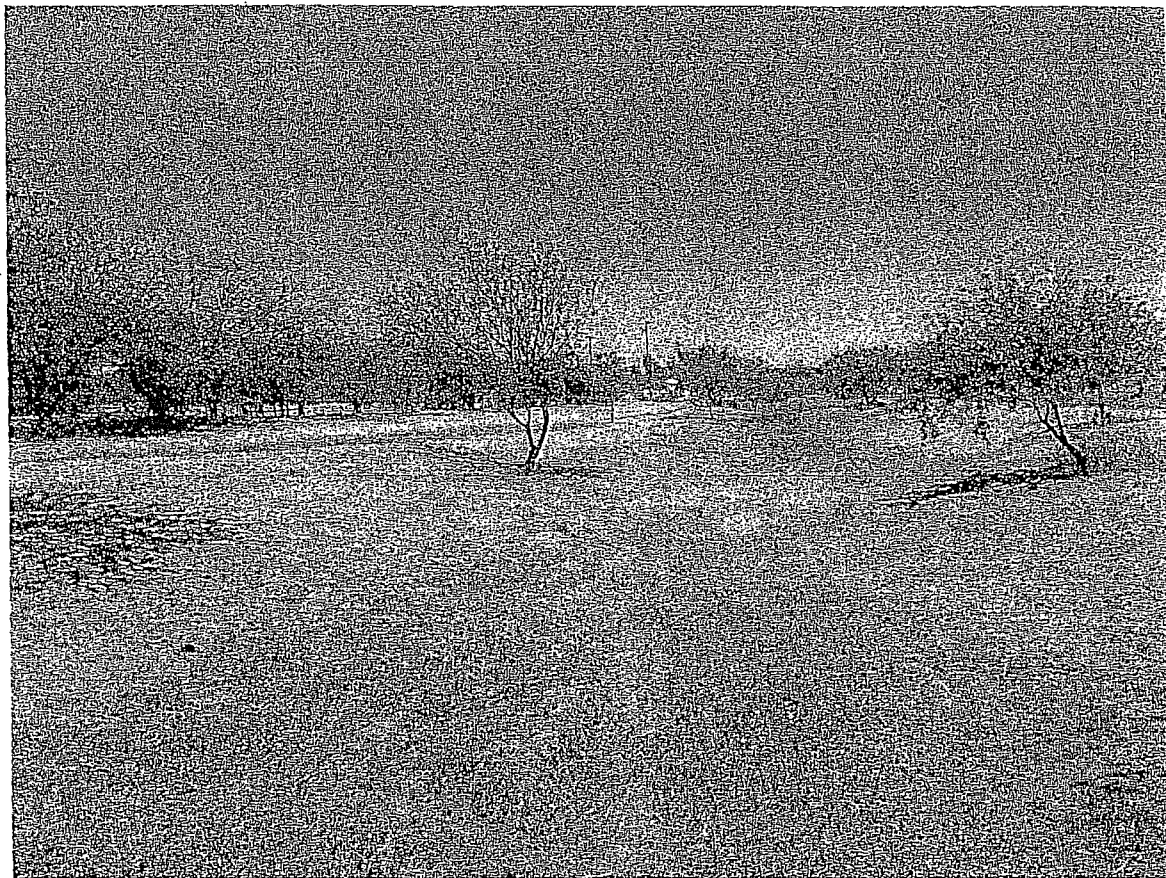
Photo faces west, upstream of River Road. This is the channel that drains the Finger Rock Wash towards River Road along Roger Road.
