# Thornydale Sumter Specific Plan

## V. CONDITIONS OF APPROVAL

### A. Purpose

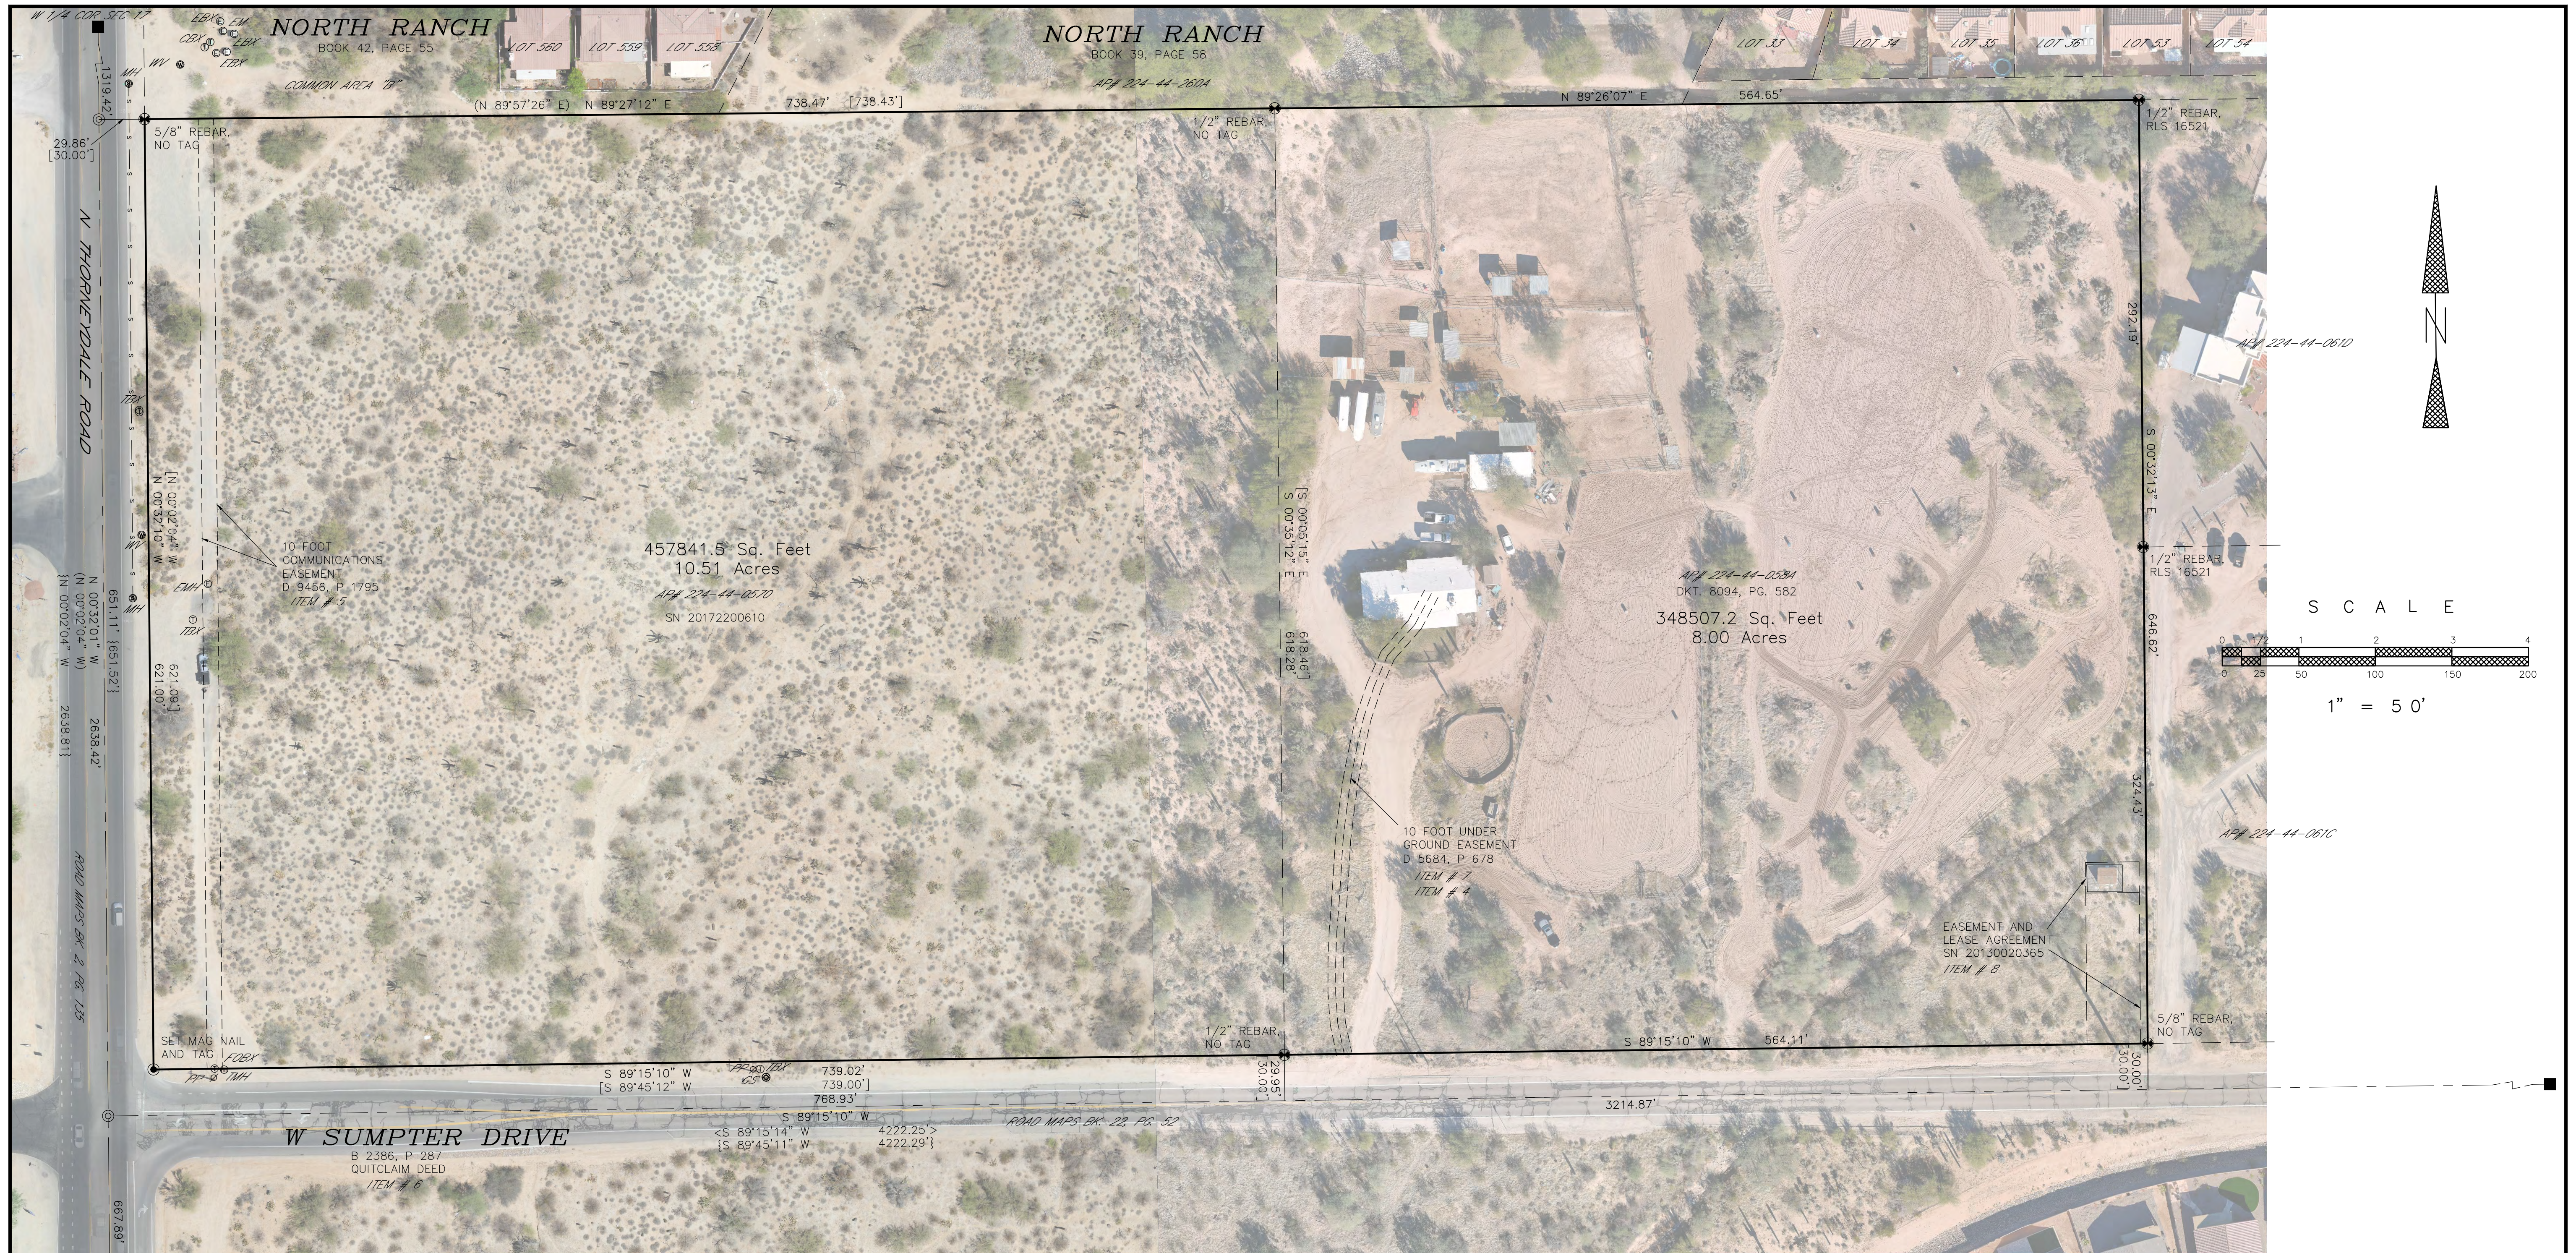
Property Survey

MONUMENTS FOUND WERE ACCEPTED BASED ON A PARTIAL RETRACEMENT AND BREAKDOWN FOR THE SW 1/4 OF SECTION 17.
