Re: **August 7, 2018 Board of Supervisors Agenda Item Regarding Golden Pin Lanes Acquisition Agreement**

Re: Golden Pin Lanes Buildings and Site Assessment – FM Final Report dated July 12, 2018

Golden Pin Lanes Buildings & Site

FINAL REPORT
7-12-2018

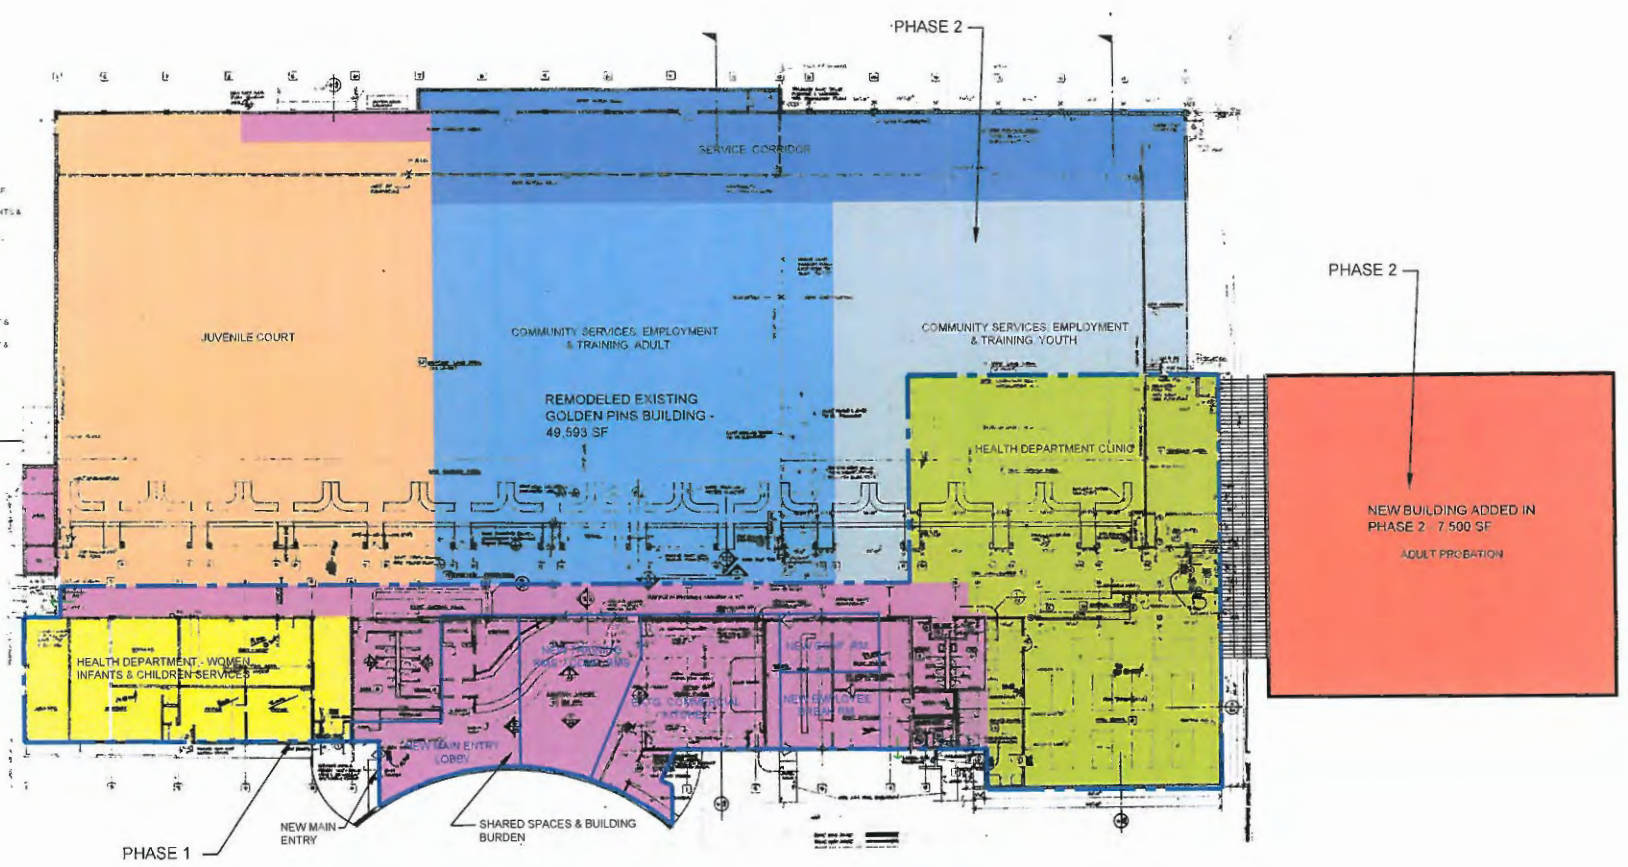
NORTHWEST SERVICE CENTER - BLOCK DIAGRAM
7/12/18

- PHASE 1**
- HEALTH DEPARTMENT CLINIC - 7,975 SF
 - HEALTH DEPARTMENT - WOMEN, INFANTS & CHILDREN SERVICES - 2,704 SF
 - SHARED SPACES & BUILDING BURDEN - 7,445 SF
- PHASE 2**
- COMMUNITY SERVICES, EMPLOYMENT & TRAINING - ADULT - 10,140 SF
 - COMMUNITY SERVICES, EMPLOYMENT & TRAINING - YOUTH - 5,628 SF
 - BEAVER CONATOR - 5,220 SF
 - JUVENILE COURT - 11,475 SF
 - ADULT PROBATION - 7,500 SF
- TOTAL AREA** 57,093 SF
