**BOARD OF SUPERVISORS AGENDA ITEM REPORT (BOSAIR)**

**Award Type:** Agenda Item  
**BOSAIR Activity:** Board Meeting Request  
**Requested Board Meeting Date:** 08/11/2026  
**Project Title / Description:** P26CU00002 PADILLA - W. DIAMOND BELL RANCH ROAD WIRELESS COMMUNICATION TOWER (APPEAL)

**PADILLA – W. DIAMOND BELL RANCH ROAD  
Type I Conditional Use – Wireless Communications Facility**

## RF DESIGN ANALYSIS

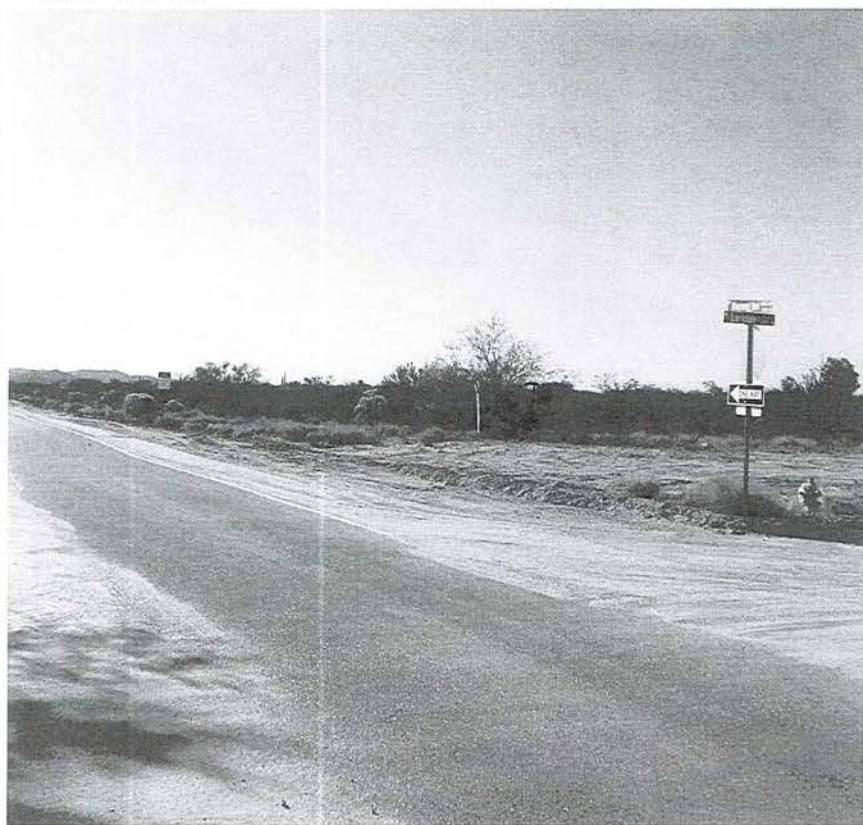
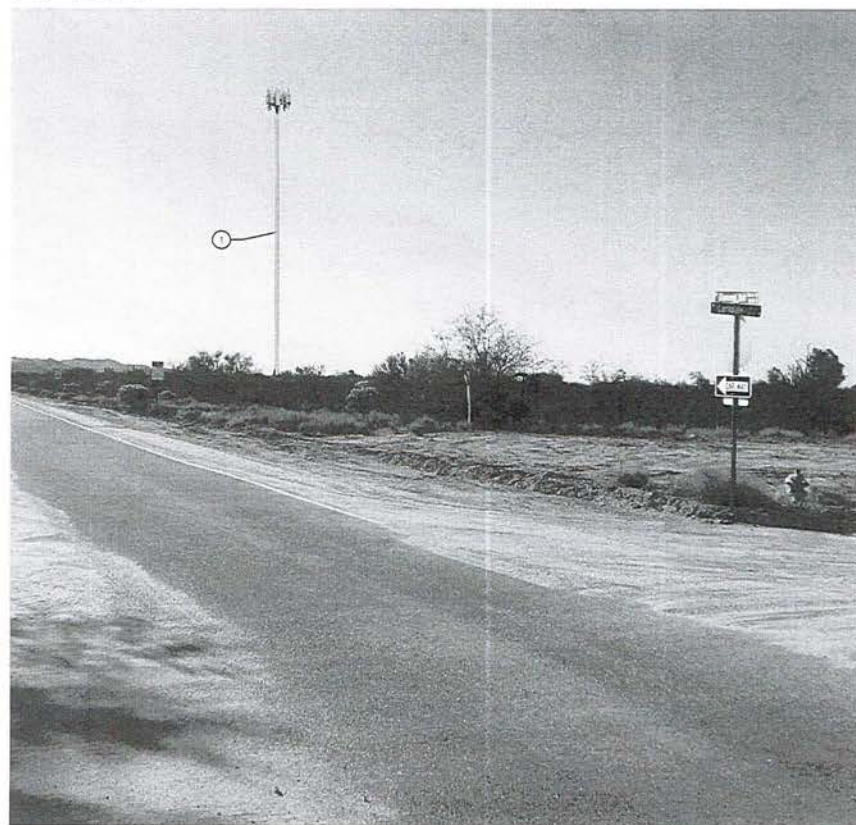
PS-1

1. PROPOSED ROCKY MOUNTAIN TOWERS 150' MONOPOLY WITH ANTENNAS

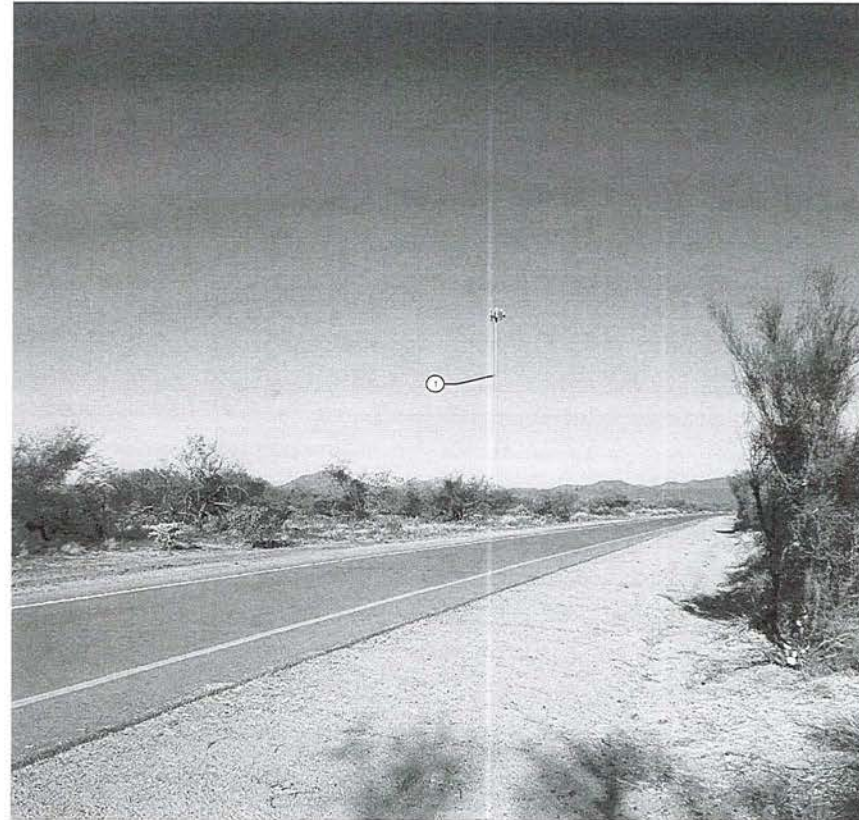
AFTER:

SIMULATIONS ARE AN ARTISTIC ILLUSTRATION CREATED TO REPRESENT HOW THE PROPOSED PROJECT MAY LOOK ONCE CONSTRUCTED. SIMULATIONS ARE CREATED TO MATCH THE CURRENT DESIGN AS ACCURATELY AS POSSIBLE, BUT ARE NOT GUARANTEED TO MATCH THE FINAL BUILD.

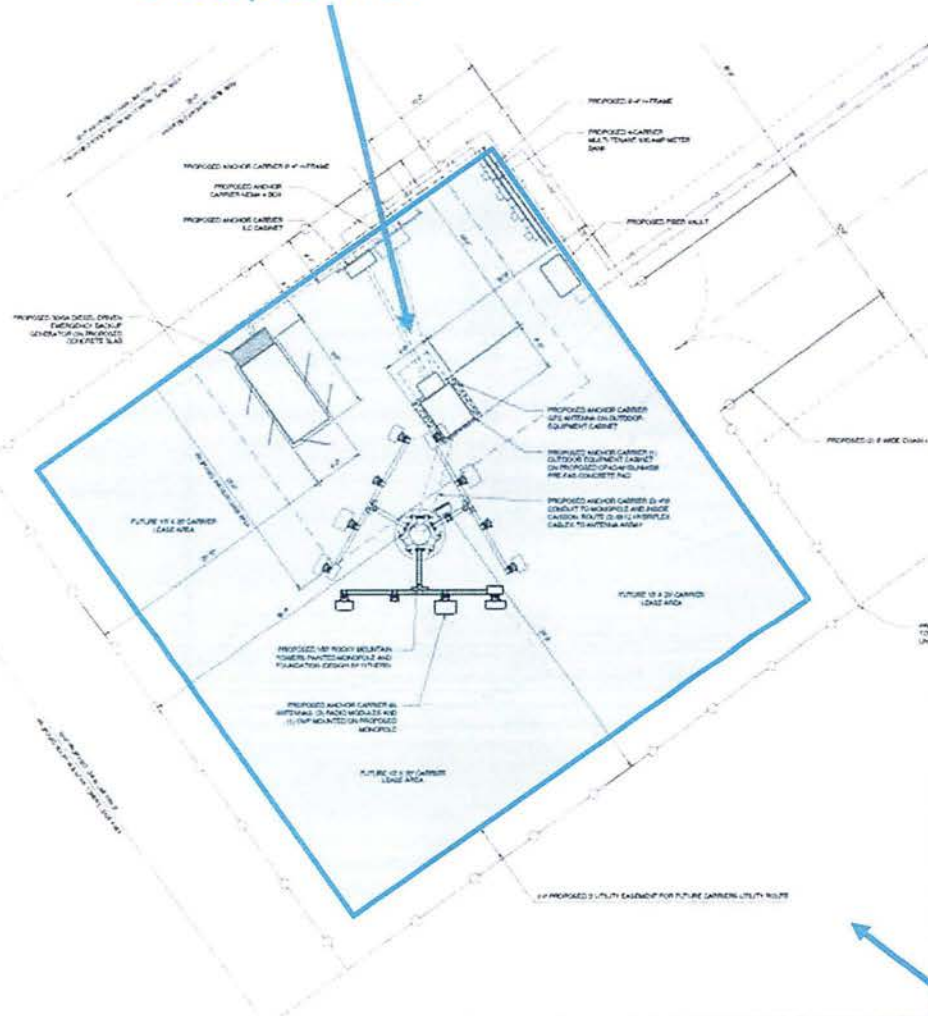
1/1000 of the power on the ground around the site

- Next to the tower in the compound in controlled environment (Occupational)
- Outside of the compound and buildings the maximum calculated density is less than 10% of the General Public Standard

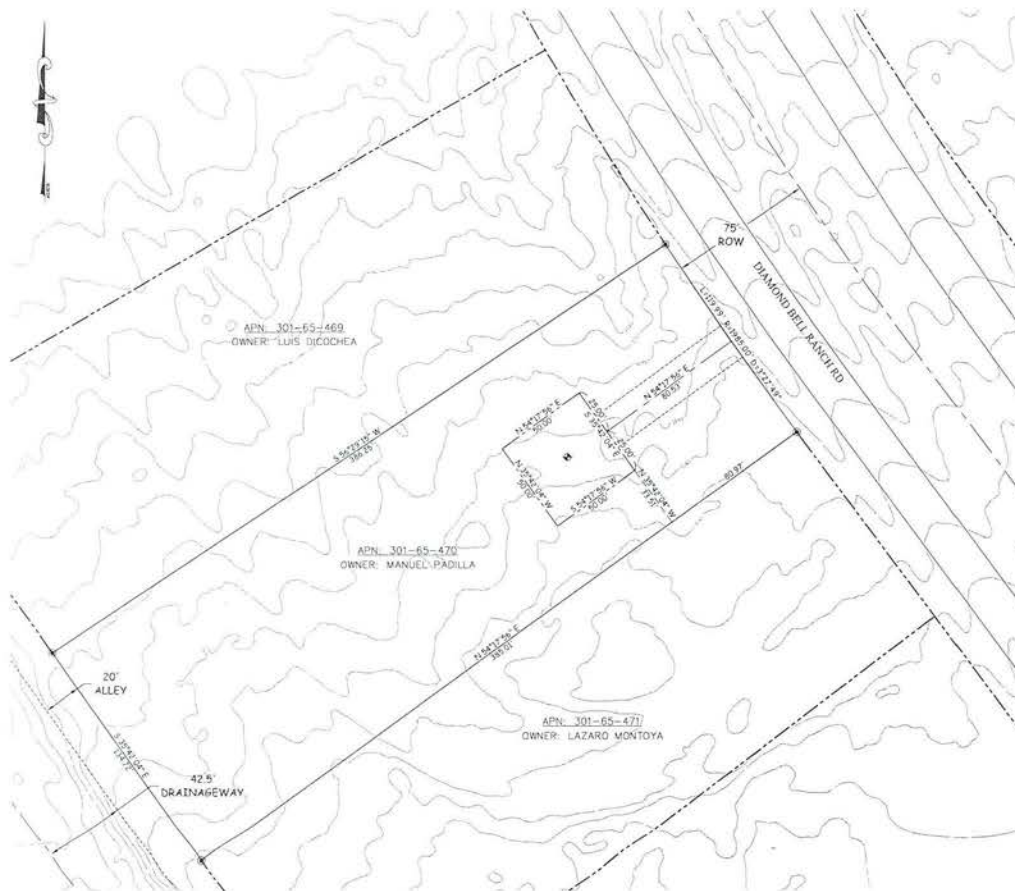
**Site Plan**

CENTER OF PROPOSED MONOPOLE (NAD83)  
LATITUDE 31° 59' 59.58" NORTH  
LONGITUDE 111° 18' 12.05" WEST  
ELEVATION 3139.87' (NAVD83)
