**Pima County Department of Finance & Risk Management**  
**CCMP Report, dtd 28<sup>th</sup> May, 2014**

**Randy Gimblett & Kerry Baldwin,  
CCMP Plan Assessment & Recommendations, May 2014**

## ***2014 Property Inventory Report***

## ***Maintenance Priority Sheet***

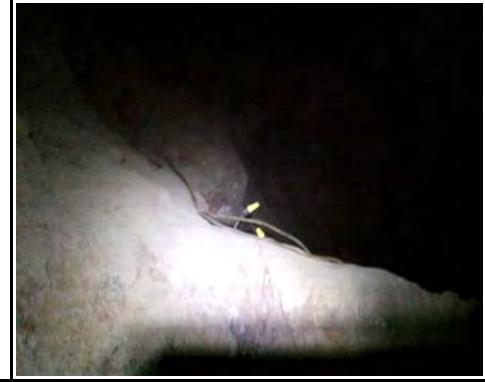
4.	<p>Electric equipment shall be free from recognized hazards that are likely to cause death or serious physical harm to employees.</p> <p>Any open electrical should be properly encased. Identify parts that are no longer energized, and then have them removed or moved off path to eliminate trip hazards.</p>	<p><b>OSHA 29CFR1910.3 03(b)(1)</b></p> <p><b>Public Safety and Liability</b></p>	Intermediate Trail

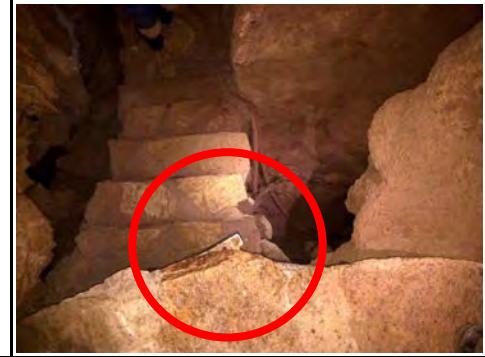
5.	<p>Path to Intermediate trail has metal bar that extends past the rock.</p> <p>Recommended that this metal bar be removed or guarded to prevent injury.</p>	<p><b>Public Safety and Liability</b></p>	Intermediate Trail

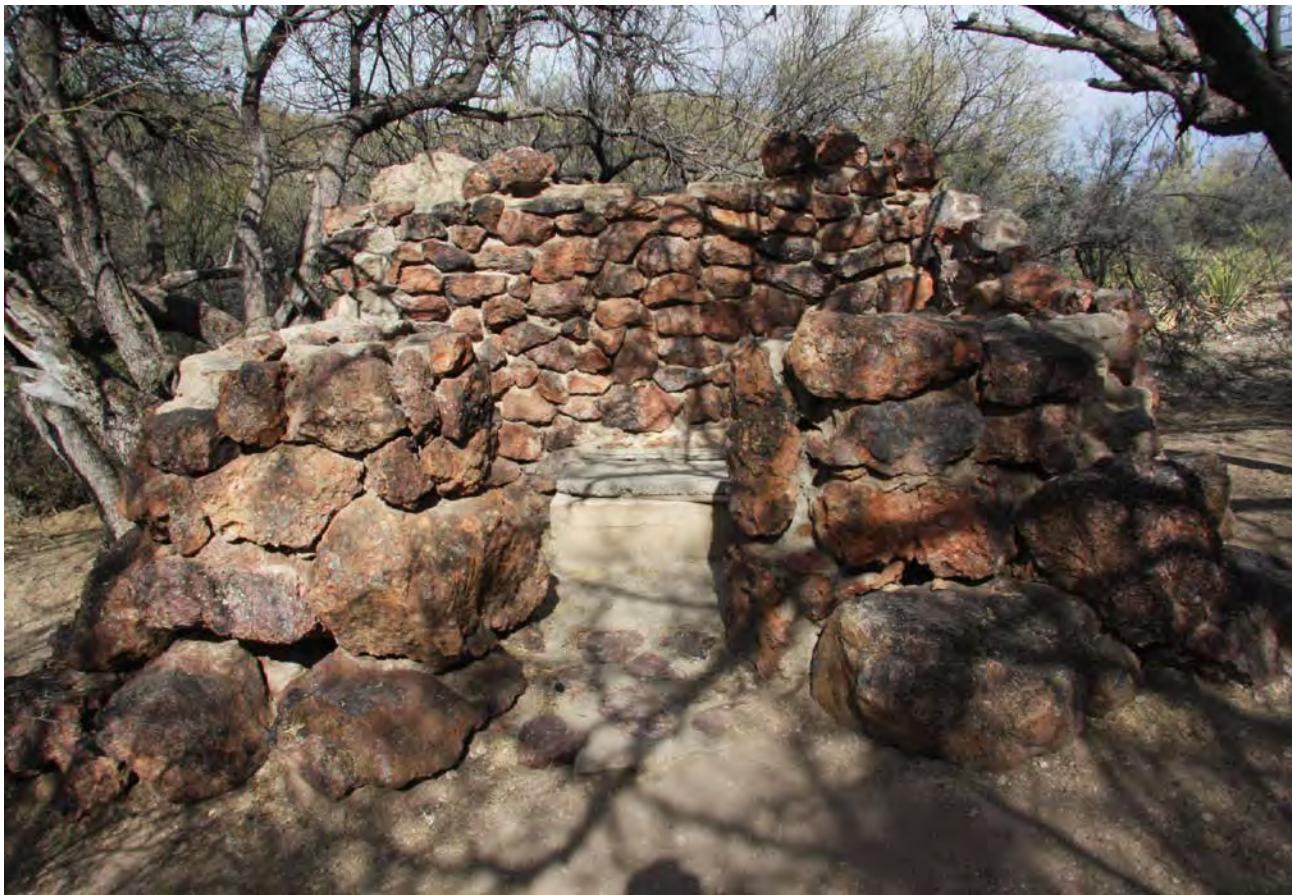
Facility:	Colossal Cave Mountain Park	Page Number	2
Building Name:	El Bosquecito Latine Ruins	Photo By:	G.W. Bundrick

Building Size:	250 Square Feet
Replacement Cost:	\$ 43,750.00 Estimated \$175.00 per square foot due to historical status.
Building Materials:	Native rock from the park along with concrete vault.
Building Condition:	Poor
Building Age:	1937
Photo Date	February 24, 2014

The latrine has been vandalized over the years and is in poor condition.

Recommend that the latrine be evaluated in order to determine the best possible course of long-term protection. The structure has historical status and requires some type of protection.

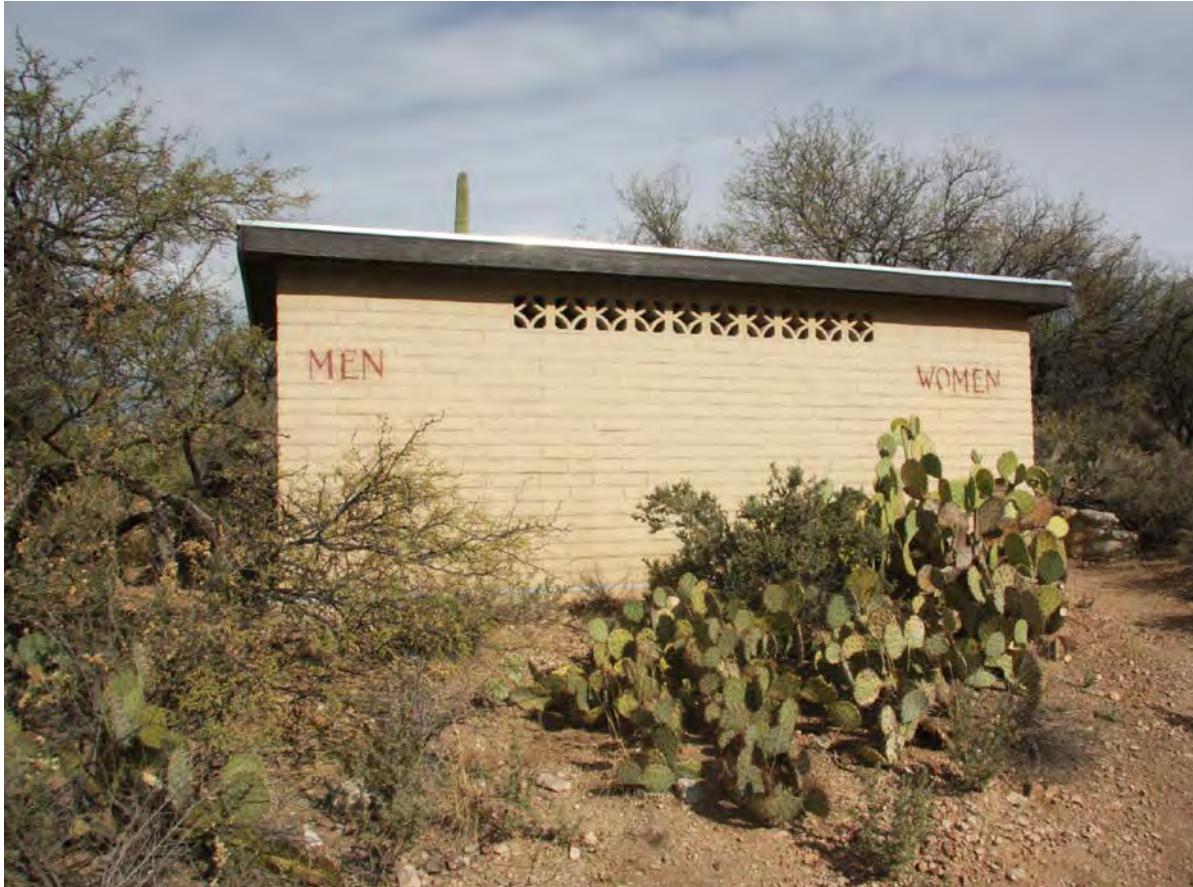
<b>Building Size:</b>	400 Square Feet
<b>Replacement Cost:</b>	\$ 68,000.00 Estimated at \$170.00 per square foot replacement cost.
<b>Building Materials:</b>	Concrete slump block with vault toilets.
<b>Building Condition:</b>	Good
<b>Building Age:</b>	1970
<b>Photo Date:</b>	February 24, 2014

At time of inspection, the restroom was found to be clean and well maintained.

Although the sex use of the restroom is clearly marked on the south side, no visible signage is in place the north side; this causes confusion for those approaching the facility from other directions.

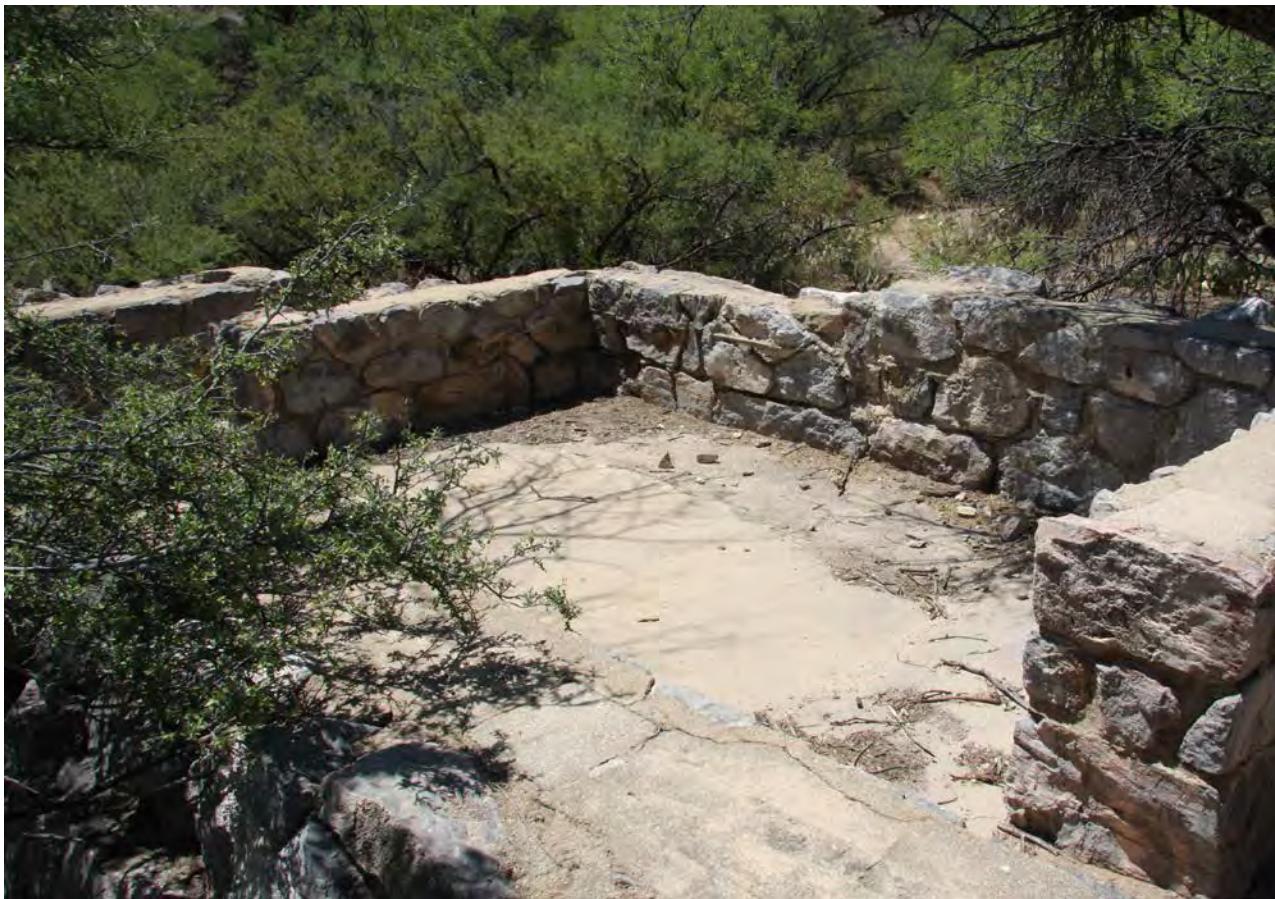
<b>Building Size:</b>	338 Square Feet
<b>Replacement Cost:</b>	\$ 67,600.00 <i>Estimated at \$200.00 per square foot replacement cost.</i>
<b>Building Materials:</b>	Constructed from native hand-chiseled limestone.
<b>Building Condition:</b>	Poor
<b>Building Age:</b>	1937
<b>Photo Date:</b>	February 24, 2014

*The replacement value does not take into consideration that the structure is a CCC building and that it has historical significance. The replacement value was based on a square foot cost for a complete replacement.*

*The structure has a considerable amount of historical value and should be developed into some type of interpretive display; however, if this recommendation is followed the site will need to be secured.*

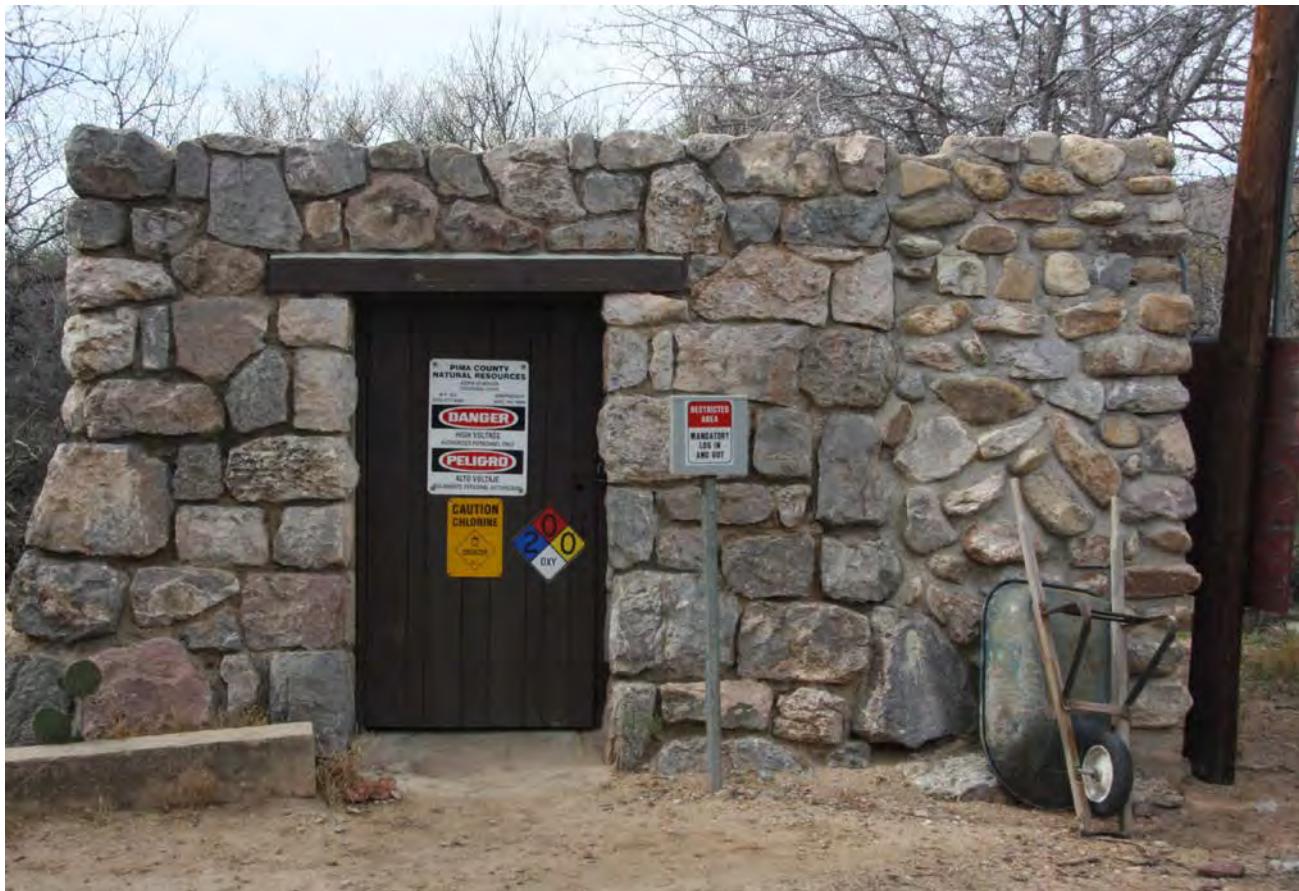
Building Size:	220 Square Feet
Replacement Cost:	\$ 55,000.00 Estimated at \$250.00 per square foot replacement cost.
Building Materials:	Constructed from native hand-chiseled limestone.
Building Condition:	Good
Building Age:	1936/1978/2004
Photo Date:	February 24, 2014

The building has been well maintained and appears to be in very good condition.

The La Sevilla Pump House is still an active site, providing protection for the drinking water chlorination system. The majority of the rock structure was constructed by the CCC in 1936; however, an addition to the building was done in 1978 by the Youth Conservation Corp. In 2004 some of the wood structure was replaced with a preservation grant.

Although this building is still in use, it is recommended that long term preservation be considered as well as an alternative for the chlorination system. The building has tremendous historical value and should be considered as a CCC asset and included within the visitor's tour route.

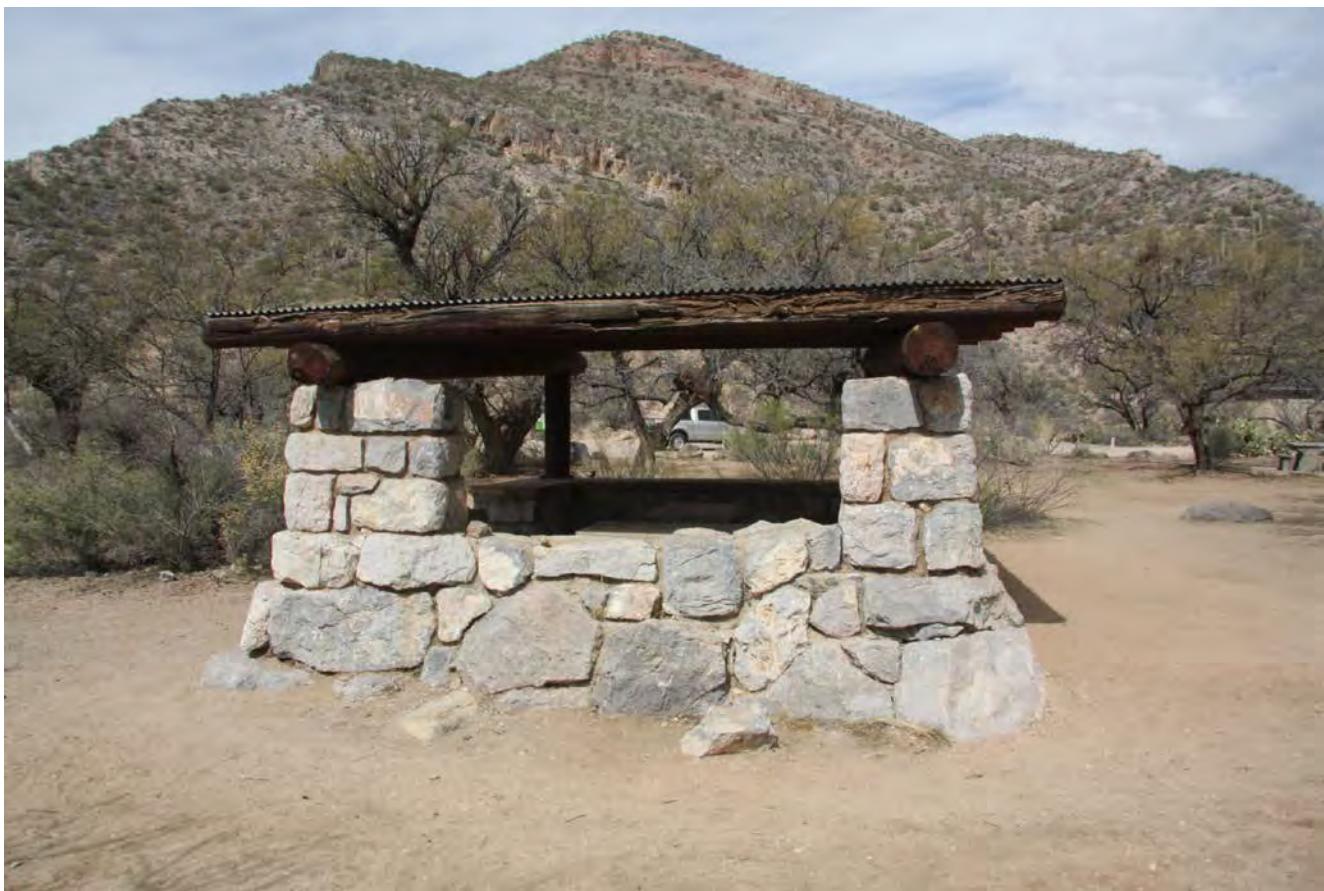
<b>Building Size:</b>	391 Square Feet
<b>Replacement Cost:</b>	\$ 97,750.00 Estimated at \$250.00 per square foot replacement cost.
<b>Building Materials:</b>	Constructed from native hand-chiseled limestone.
<b>Building Condition:</b>	Very good condition
<b>Building Age:</b>	1935-36 Roof re-constructed in 2004
<b>Photo Date:</b>	February 24, 2014

At the time of inspection, the Ramada was found to be in good condition; however, one of the peeler poles used for the roof is showing sever signs of dry rot and requires replacement before the roof panels are damaged.

When replacing the support beam, it is recommended that the wood is inset so that it's covered by the metal.

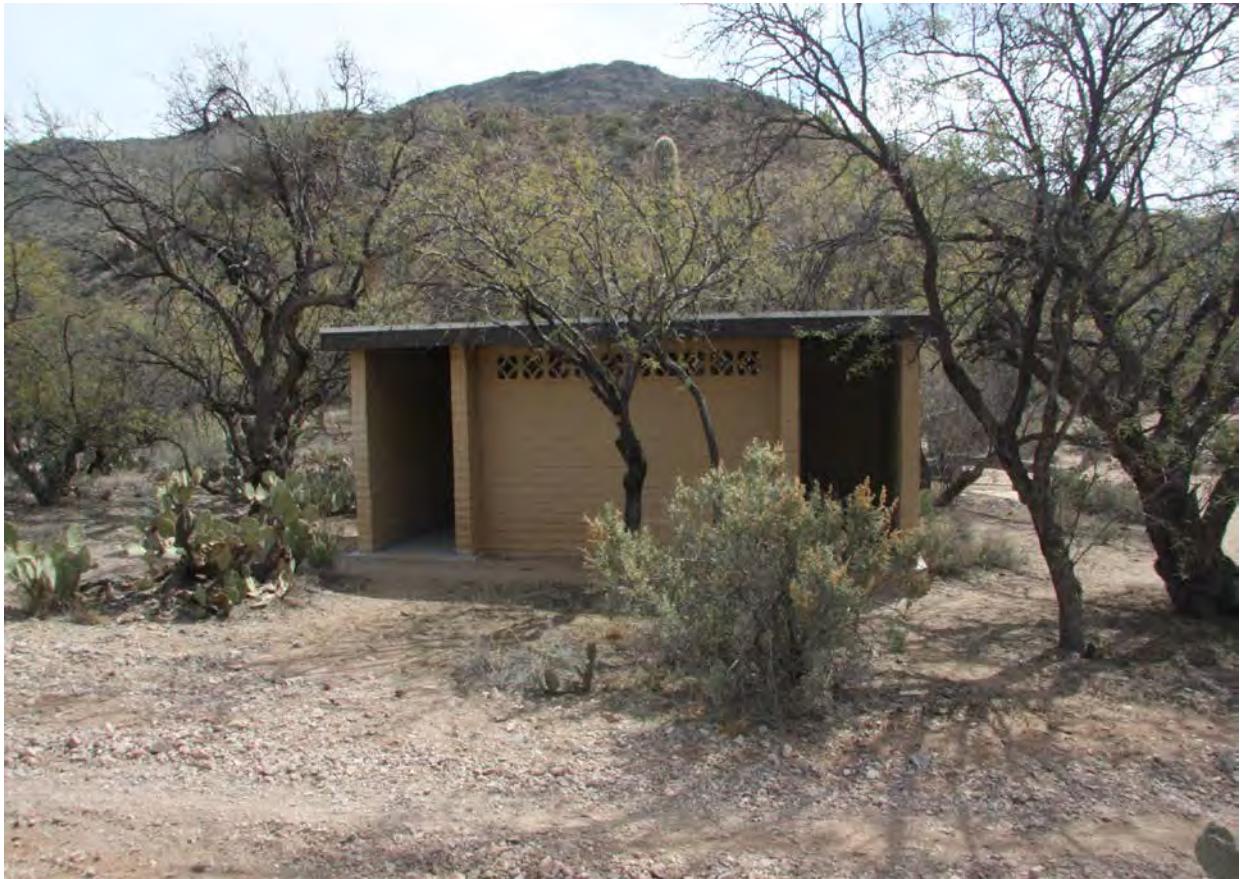
<b>Building Size:</b>	400 Square Feet
<b>Replacement Cost:</b>	\$68,000.00   Estimated at \$170.00 per square foot replacement cost.
<b>Building Materials:</b>	Concrete slump block with vault toilets.
<b>Building Condition:</b>	Good
<b>Building Age:</b>	1970
<b>Photo Date:</b>	2/26/2014

All of the recommendations that were made during the last inspection have been completed; however, it is strongly recommended that walkways be installed in order to accommodate the disabled. although the sex-use has been identified on the south-side of the building, the same is needed on the north-side for those approaching from that direction.

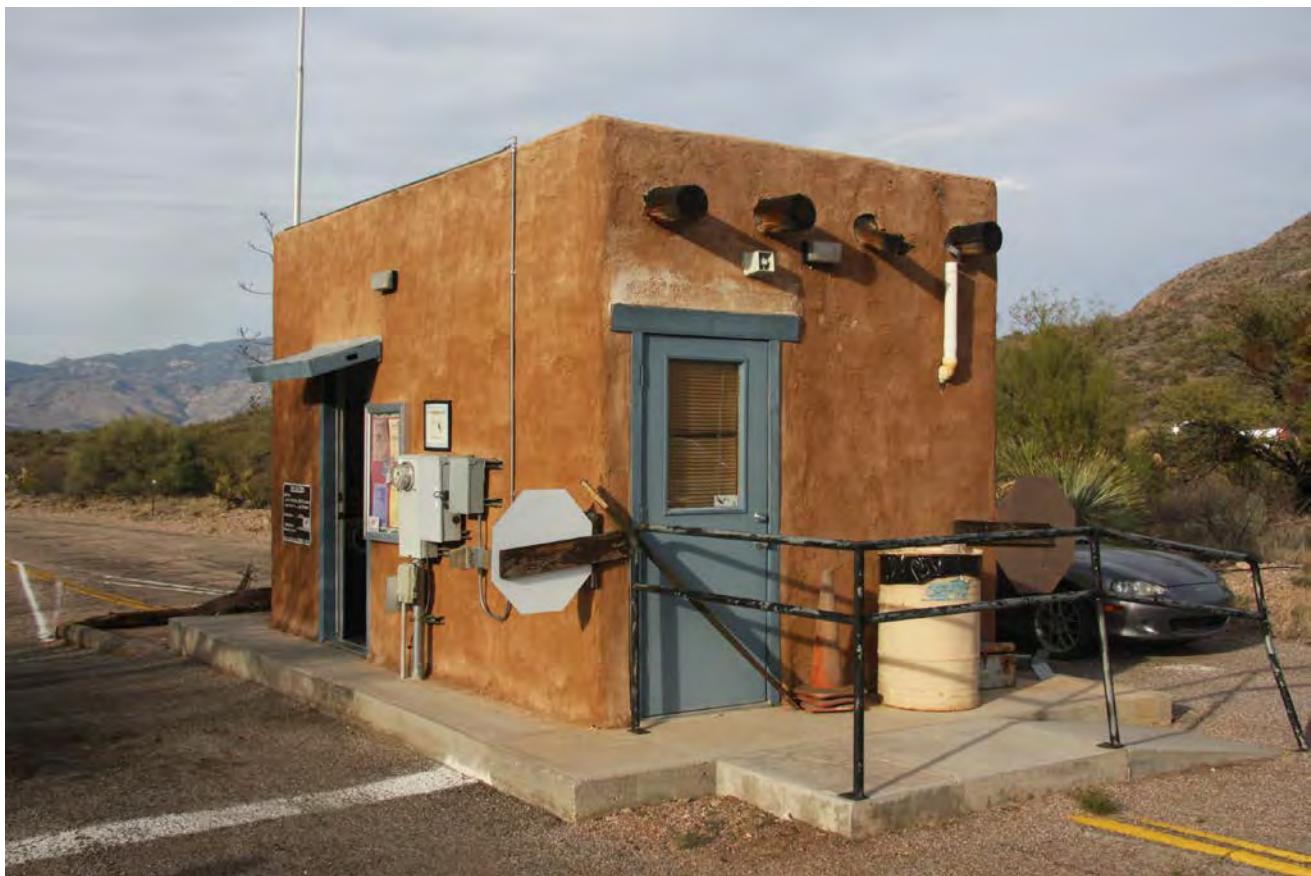
<b>Building Size:</b>	160 Square Feet
<b>Replacement Cost:</b>	\$ 16,000.00 Estimated at \$100.00 per square foot replacement cost.
<b>Building Materials:</b>	Frame/Stucco
<b>Building Condition:</b>	Fair
<b>Building Age:</b>	2000
<b>Photo Date:</b>	February 24, 2014

*Although the entrance building has satisfactorily been serving its function, it is highly recommended that a complete analysis be done with regards to first impression by the visitor, size, color and modern restroom facilities.*

*It is highly recommended that the damaged railing be replaced and painted as soon as possible.*

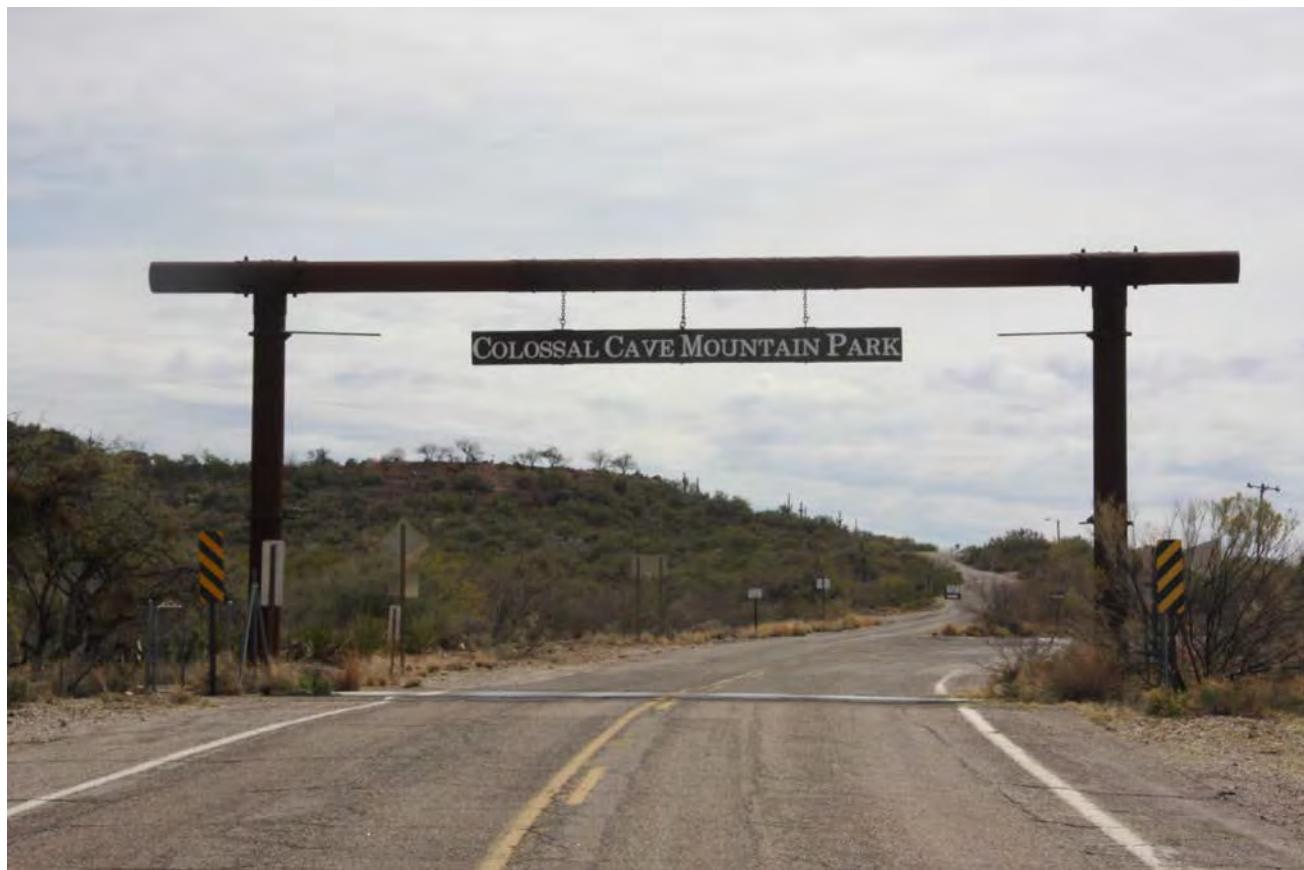
Building Size:	40-feet wide by 20 feet high
Replacement Cost:	\$25,500 Estimate only
Building Materials:	Steel
Building Condition:	Good
Building Age:	2000
Photo Date:	February 24, 2014

Colossal Cave Mountain Park actually has two entrance signs, one at the main entry point and one at the entrance to Posta Quemada Ranch. The sign at Posta Quemada Ranch is constructed out of telephone poles and has a replacement of estimate of \$1000.00; the value has been included.

A second road sign, with venues listed, exists at the entrance to Posta Quemada; the replacement value of this particular sign has been valued at \$500.00 . All of the signs have been included within the replacement cost listed above. To view the other two signs visit the 2014 Colossal Cave Photos file.

The telephone poles that support the entrance sign into Posta Quemada Ranch will need to be evaluated annually to insure stability. The poles are old and show signs of structural deficiencies.

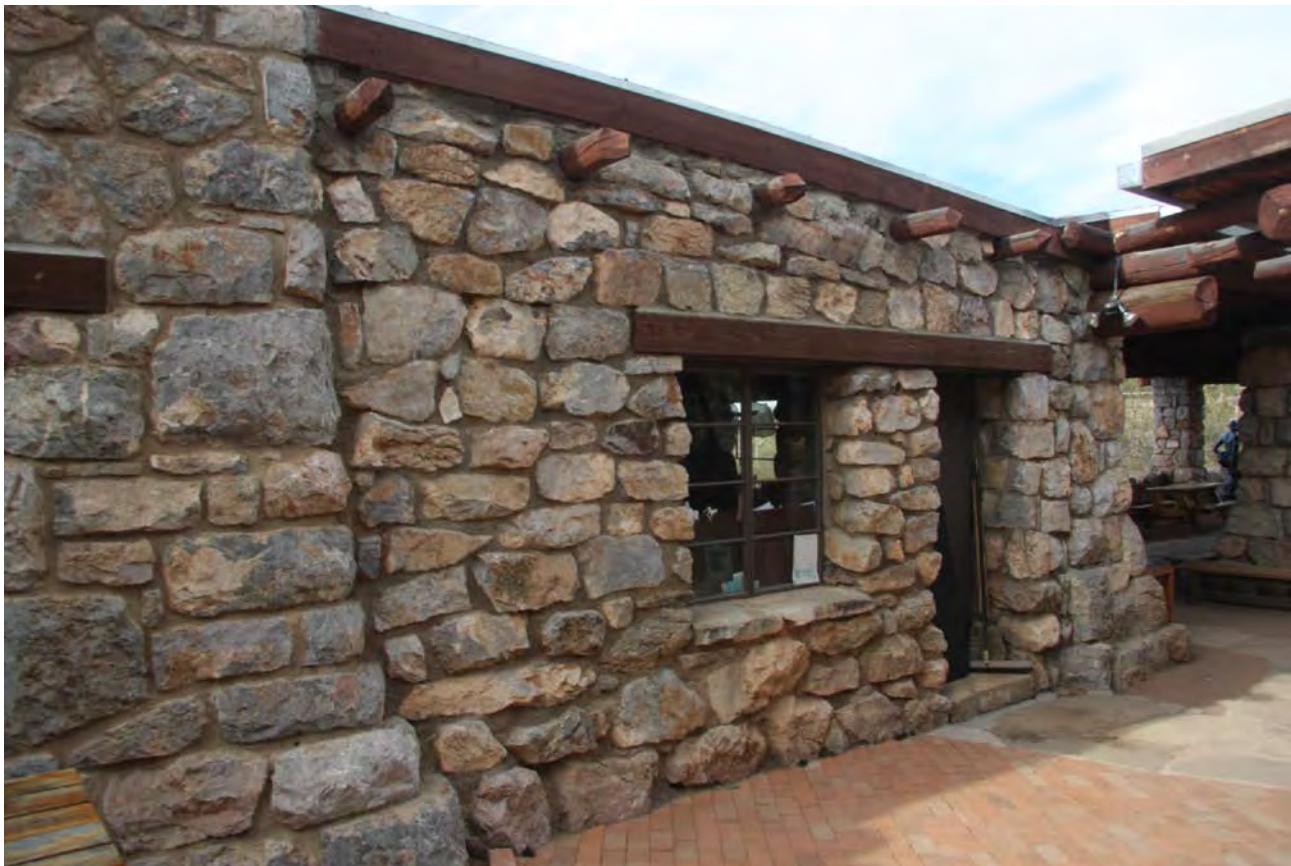
<b>Building Size:</b>	2,630 square feet of building; 2,210 square feet of retaining wall.
<b>Replacement Cost:</b>	\$ 989,000.00 See replacement calculations listed below.
<b>Building Materials:</b>	Wall constructed from native hand-chiseled limestone with wood rafters/roof.
<b>Building Condition:</b>	The hand cut limestone walls are in very good condition.
<b>Building Age:</b>	1936-37/2004
<b>Photo Date:</b>	February 24, 2014

The value of the building, including the lower restrooms has been estimated at a replacement value of \$250.00 per square foot; the retainer walls have been valued at \$150.00 per square foot.

In 2004 the wooden beams and door jams were replaced as a part of a Pima County historic grant. The adjoining Ramada was included within the restoration project.

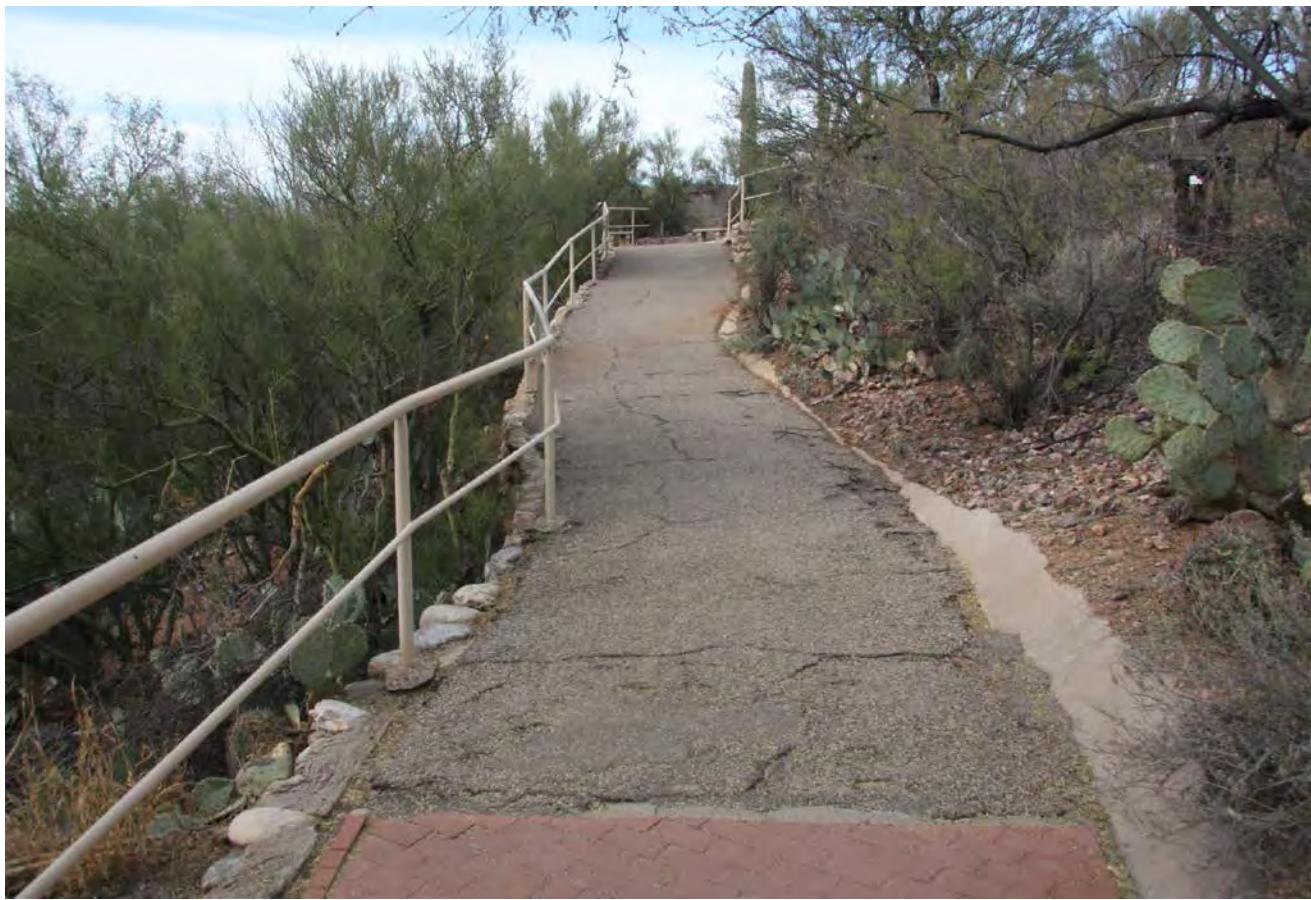
<b>Building Size:</b>	1,680 Square Feet With Safety Railing.
<b>Replacement Cost:</b>	\$42,000    Estimated at \$25.00 per square foot replacement cost.
<b>Building Materials:</b>	Asphalt/Concrete
<b>Building Condition:</b>	Fair
<b>Building Age:</b>	1975
<b>Photo Date</b>	February 24, 2014

*The replacement cost only includes the railing and asphalt. Does not include the original cost of grading. The pathway is in need of a new coat of asphalt, this should be included when the parking lot is scheduled.*

*Secure the hand rails where loose.*

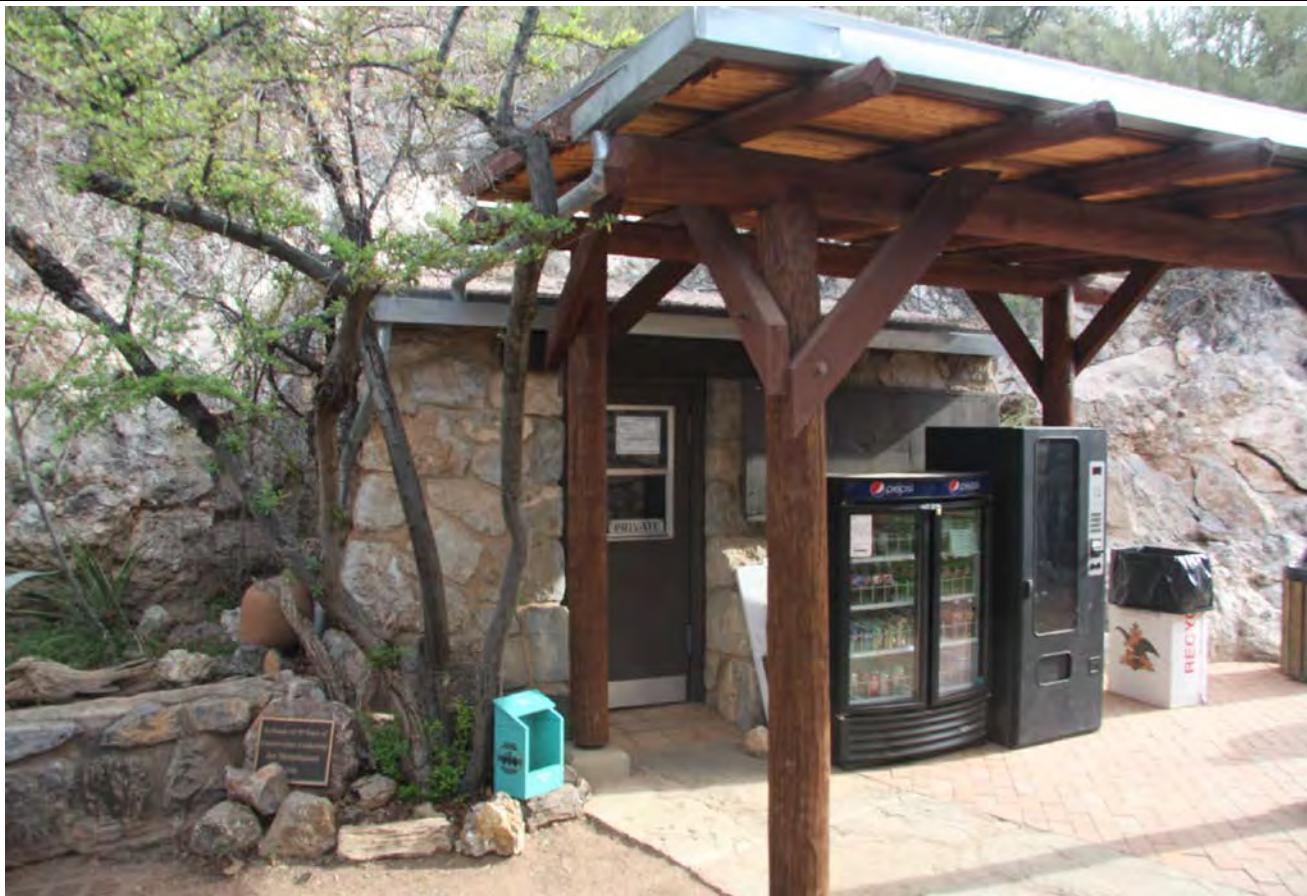
<b>Building Size:</b>	176-square feet, plus a 143-square foot Ramada.
<b>Replacement Cost:</b>	\$ 58,000.00 See itemized replacement cost listed below.
<b>Building Materials:</b>	Walls constructed from native hand-chiseled limestone with wood rafters/roof.
<b>Building Condition:</b>	Excellent.
<b>Building Age:</b>	1935-36
<b>Photo Date:</b>	February 24, 2014

The guides room was constructed by the Civilian Conservation Corps sometime between 1935 and 36. The roof on the guides room along with the Ramada were replaced in 2005 with Pima County bond funds. The replacement cost for this structure has been calculated at \$250.00 per square foot for the building and \$100.00 per square foot for the attached Ramada.

Recommend that all exposed wood be periodically treated with a preservative.

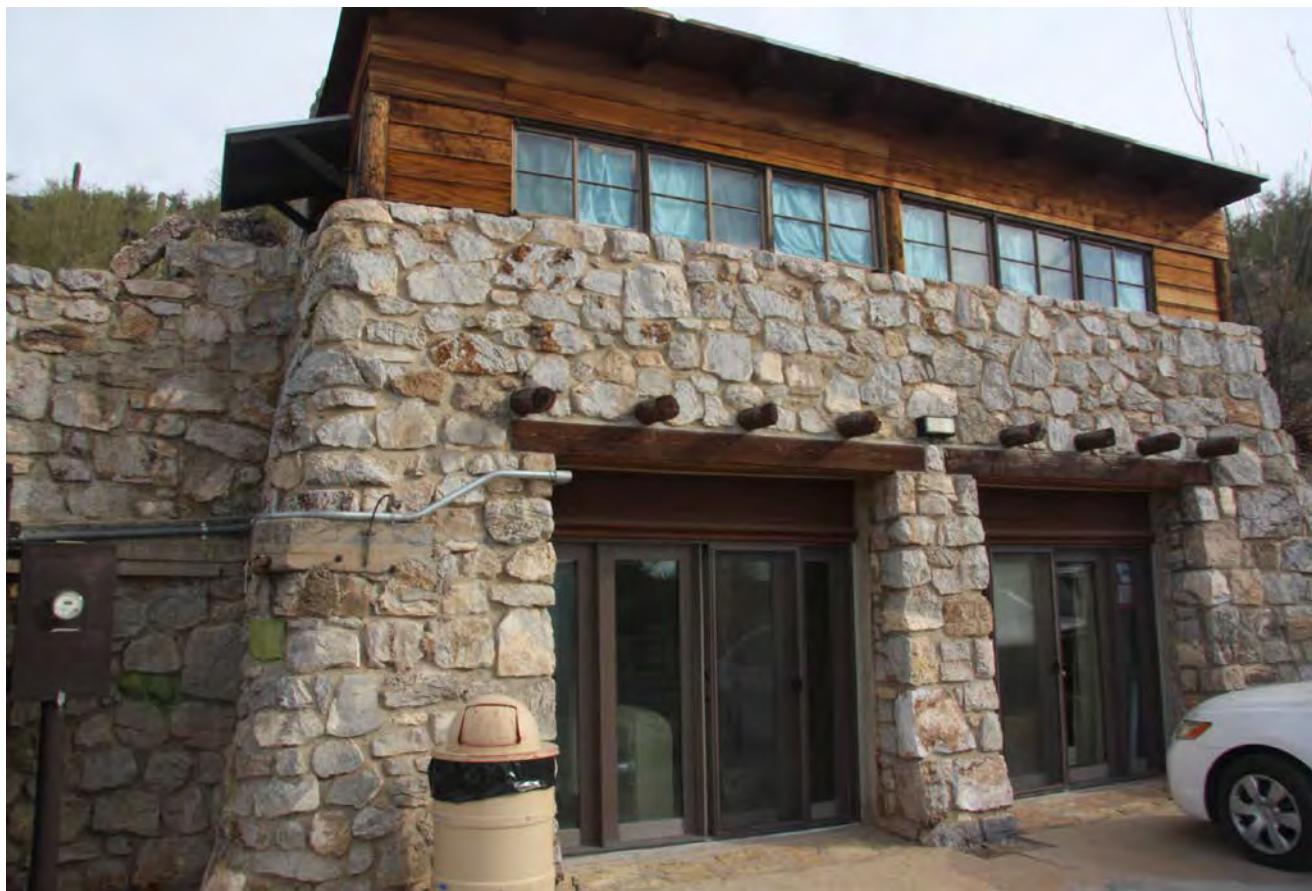
<b>Building Size:</b>	1,467 Square Feet
<b>Replacement Cost:</b>	\$ 366,750.00 Estimated replacement cost \$250.00 per square foot.
<b>Building Materials:</b>	Lower walls constructed from native hand-chiseled limestone. Upper out of wood.
<b>Building Condition:</b>	The building is in very good condition considering its age.
<b>Building Age:</b>	1935-1936 Reconstructed in 2004
<b>Photo Date:</b>	February 24, 2014

The living quarters was constructed by the Civilian Conservation Corps sometime between 1935-36. The living quarters was renovated in 2004; the sliding glass doors on the bottom floor were replaced, asbestos tile was removed from the lower portion of the building; the windows on the second floor were replaced. A portion of the outside electrical system was removed creating a much better overall. This was the first building completed by the CCC's, the bottom portion housed a generator and garage with the top portion was an apartment and porch. Overall, the rock construction is in very good condition. The roof on the back side of the building has been patched several times and requires a new roof for proper protection.

Replace the back roof on the building.  
Place anti-siphon valves on all hosebibs.

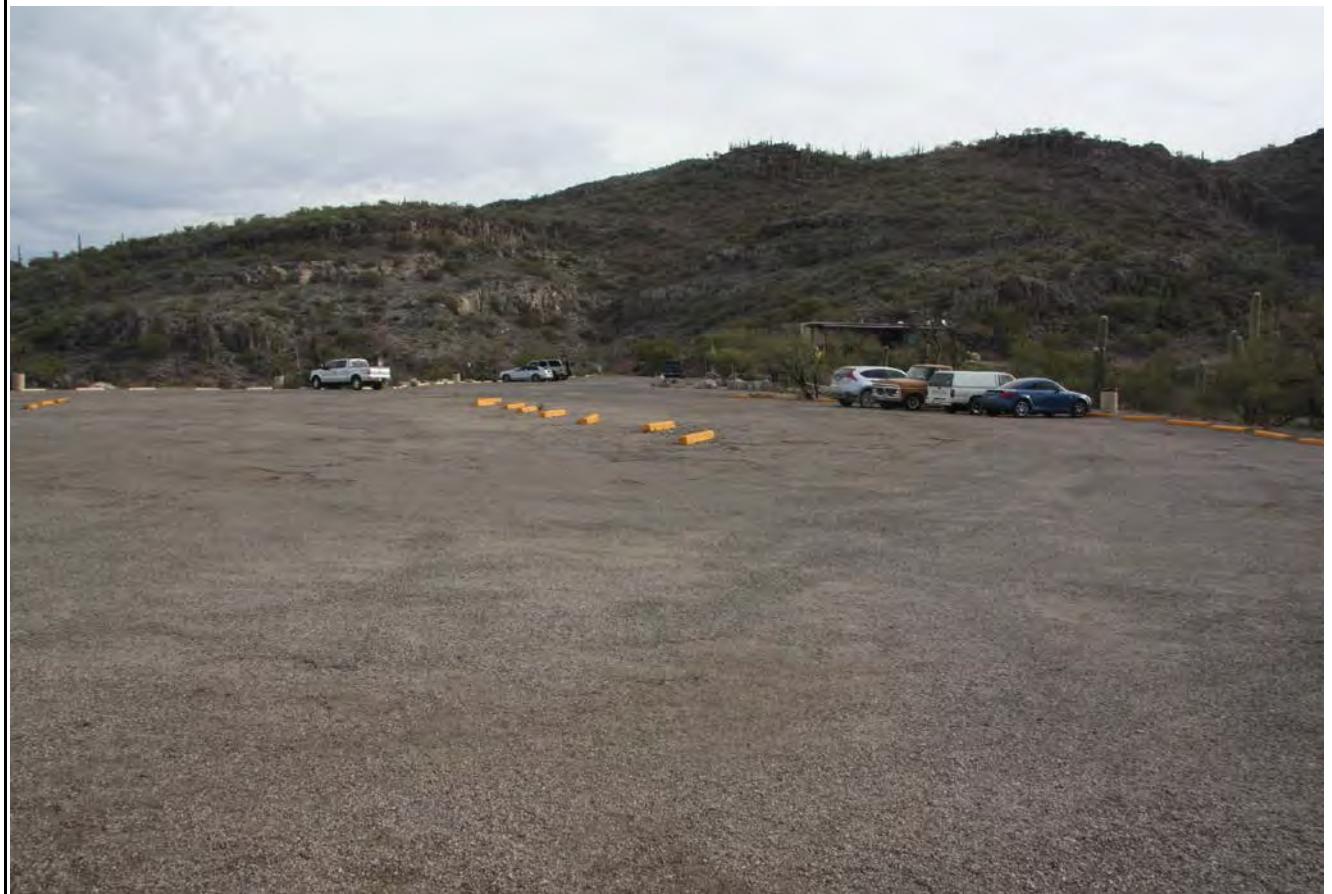
<b>Building Size:</b>	102 parking spaces 4,500 Square Yards
<b>Replacement Cost:</b>	\$ 67,500.00 Estimated at \$15.00 per square yard replacement cost for asphalt.
<b>Building Materials:</b>	2-inch asphalt over lay.
<b>Building Condition:</b>	Poor
<b>Building Age:</b>	1993 The parking lot was re-done.
<b>Photo Date:</b>	February 24, 2014

The overall appearance of the parking facility requires upgrading; the subsurface of the lot is uneven recommend grading, compacting and adding 2-inches of asphalt for long term protection.

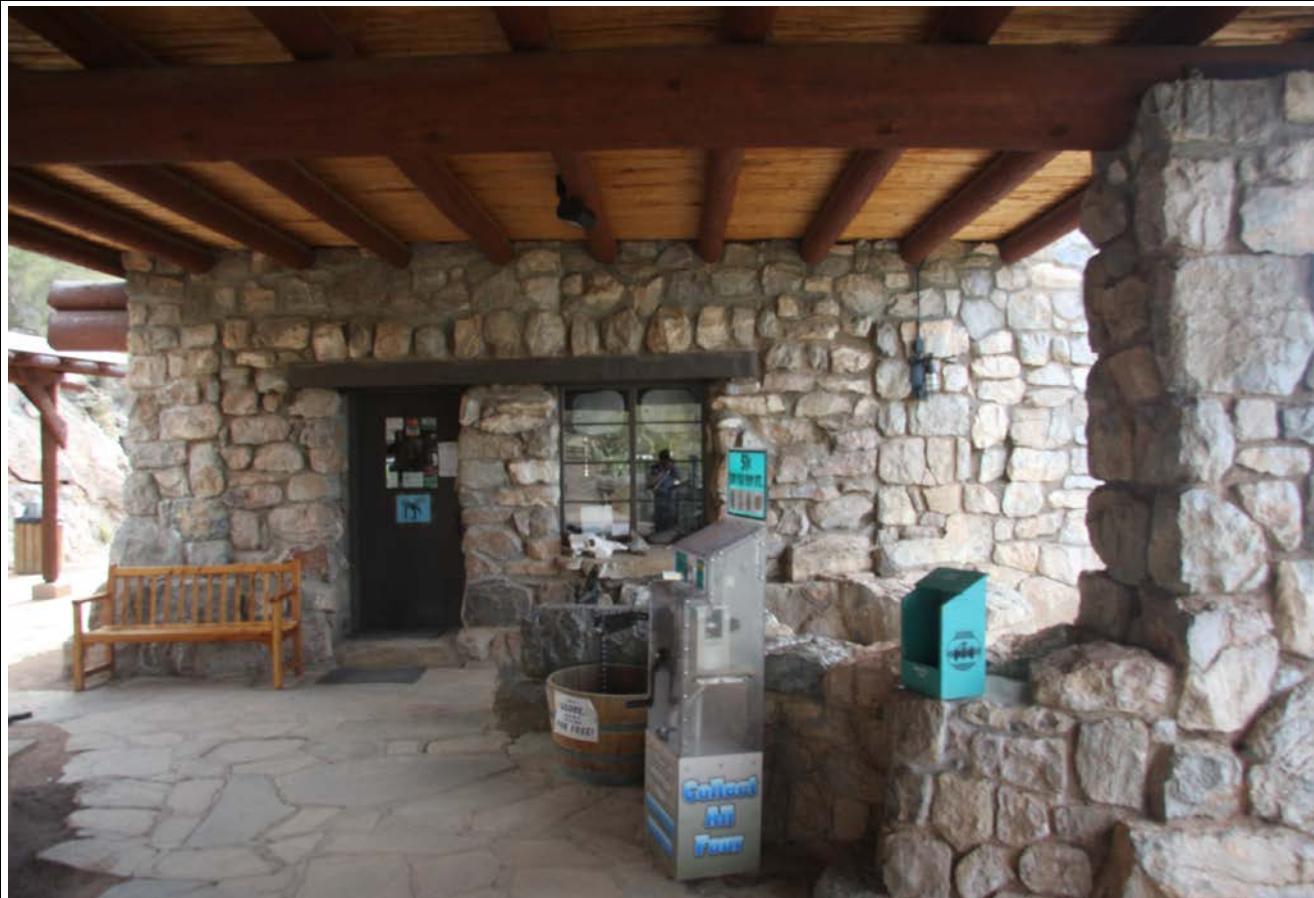
<b>Building Size:</b>	1,984 Square Feet.	Open Air Ramada With Stone Pillars and Solid Roof
<b>Replacement Cost:</b>	\$ 297,600.00	Estimated at \$125.00 per foot replacement cost.
<b>Building Materials:</b>	Hand cut stones for the pillars with a solid wooden roof.	
<b>Building Condition:</b>	Good	
<b>Building Age:</b>	1932, 1962	Roof re-constructed in 2004
<b>Photo Date:</b>	February 24, 2014

The Ramada was constructed by the CCC's in 1936-37 connecting the cave's entrance with the Custodian's House. The original Ramada has saguaro ribs for the roof, this was changed in 1962 to a solid roof structure. In 2004 County Bond Funds were provided to reconstruct the roof and make it similar to the original one. The rock floor remains the same as constructed by the CCC. The overall condition of the Ramada is very good. The Ramada as know today, was once much longer. The Ramada actually continued through the office door to the next adjoining wall. A portion of the Ramada was enclosed to increase the size of the Administration Building.

Recommend that all exposed wood be treated periodically to protect against the sun and dry rot. Remove the debris from on top of the roof.

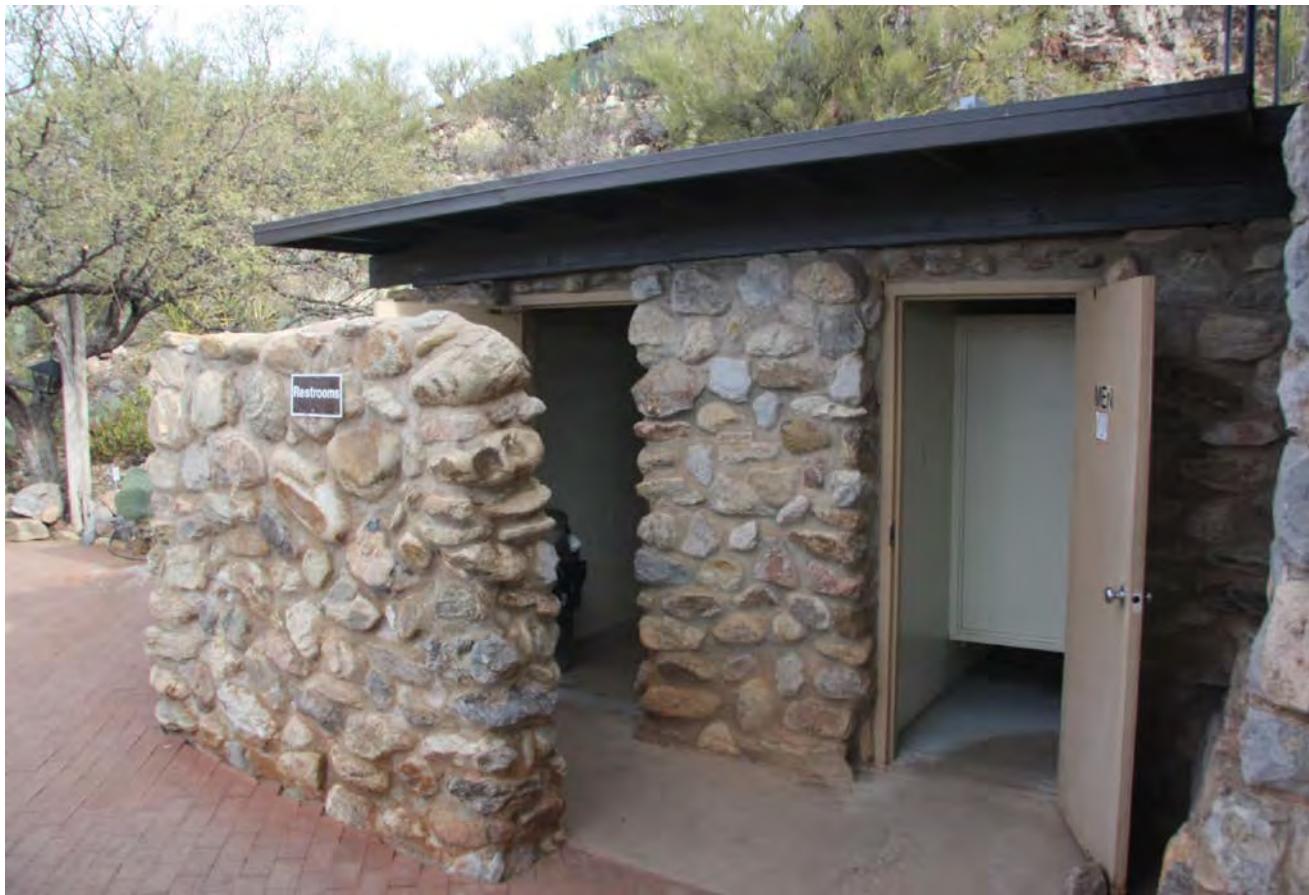
<b>Building Size:</b>	165 Square Feet
<b>Replacement Cost:</b>	\$ 41,250.00 Estimated at \$250.00 per square foot replacement cost.
<b>Building Materials:</b>	Stone veneer walls, super secure restroom.
<b>Building Condition:</b>	Fair
<b>Building Age:</b>	1975
<b>Photo Date:</b>	February 24, 2014

*The Restroom was scheduled for replacement with 2004 bond funds. Due to a shortage of available funding, the restroom project was eliminated from consideration.*

*Overall, the Restroom is too small and does not have sufficient disability access. The Restroom should be scheduled for replacement when funds become available.*

*It is recommended that a design master plan be completed prior to the replacement so that additional consideration can be given to the best location as well as associated amenities.*

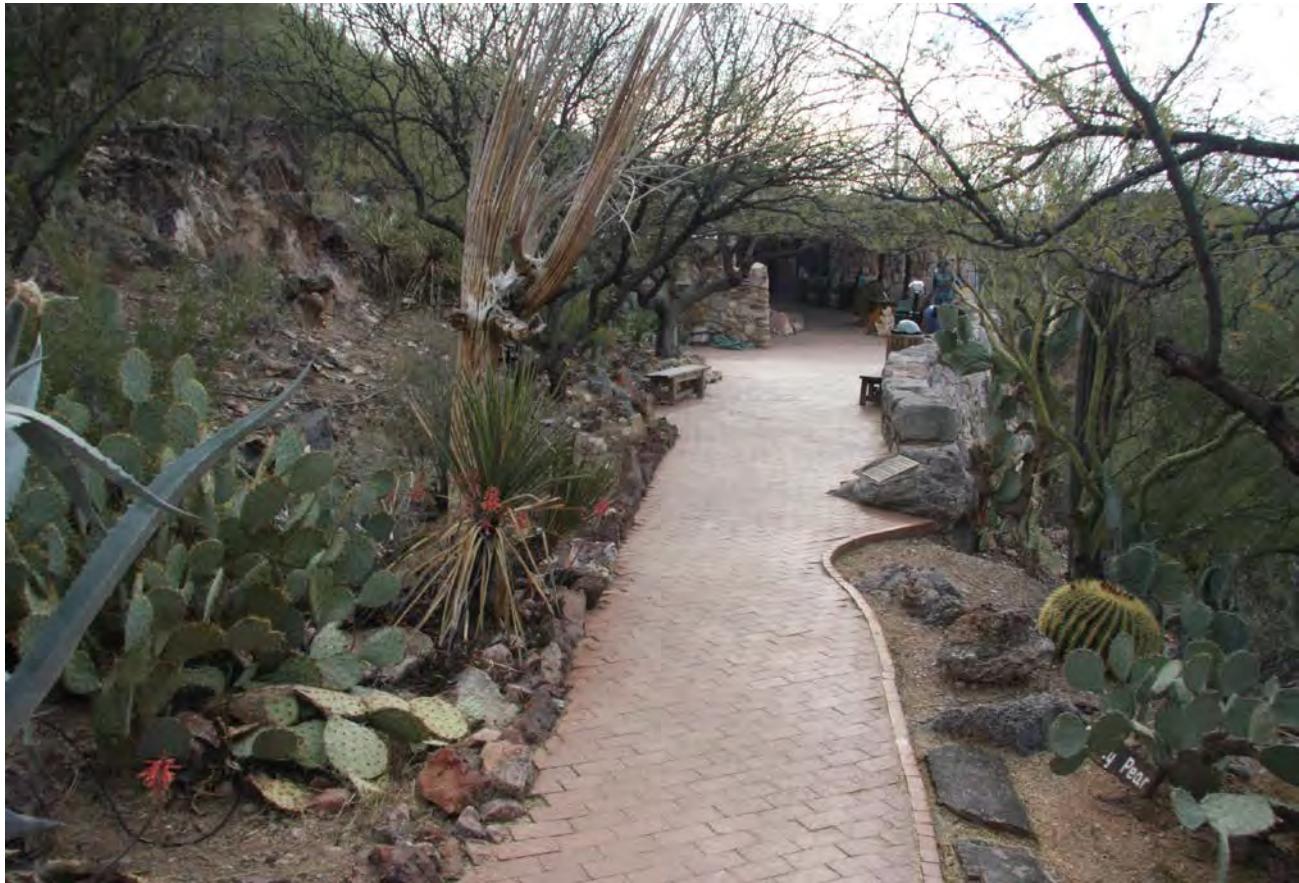
<b>Building Size:</b>	1,930 Square Feet
<b>Replacement Cost:</b>	\$ 46,320.00 Estimated at \$24.00 per square foot replacement cost.
<b>Building Materials:</b>	Two inch thick red brick
<b>Building Condition:</b>	Good
<b>Building Age:</b>	1975
<b>Photo Date:</b>	February 24, 2014

*The brick was installed in 1975 by contract using Pima County Bond Funds. The pathway follows the original route constructed by the CCC's in 1936. The steps leading from the brick pathway to the parking lot were part of the 1936 project. Although the path is somewhat narrow by today's standards and has a few ideal tripping hazards along the sides, the staff have done an excellent job of keeping it clean and visible.*
