**Pima County Department of Finance & Risk Management**  
**CCMP Report, dtd 28<sup>th</sup> May, 2014**

**Randy Gimblett & Kerry Baldwin,  
CCMP Plan Assessment & Recommendations, May 2014**

## ***2014 Property Inventory Report***

## ***Maintenance Priority Sheet***

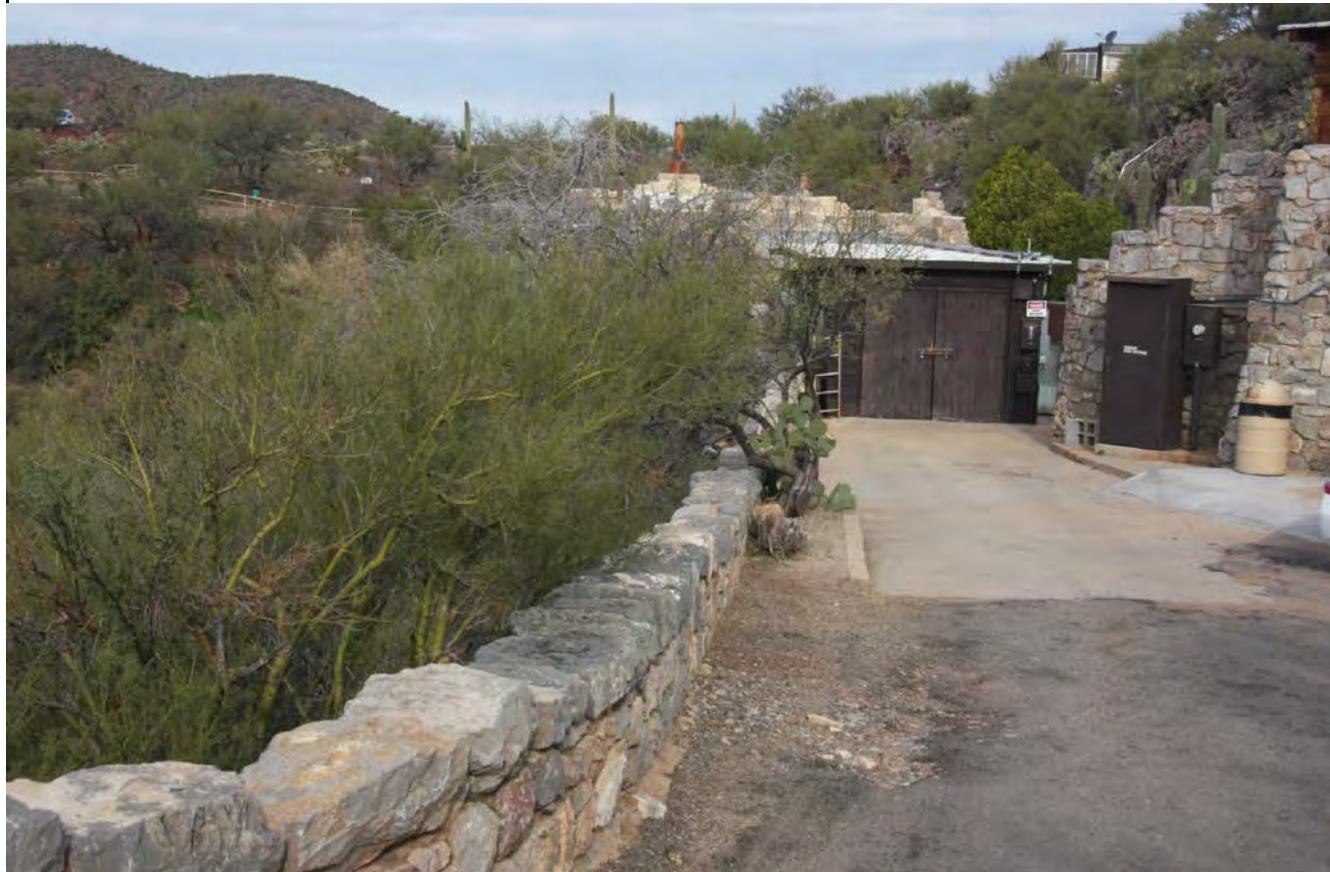
<b>Building Size:</b>	343-lineal feet
<b>Replacement Cost:</b>	\$ 68,600.00 Estimated at \$200.00 per lineal foot replacement cost.
<b>Building Materials:</b>	Hand chiseled limestone rock.
<b>Building Condition:</b>	Very good
<b>Building Age:</b>	1935-36
<b>Photo Date:</b>	February 24, 2014

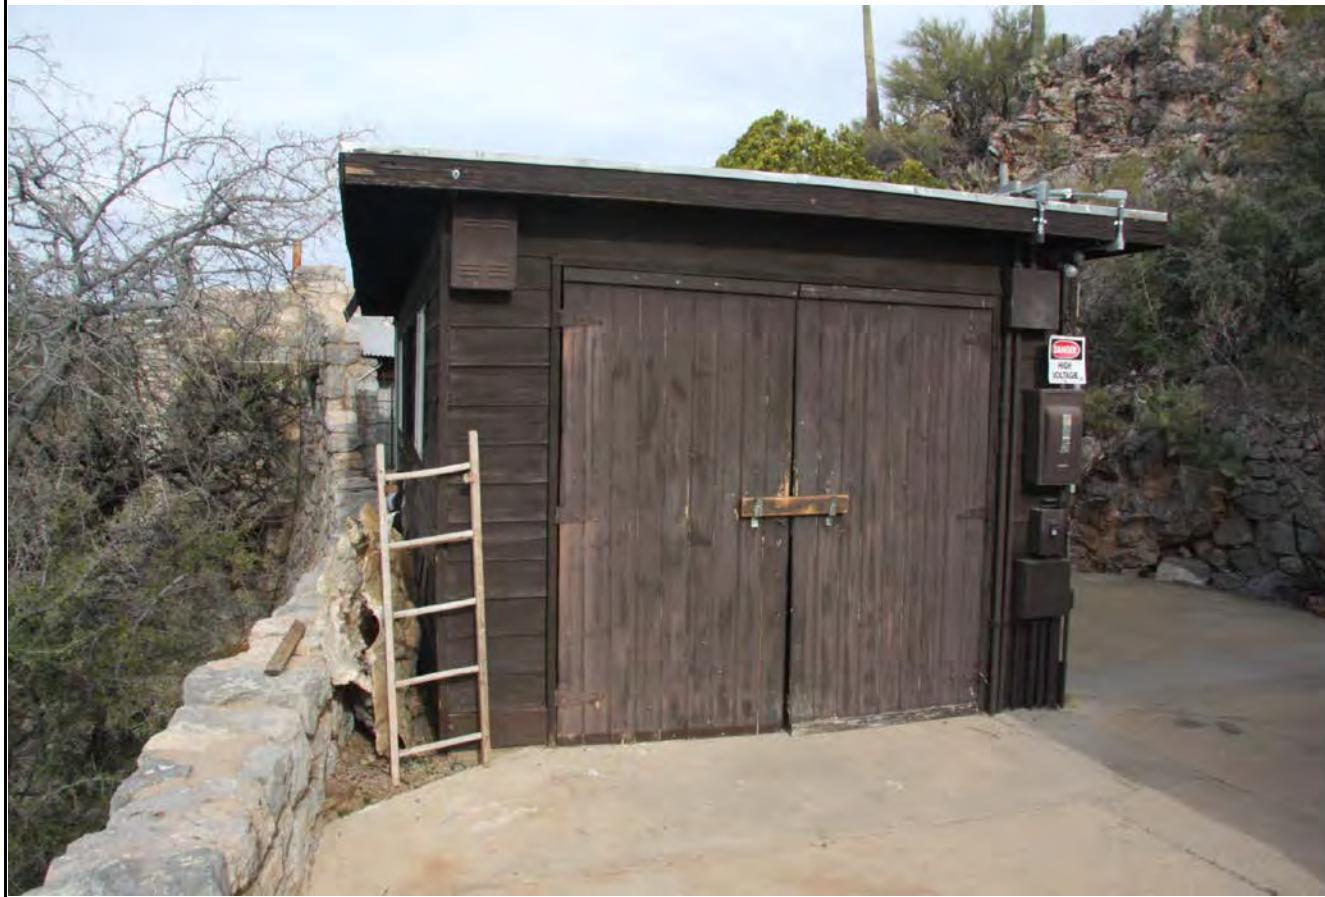
<b>Building Size:</b>	240 Square Feet
<b>Replacement Cost:</b>	\$ 18,000.00 Estimated at \$75.00 per square foot replacement cost.
<b>Building Materials:</b>	Wood
<b>Building Condition:</b>	Fair
<b>Building Age:</b>	1960
<b>Photo Date:</b>	February 24, 2014

The Laundry Building was constructed in 1960 by Pima County staff from the Parks Department for storage purposes. Overall, the wooden structure has held up pretty well considering its age and the hot dry climate of Arizona. If the building is to remain, a number of the wooden planks should be replaced.

Replace all wooden planks that are broken or rotted out.

During the repair phase the roof structure should be evaluated and brought up to code.

The plumbing and hot water heater are in need of repair.

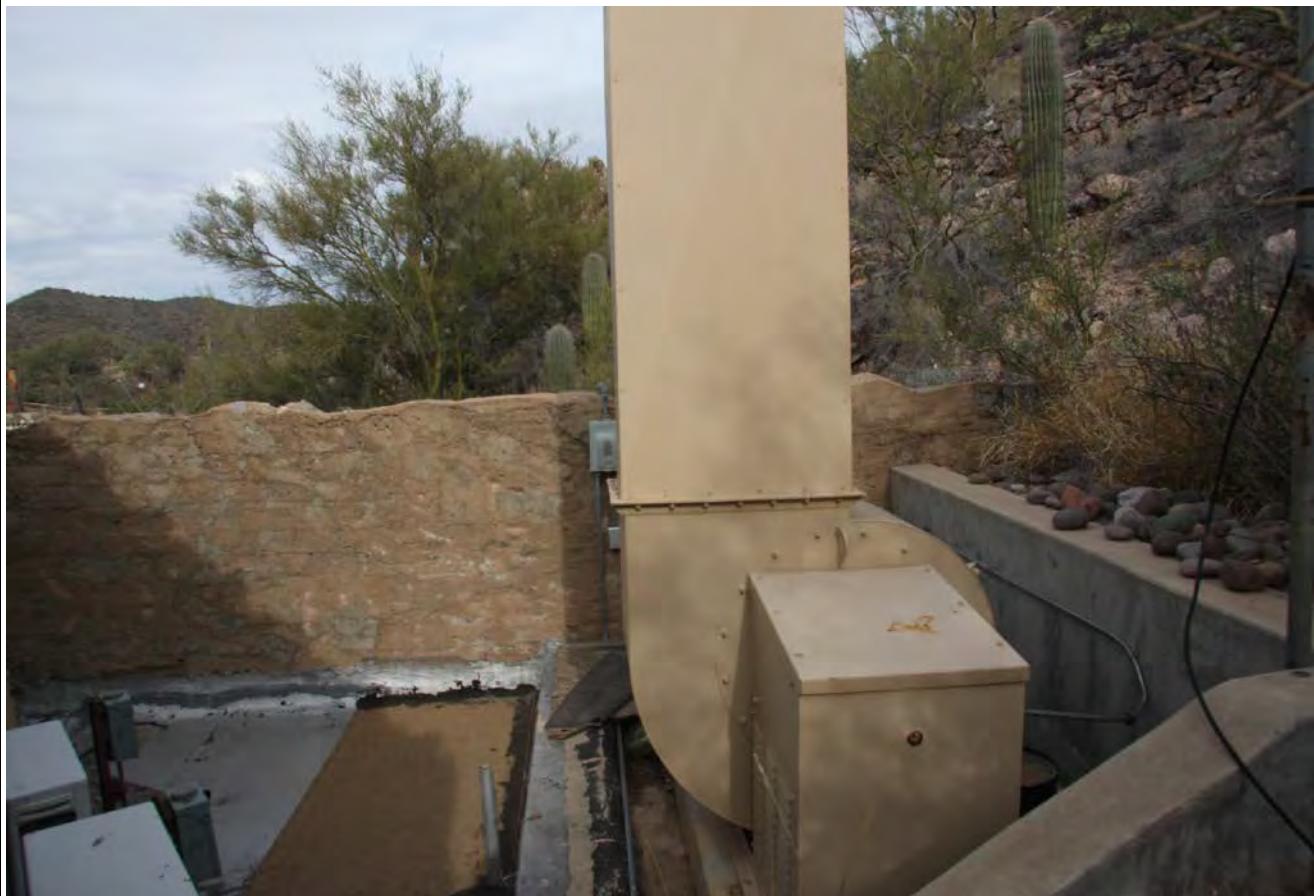
**Building Size:** One exhaust unit used for circulating air within the cave.

**Replacement Cost:** \$ 35,000.00

**Building Materials:** Mechanical equipment with concrete foundation.

**Building Condition:** Good

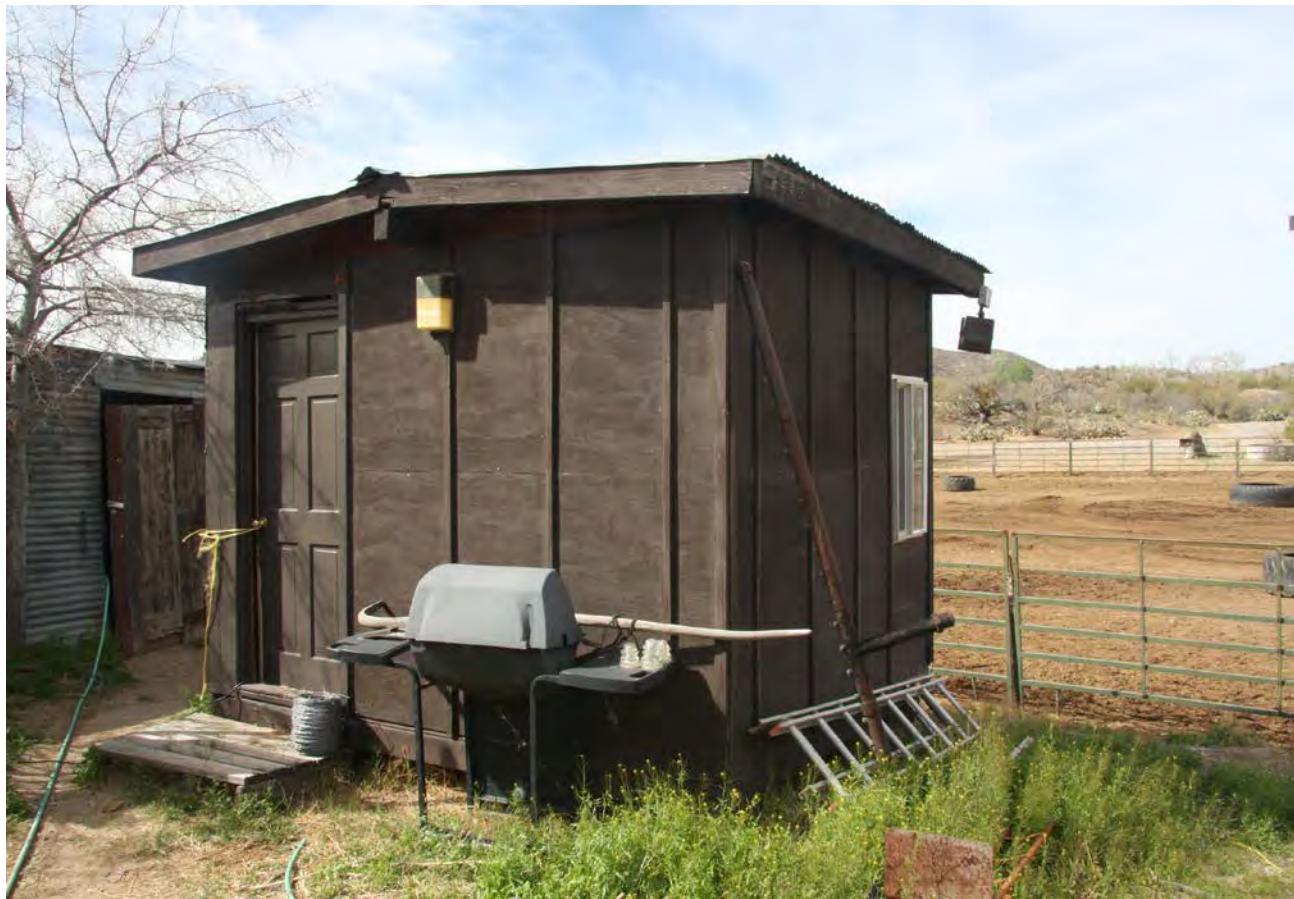
<b>Building Size:</b>	120 Square Feet
<b>Replacement Cost:</b>	\$ 6,000.00 Estimated at \$50.00 per square foot replacement cost.
<b>Building Materials:</b>	Wood
<b>Building Condition:</b>	Poor
<b>Building Age:</b>	2000
<b>Photo Date:</b>	February 24, 2014

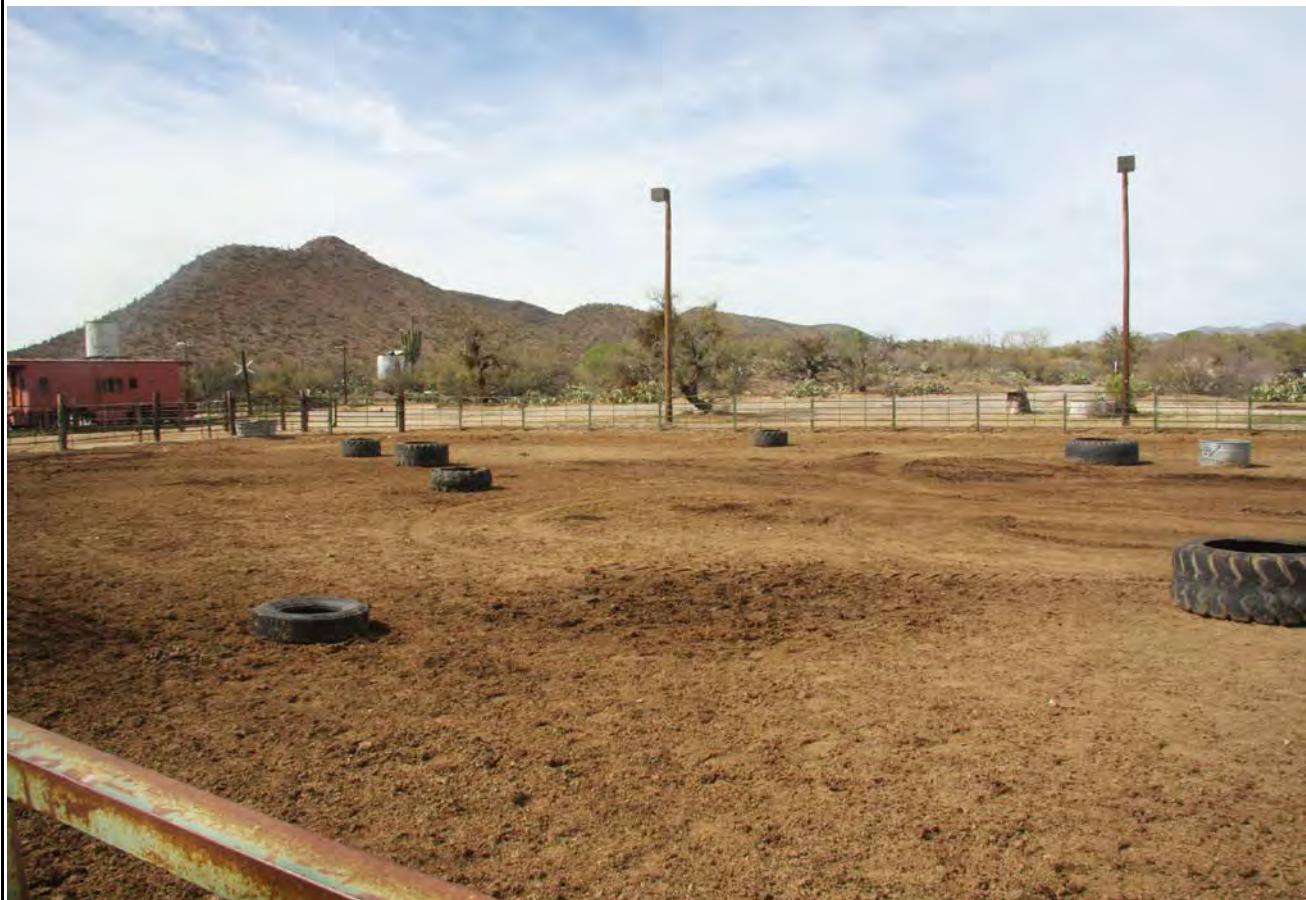
<b>Building Size:</b>	240' X 135' (32,400 square feet)
<b>Replacement Cost:</b>	\$ 80,000.00 Replacement cost based on estimates from CCMP staff.
<b>Building Materials:</b>	Portable panels with 7 lights mounted on wooden poles.
<b>Building Condition:</b>	Good
<b>Building Age:</b>	2000
<b>Photo Date</b>	February 24, 2014

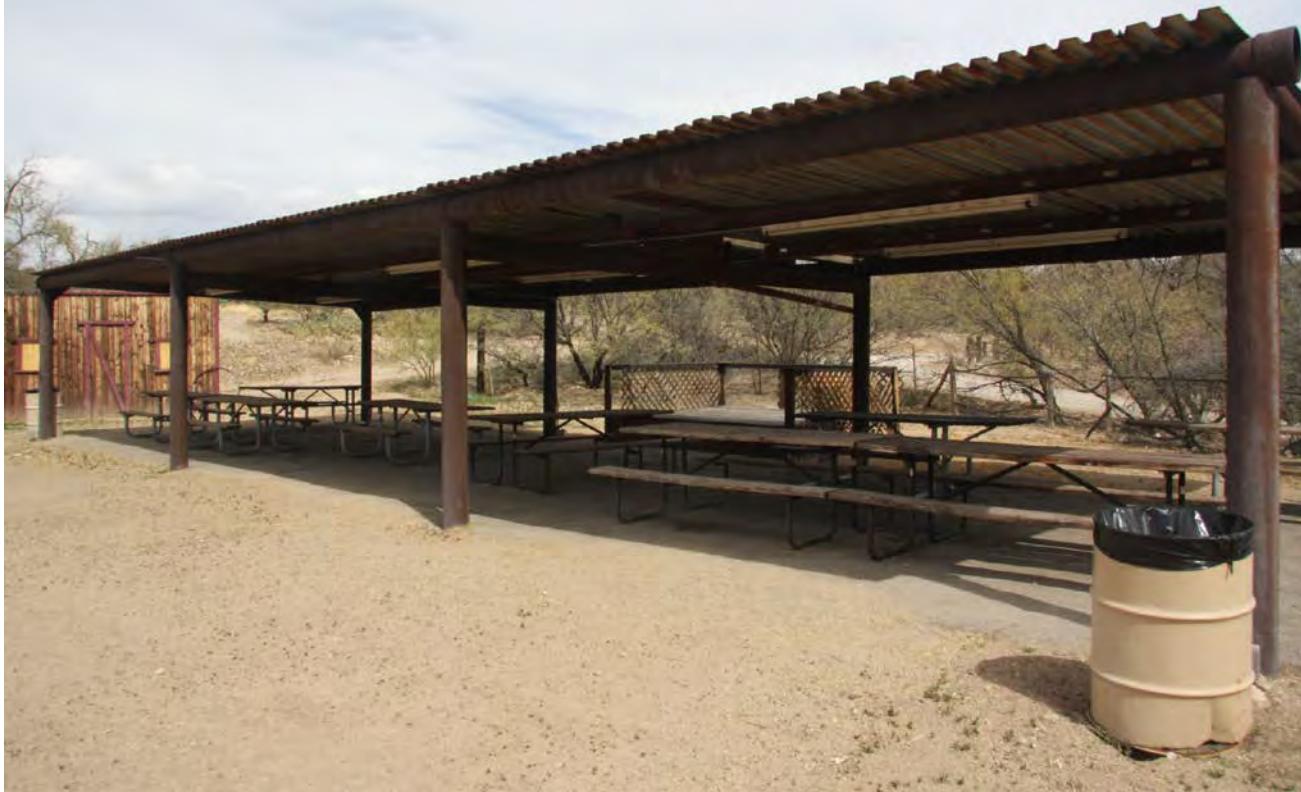
<b>Building Size:</b>	1,440 Square Feet
<b>Replacement Cost:</b>	\$ 108,000.00 <i>Estimated replacement cost at \$75.00 per square foot.</i>
<b>Building Materials:</b>	Used steel pipe pillars and beams with heavy gauge metal roofing.
<b>Building Condition:</b>	Good
<b>Building Age:</b>	1996
<b>Photo Date:</b>	February 24, 2014

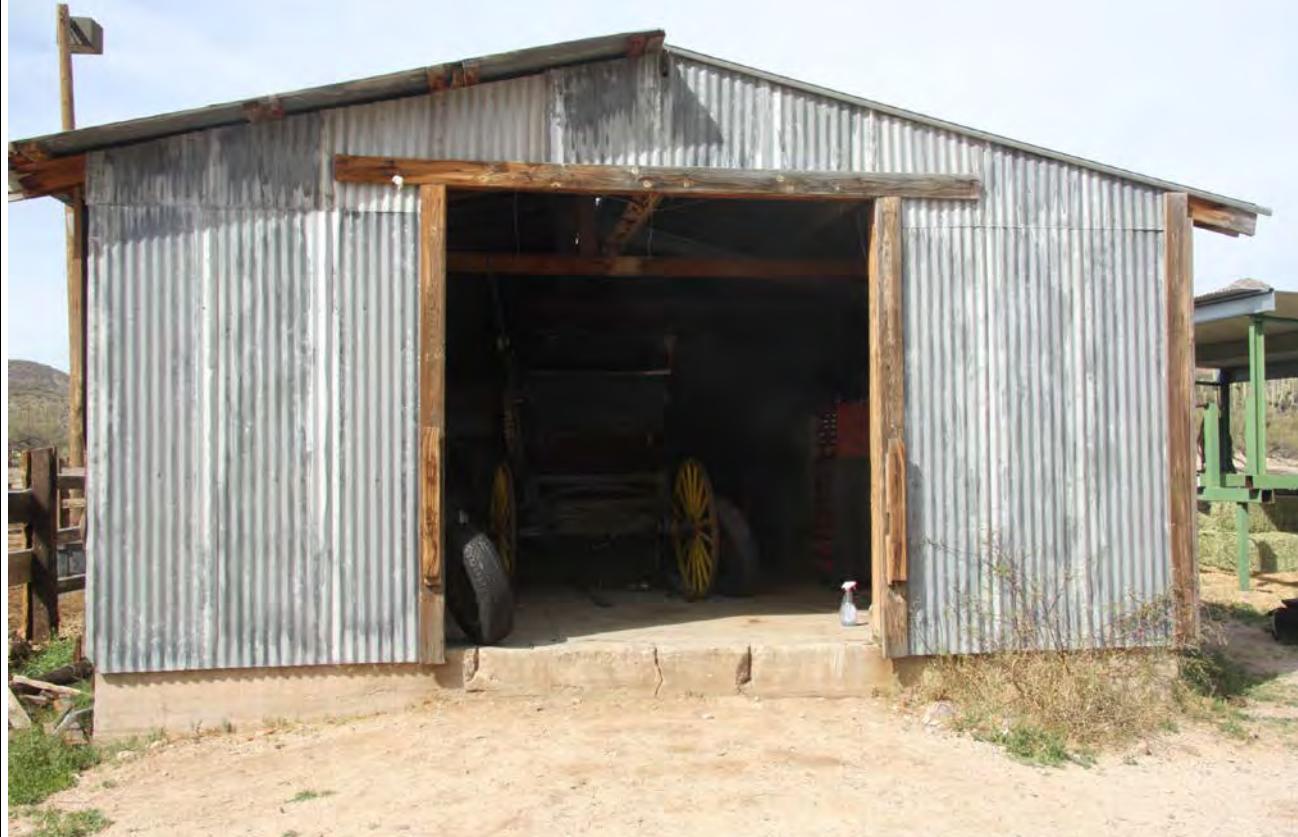
<b>Building Size:</b>	1,200 Square Feet.
<b>Replacement Cost:</b>	\$ 90,000.00 Estimated at \$75.00 per square foot replacement cost.
<b>Building Materials:</b>	Concrete Foundation With Concrete Floor. Metal Truss With Metal Siding.
<b>Building Condition:</b>	Good
<b>Building Age:</b>	1935-2003
<b>Photo Date:</b>	February 24, 2014

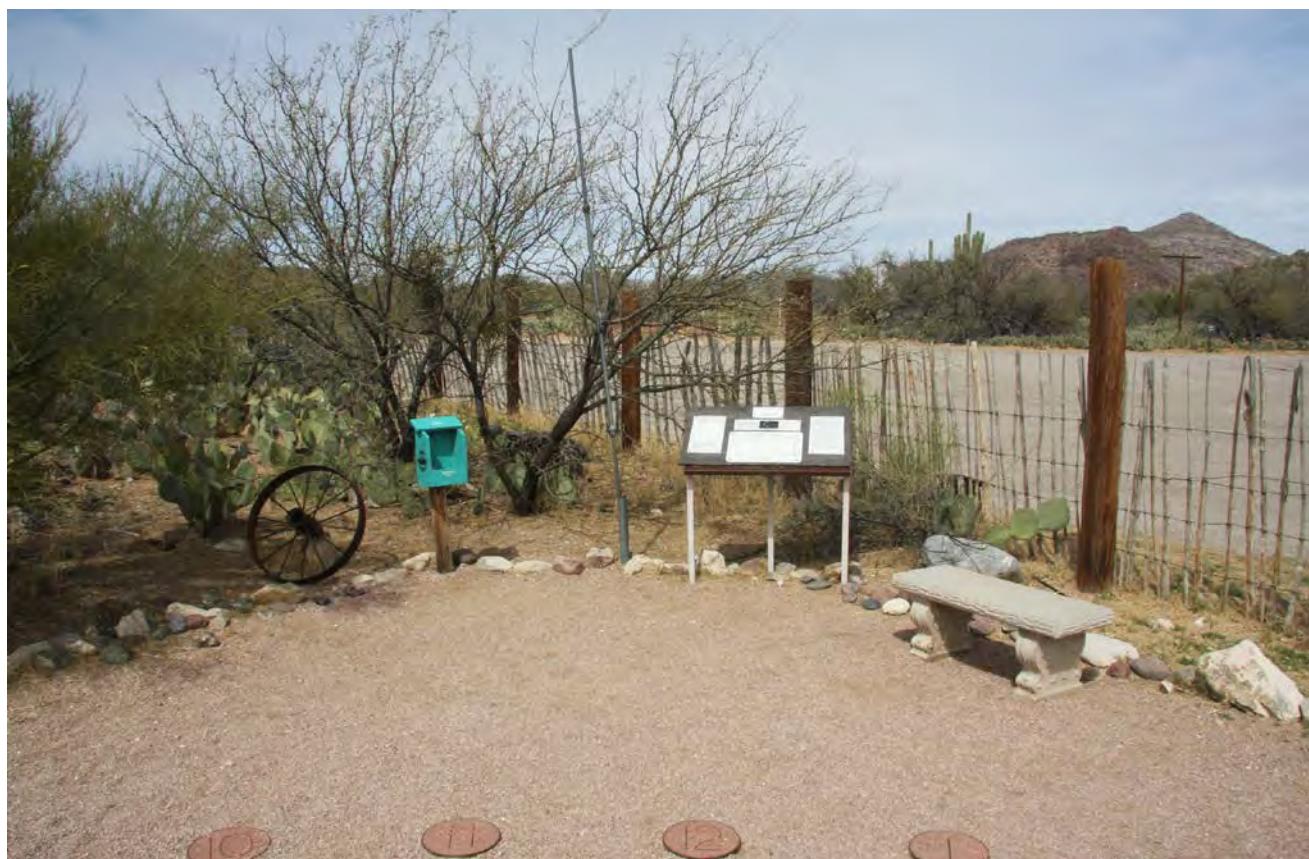
Building Size:	Approximately 1/2-acre
Replacement Cost:	\$ 10,000.00 See replacement calculations listed below.
Building Materials:	Variety
Building Condition:	Needs attention
Building Age:	2003
Photo Date:	February 24, 2014

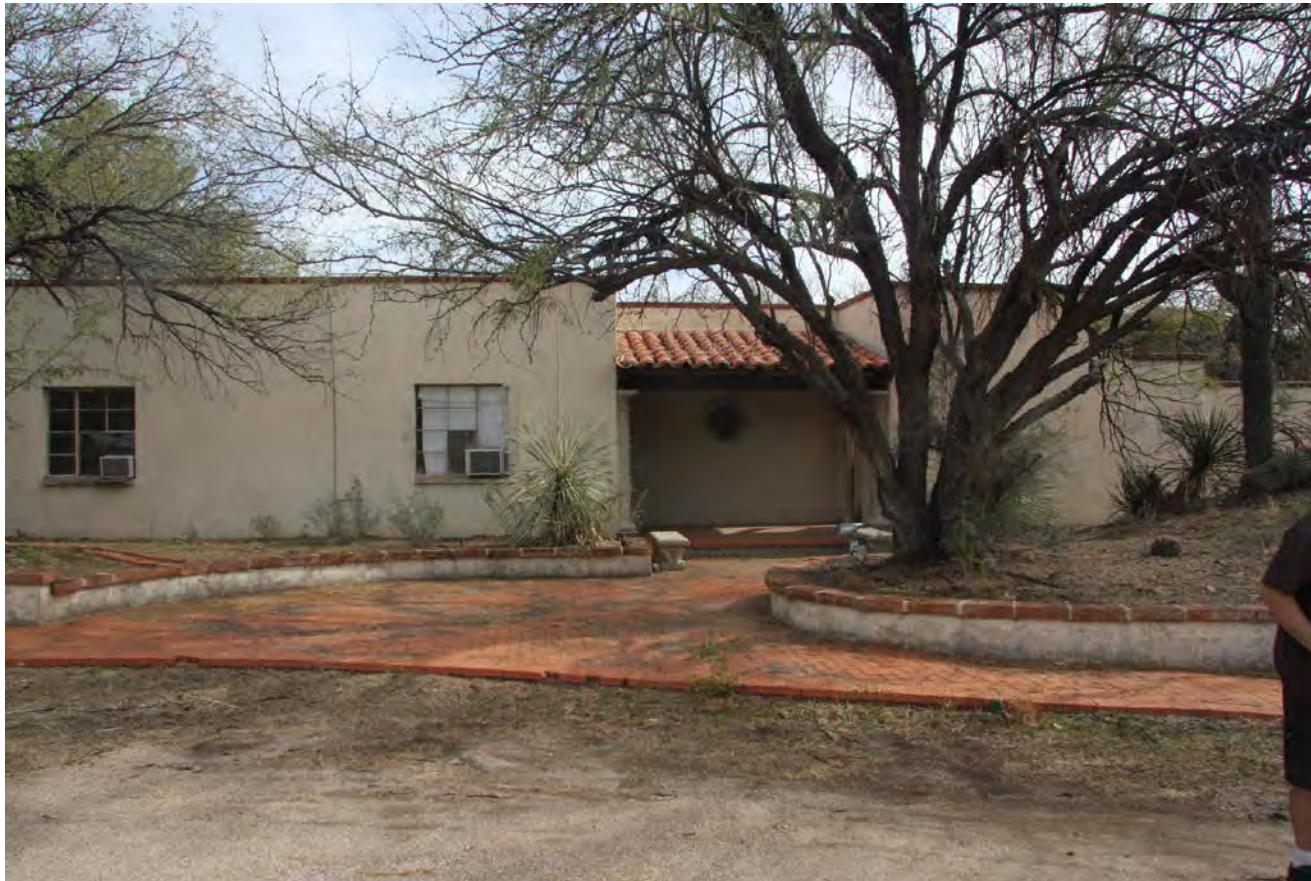
<b>Building Size:</b>	2059 Square feet
<b>Replacement Cost:</b>	\$ 411,800.00 Estimated at \$200.00 per square foot replacement cost.
<b>Building Materials:</b>	CMU With Stucco
<b>Building Condition:</b>	Fair
<b>Building Age:</b>	1935/1978
<b>Photo Date:</b>	February 24, 2014

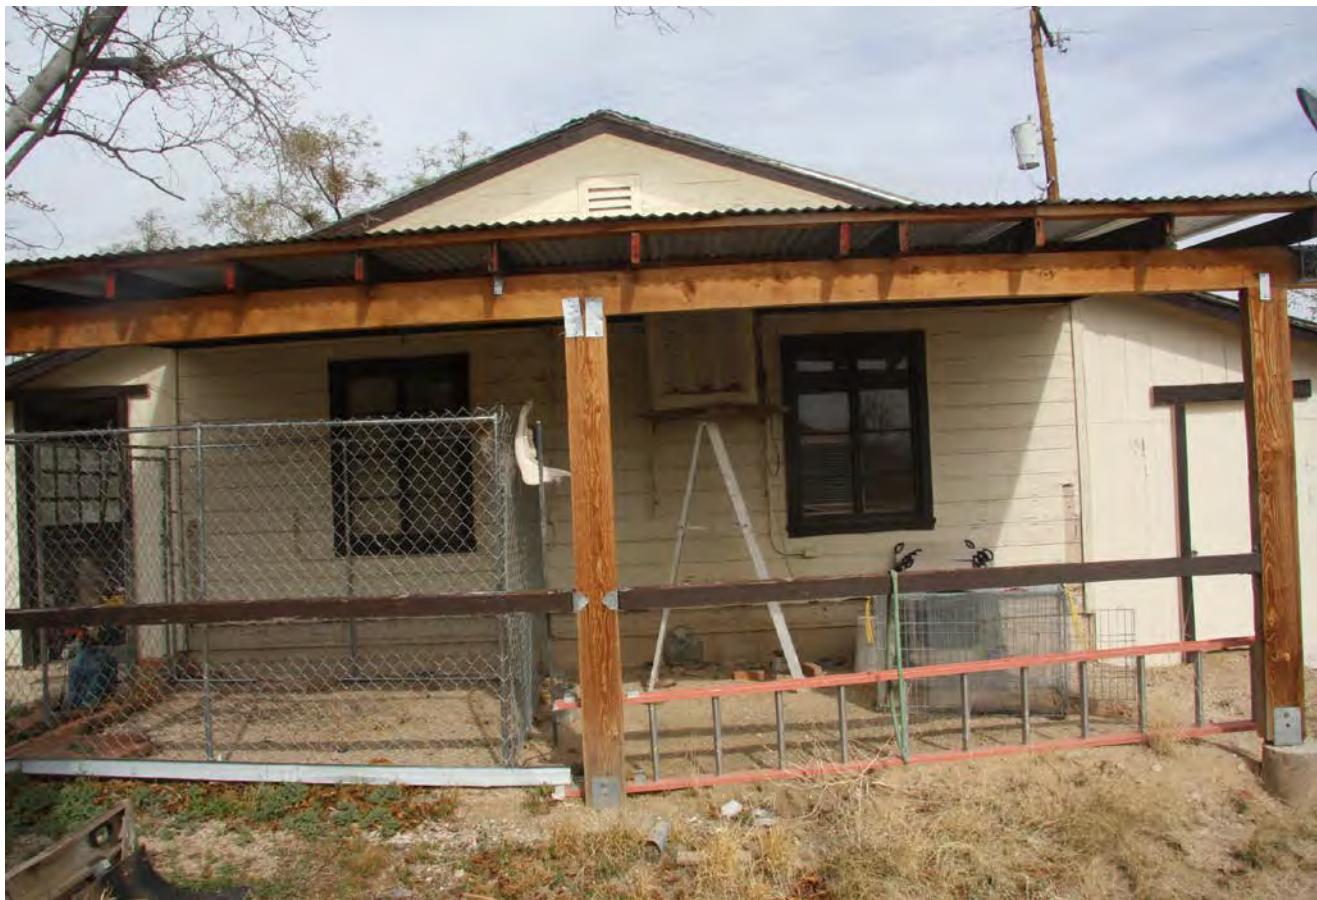
<b>Building Size:</b>	990 Square Feet
<b>Replacement Cost:</b>	\$ 198,000.00 Estimated at \$200.00 per square foot replacement cost.
<b>Building Materials:</b>	Wood frame with wood siding.
<b>Building Condition:</b>	Fair
<b>Building Age:</b>	1940
<b>Photo Date:</b>	February 24, 2014

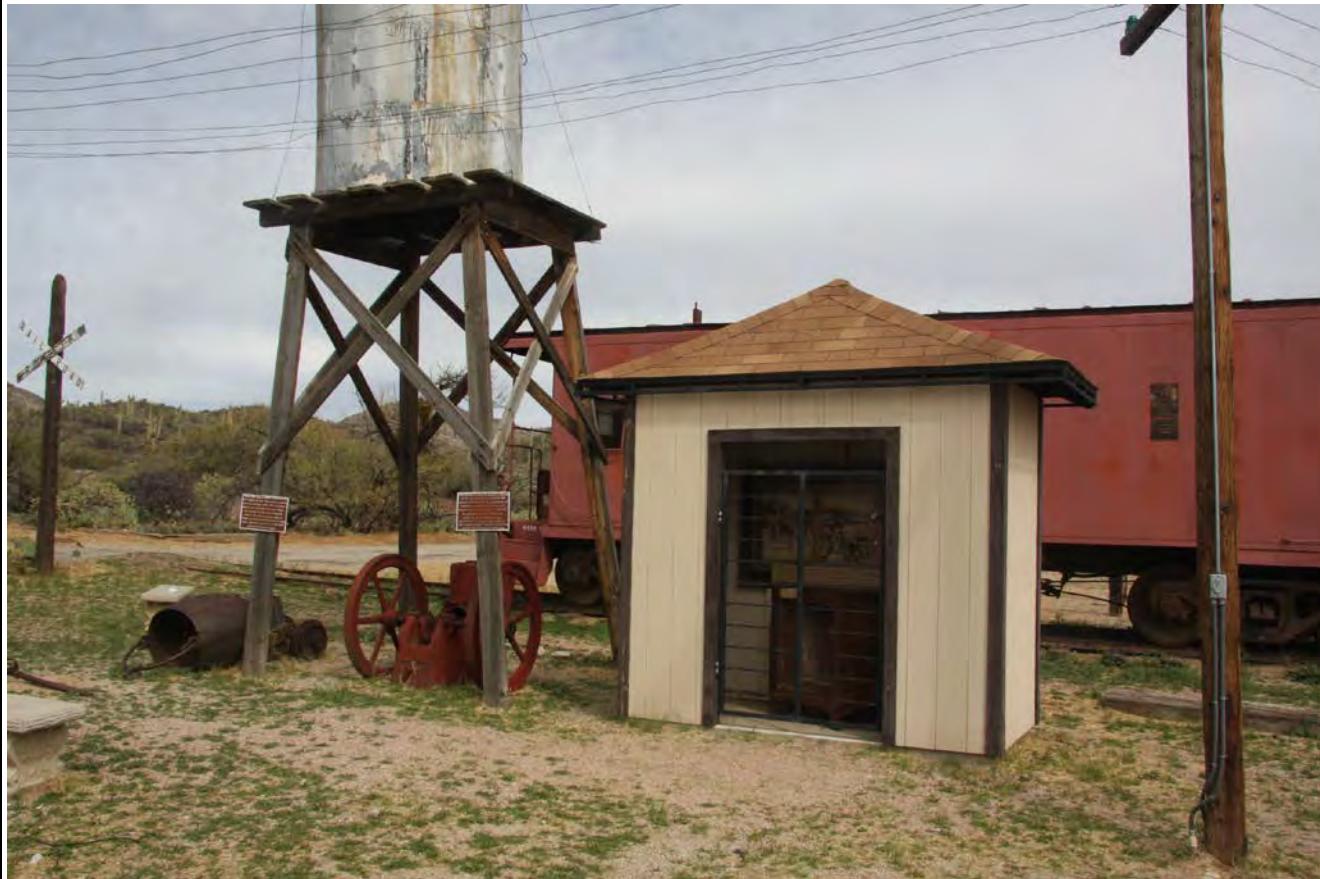
Facility:	Colossal Cave Mountain Park	Page Number	29
Building Name:	Historic Train Station Display	Photo By:	G.W. Bundrick

<b>Building Size:</b>	Not Applicable
<b>Replacement Cost:</b>	\$ 14,400.00 The values listed were not changed from the 2006 report.
<b>Building Materials:</b>	See individual items listed below
<b>Building Condition:</b>	See individual items listed below
<b>Building Age:</b>	See individual items listed below
<b>Photo Date:</b>	February 24, 2014

<b>Remarks:</b>
1. 1970 Bay Window Caboose purchased by the Parklands Foundation for \$3000.00 from RR Salvage
2. 48-square foot display building; estimated replacement cost \$3,000
3. Communication booth; used by the railroad for communication between 1920 & 1960, has historical value, estimated value \$2,000. Includes crank phone, hand-set phone black, glass lantern and telegraph sending.
4. Telegraph switch box; historical value, estimated value \$500.00
5. Vegetable Wagon; gift to the Pima County Parklands Foundation valued at \$3,000.00
6. Water tower; built by staff in 1990, estimated value \$1000.00.
7. Cattle Scale; acquired with the park, estimated value unknown.
8. Ore Bucket; acquired with the park, historic, estimated value \$500.00
9. Small Engine; gift from Rick Dailey, estimated value \$600.00
10. Large Engine; gift from Rick Dailey, estimated value \$ 800.00.

Paint all raw wood for preservation.  
 Remove clutter from around the home once construction has been completed.  
 Repair all exterior wood of the building.

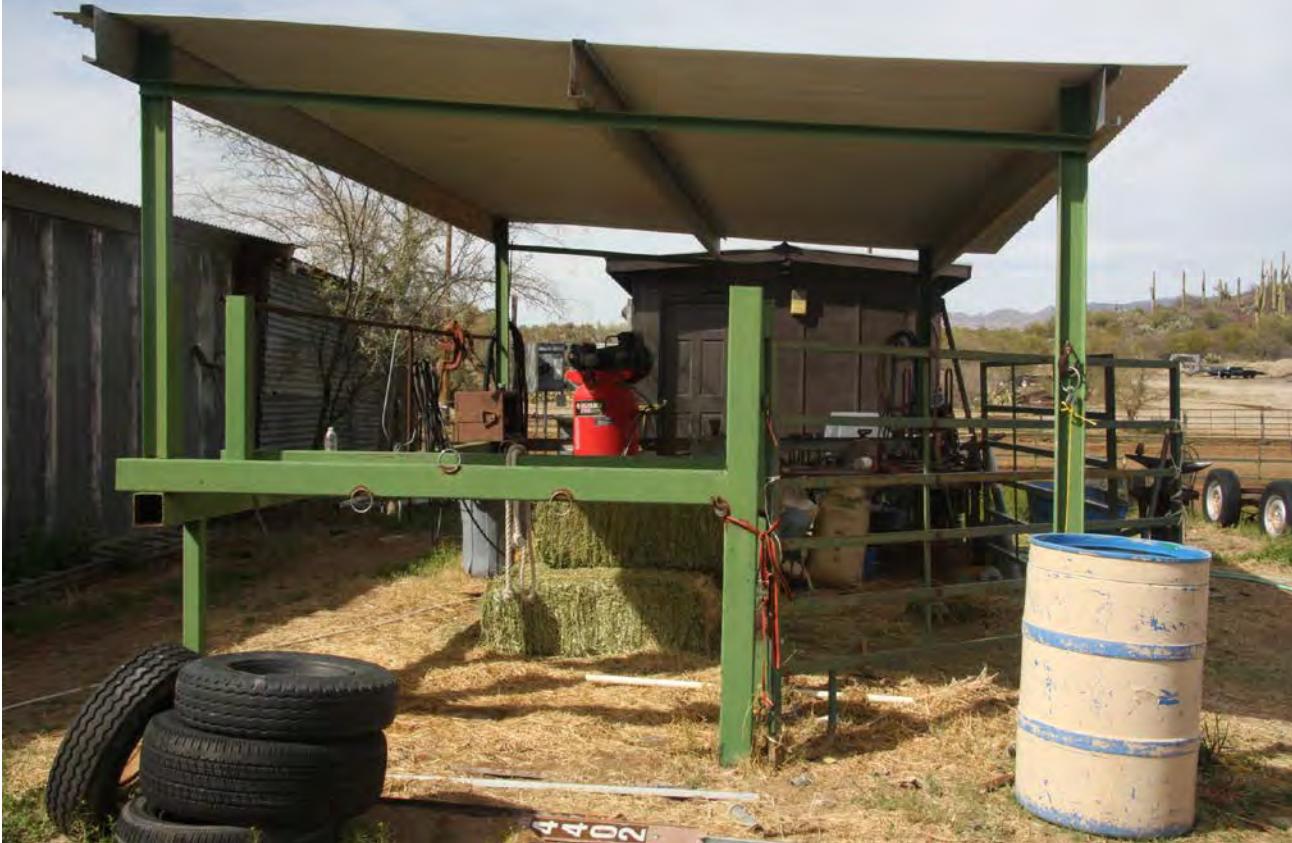
<b>Building Size:</b>	295 Square Feet.
<b>Replacement Cost:</b>	\$ 22,125.00 Replacement cost estimated at \$75.00 per square foot.
<b>Building Materials:</b>	Steel Frame With Metal Roof.
<b>Building Condition:</b>	Good
<b>Building Age:</b>	2002
<b>Photo Date:</b>	February 24, 2014

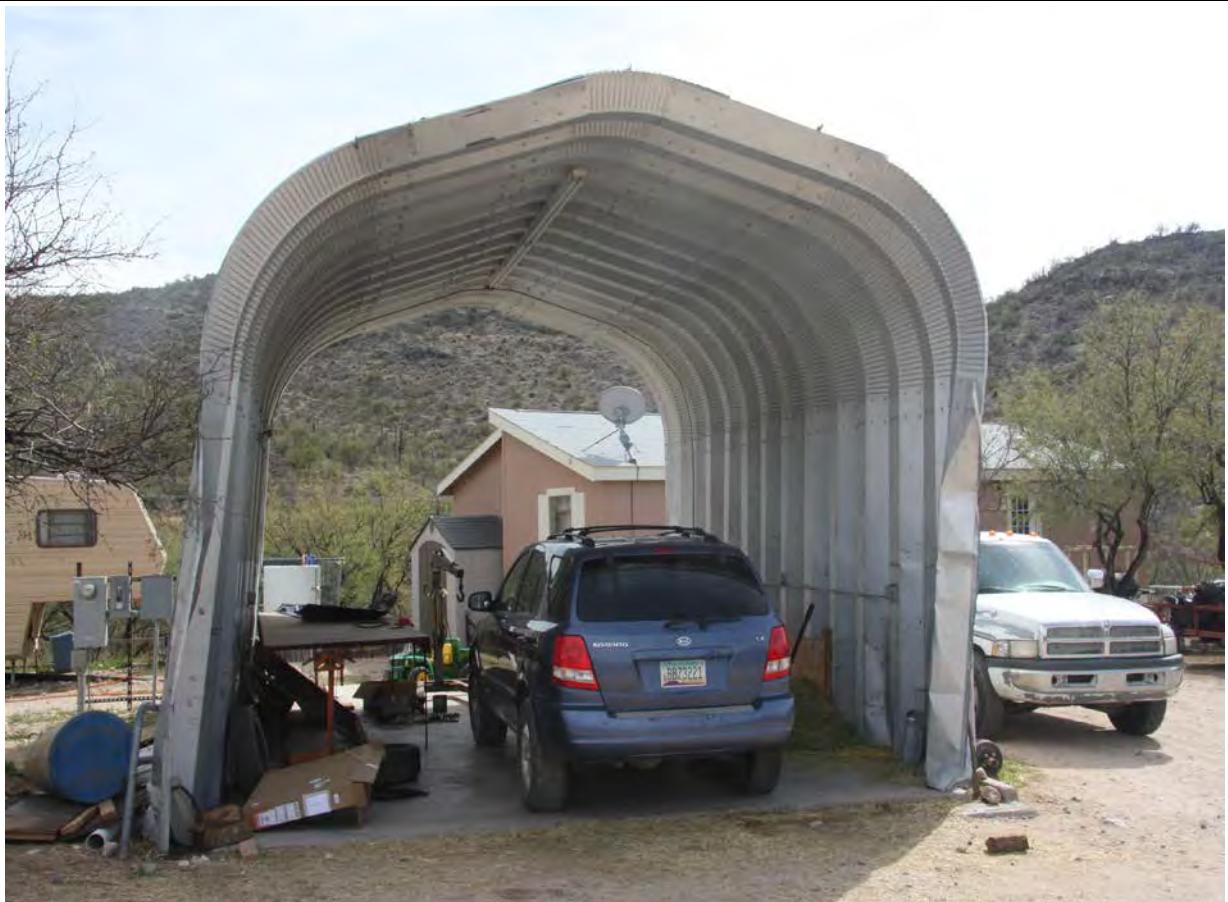
<b>Building Size:</b>	637 Square Feet
<b>Replacement Cost:</b>	\$ 47,775.00 Estimated at \$75.00 per square foot replacement cost.
<b>Building Materials:</b>	Metal
<b>Building Condition:</b>	Good
<b>Building Age:</b>	1998
<b>Photo Date</b>	2/24/2014

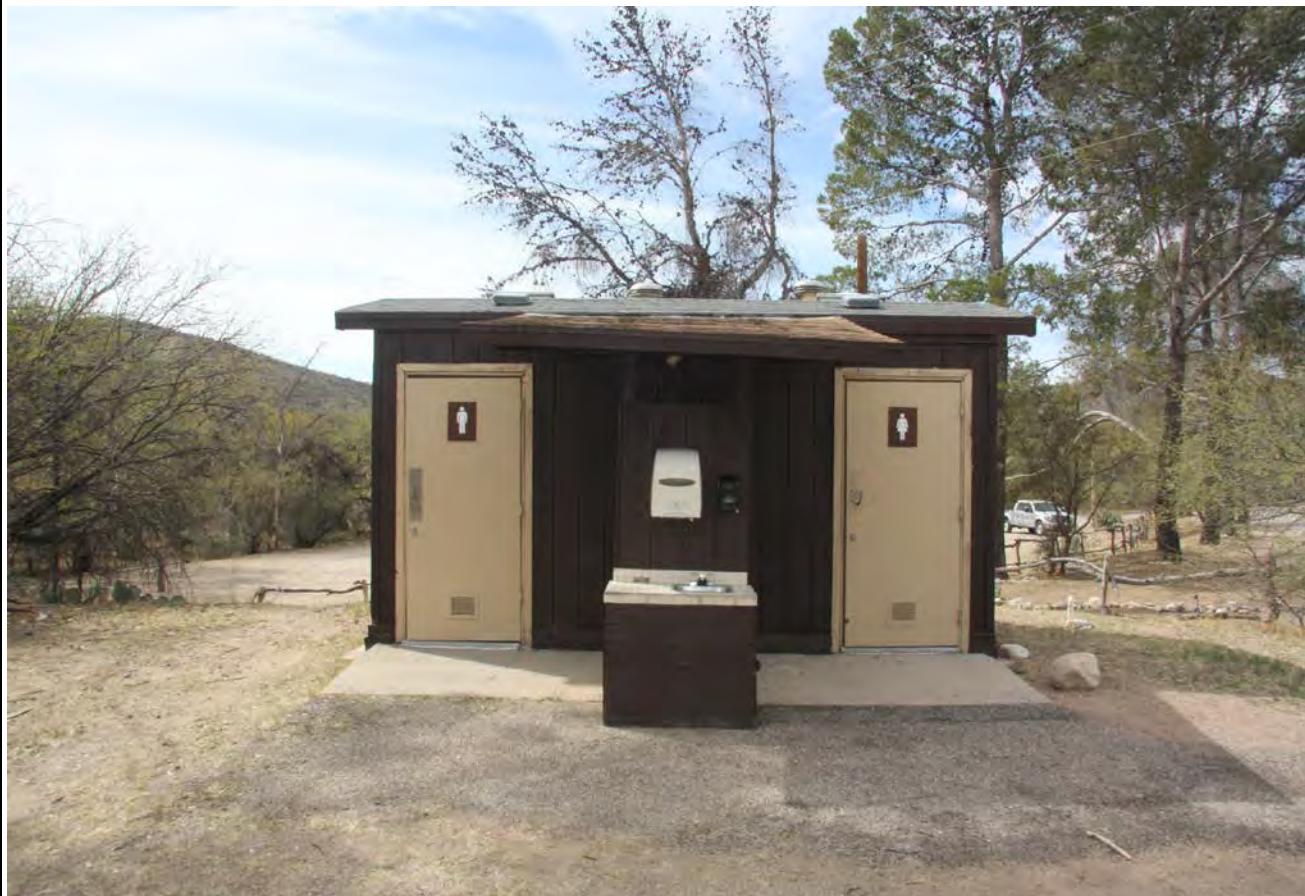
<b>Building Size:</b>	171 Square Feet
<b>Replacement Cost:</b>	\$ 25,650.00 Estimated at \$150.00 per square foot replacement cost.
<b>Building Materials:</b>	Wood exterior
<b>Building Condition:</b>	Fair
<b>Building Age:</b>	1996
<b>Photo Date:</b>	February 24, 2014

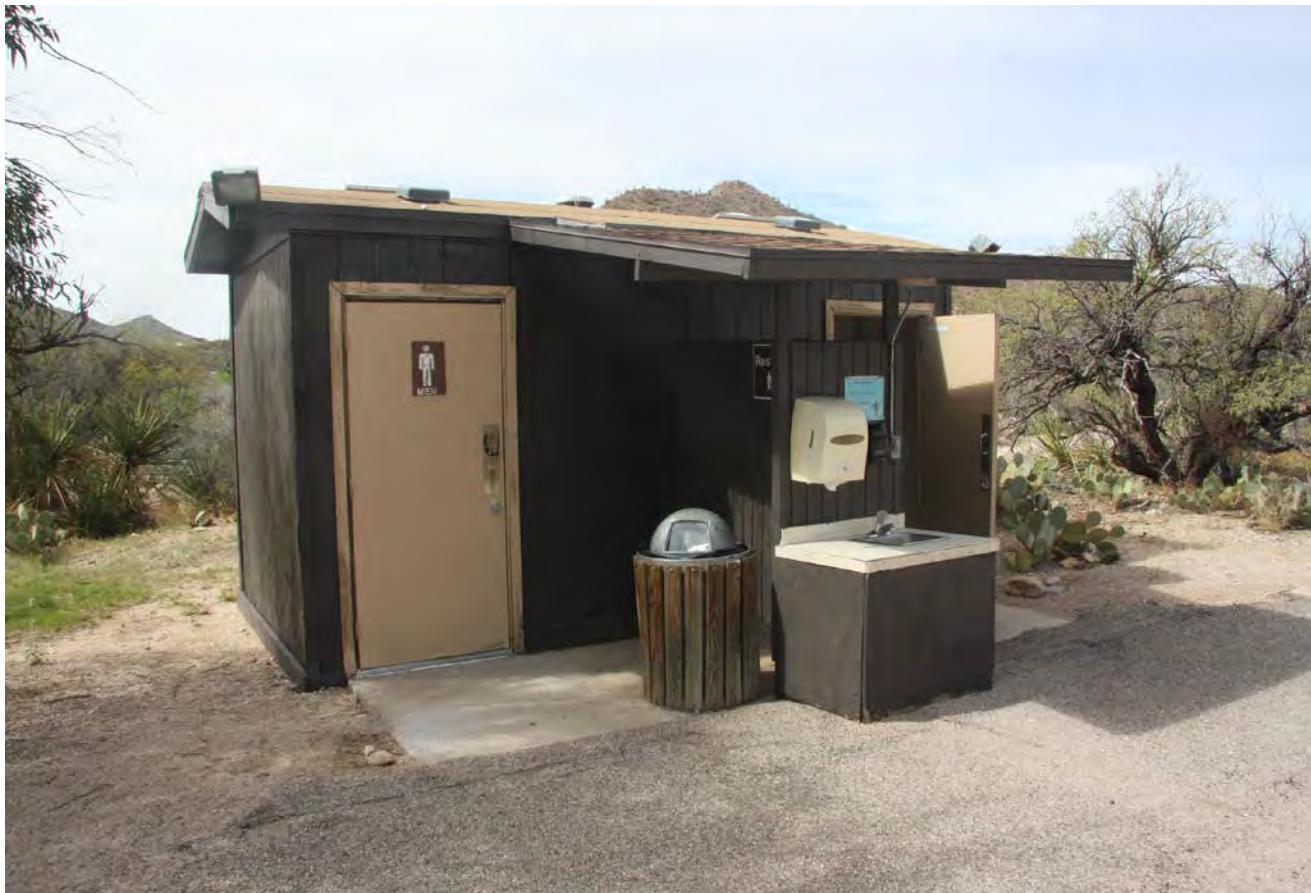
<b>Building Size:</b>	171 Square Feet
<b>Replacement Cost:</b>	\$ 25,650.00 Estimated at \$150.00 per square foot replacement.
<b>Building Materials:</b>	Wood exterior
<b>Building Condition:</b>	Fair
<b>Building Age:</b>	1996
<b>Photo Date:</b>	February 24, 2014

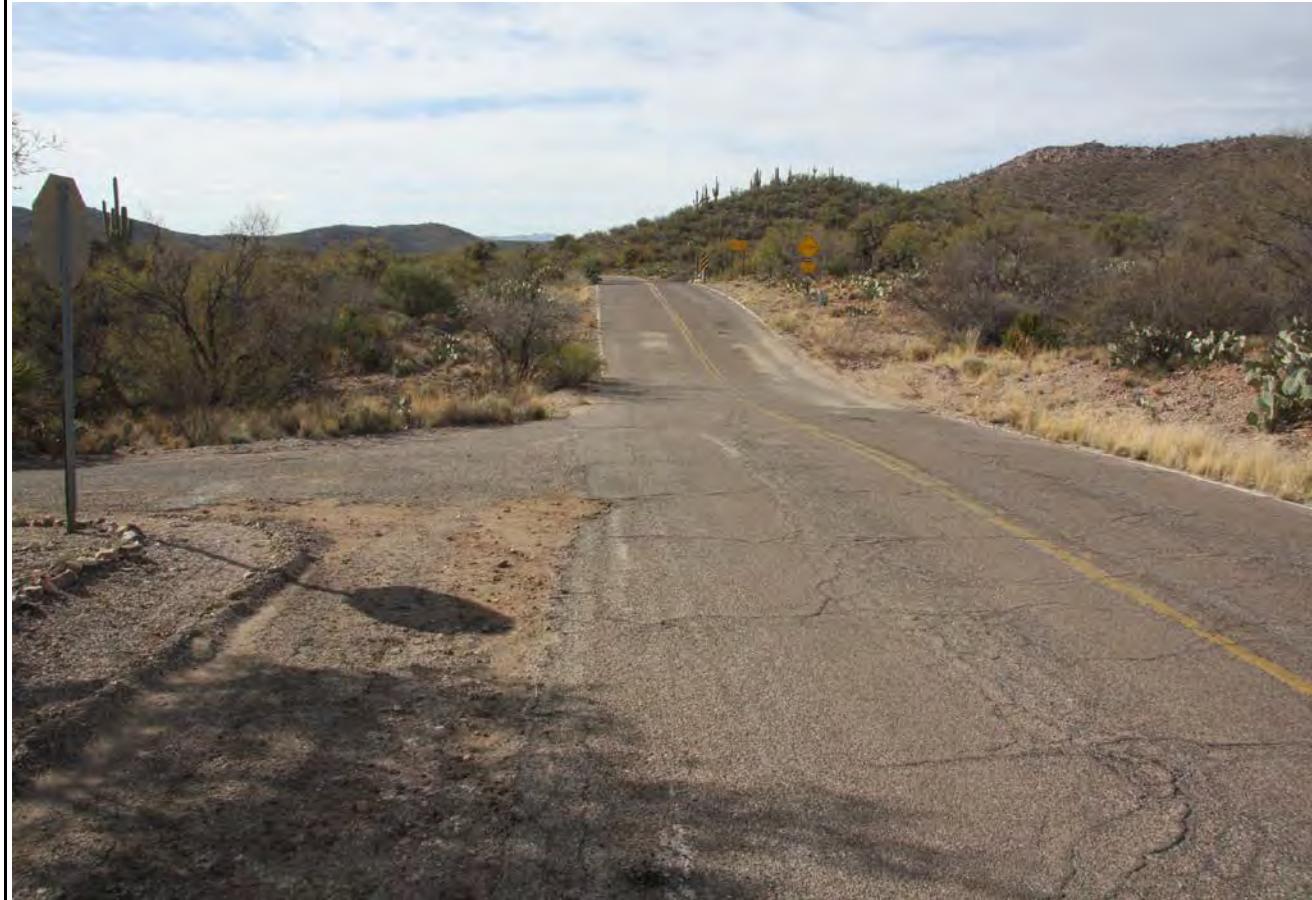
Building Size:	45,662 Square Yards.
Replacement Cost:	\$ 565,795.00 See estimate listing below.
Building Materials:	2-inch overlay over existing surface and 2-shot chip seal over existing surface.
Building Condition:	Fair
Building Age:	Paved Roads were last overlaid in 1983, Chip seal in 1998.
Photo Date:	February 24, 2014

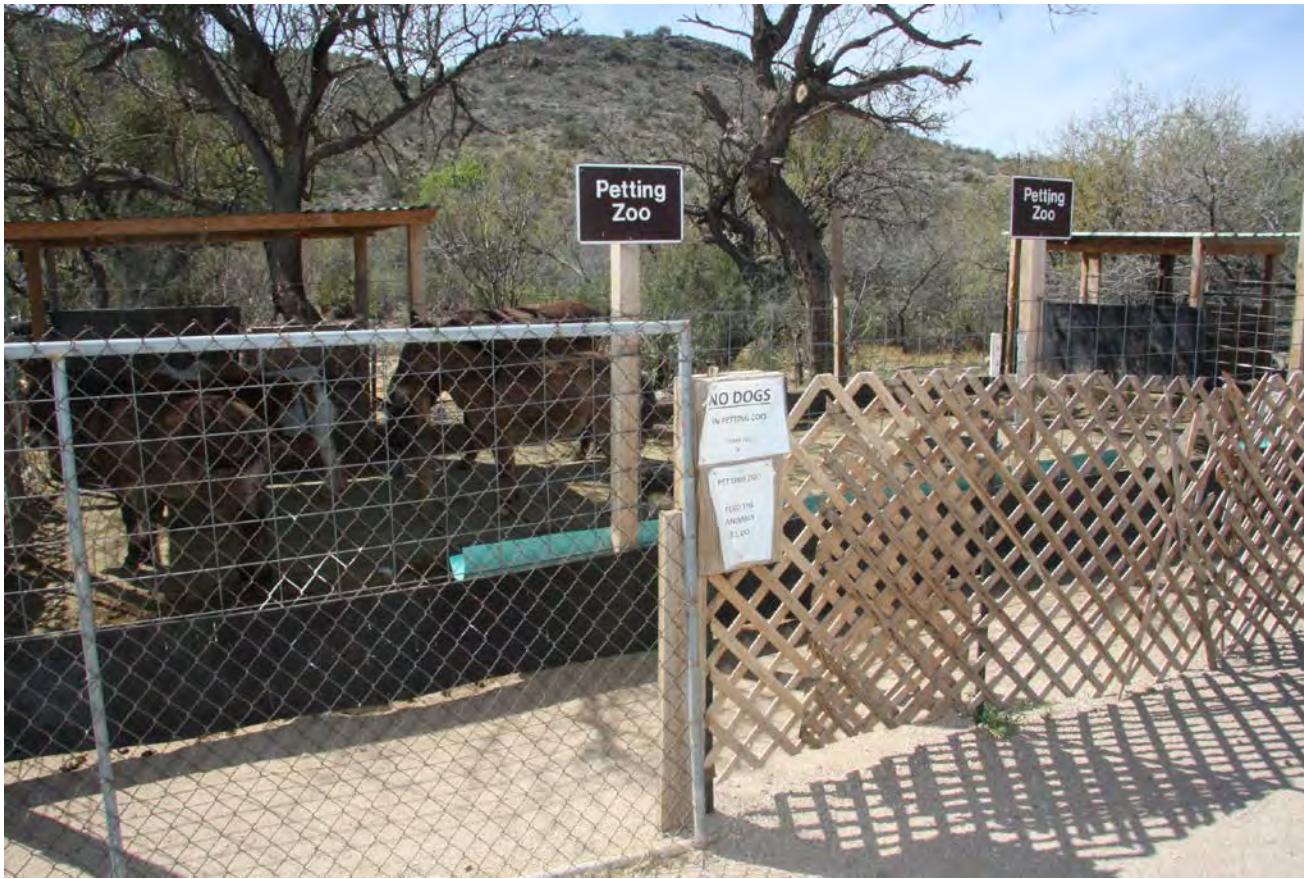
Facility:	Colossal Cave Mountain Park	Page Number	36
Building Name:	Petting Zoo	Photo By:	G.W. Bundrick

Building Size:	5-pens of various sizes
Replacement Cost:	\$ 1,000.00 Estimated only
Building Materials:	Welded wire fence panels, metal, wood and chicken wire.
Building Condition:	Fair
Building Age:	2012
Photo Date:	February 24, 2014

The entry way to the Petting Zoo is shabby and not what you would expect to find in a public park. It is recommended that more thought be put into the overall design, size and configuration of this venue.

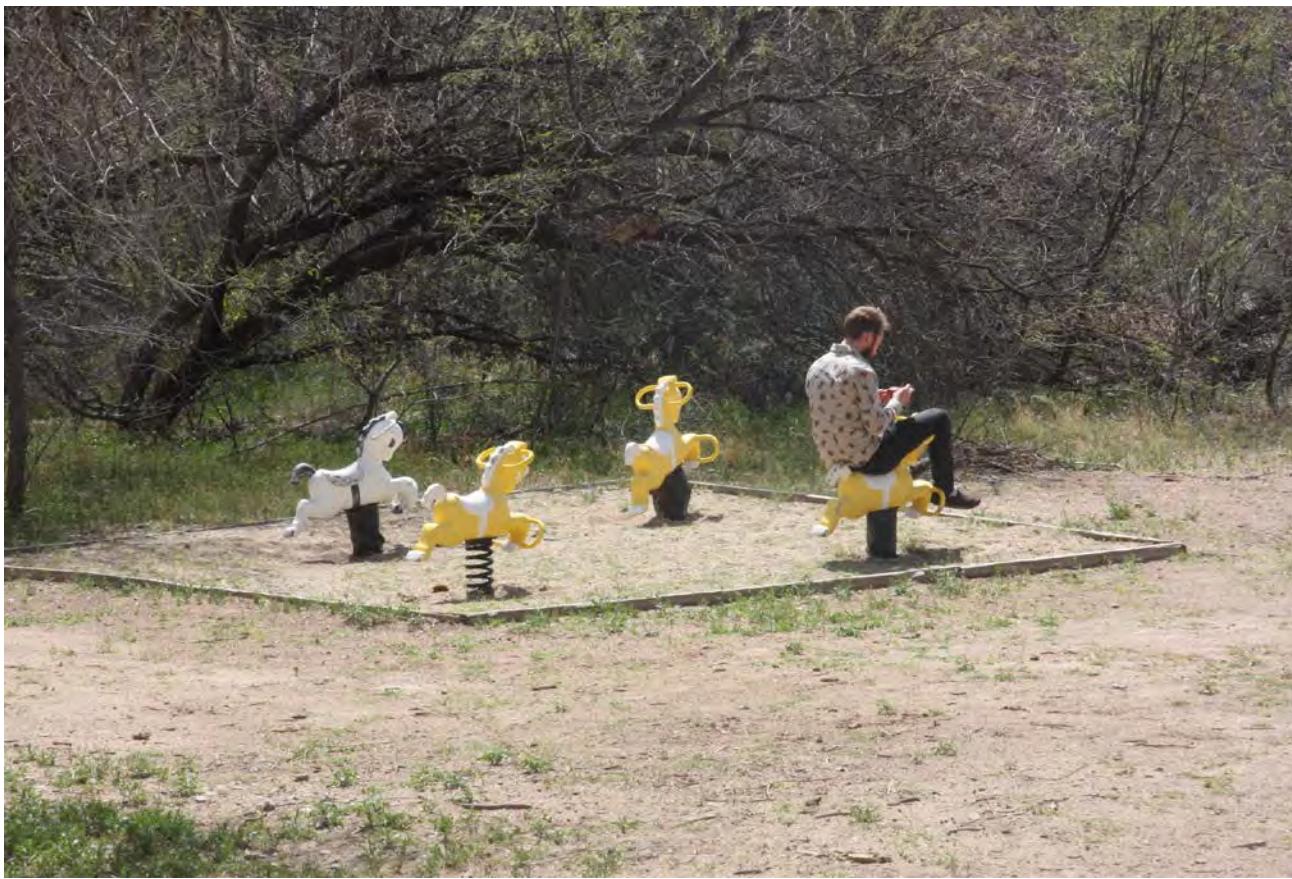
Facility:	Colossal Cave Mountain Park	Page Number	37
Building Name:	Playground equipment	Photo By:	G.W. Bundrick

Building Size:	4-piece set
Replacement Cost:	\$ 500.00 Estimate includes the sand area
Building Materials:	Manufactured ponies on steel springs.
Building Condition:	Fair
Building Age:	1999
Photo Date:	February 24, 2014
