**Pima County Department of Finance & Risk Management**  
**CCMP Report, dtd 28<sup>th</sup> May, 2014**

**Randy Gimblett & Kerry Baldwin,  
CCMP Plan Assessment & Recommendations, May 2014**

## ***2014 Property Inventory Report***

## ***Maintenance Priority Sheet***

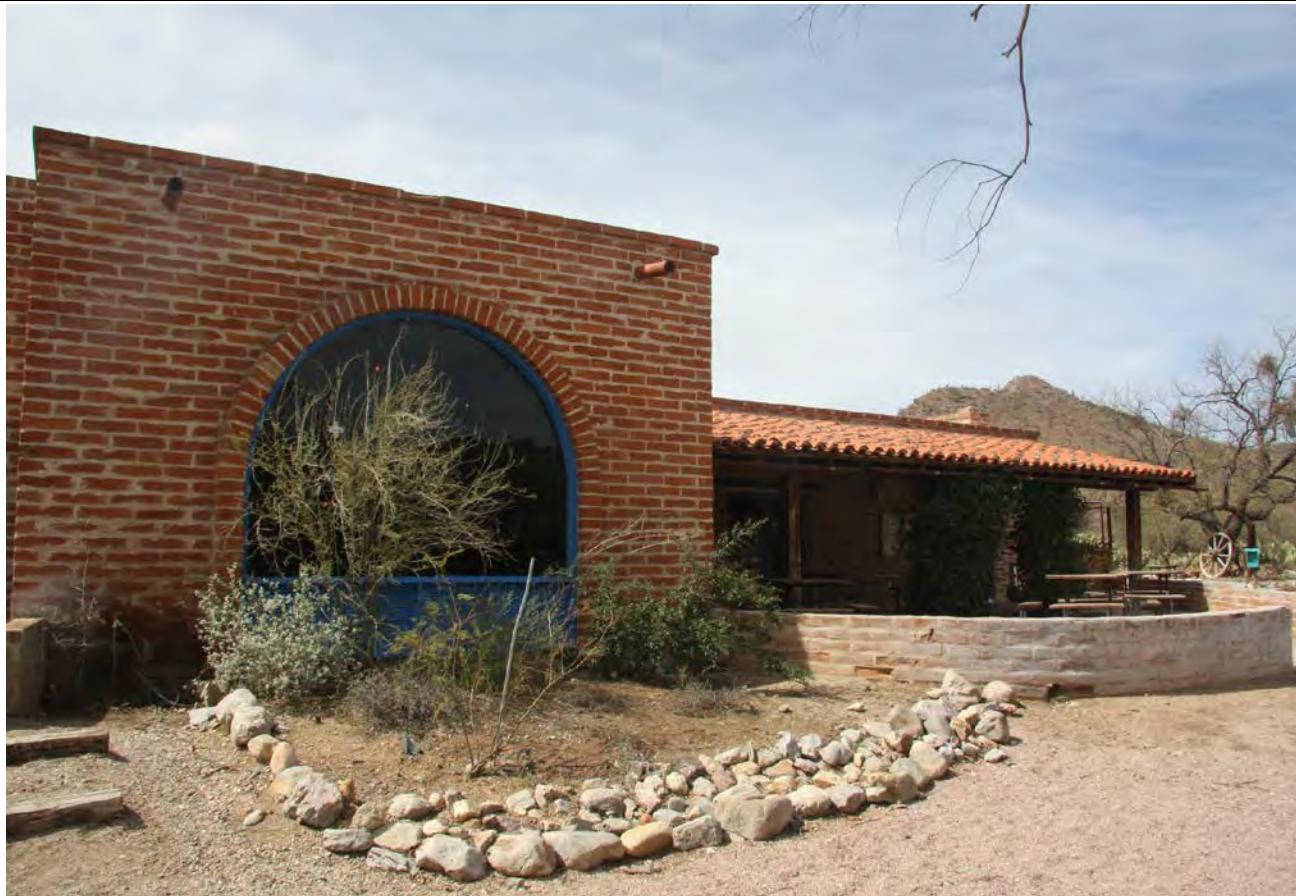
<b>Building Size:</b>	3,227 Square Feet
<b>Replacement Cost:</b>	\$ 726,075.00 Estimated at \$225.00 per square foot replacement cost.
<b>Building Materials:</b>	Burnt adobe brick with tile roof.
<b>Building Condition:</b>	Good
<b>Building Age:</b>	1954 remodeled in 1978 and again in 1998.
<b>Photo Date</b>	February 24, 2014

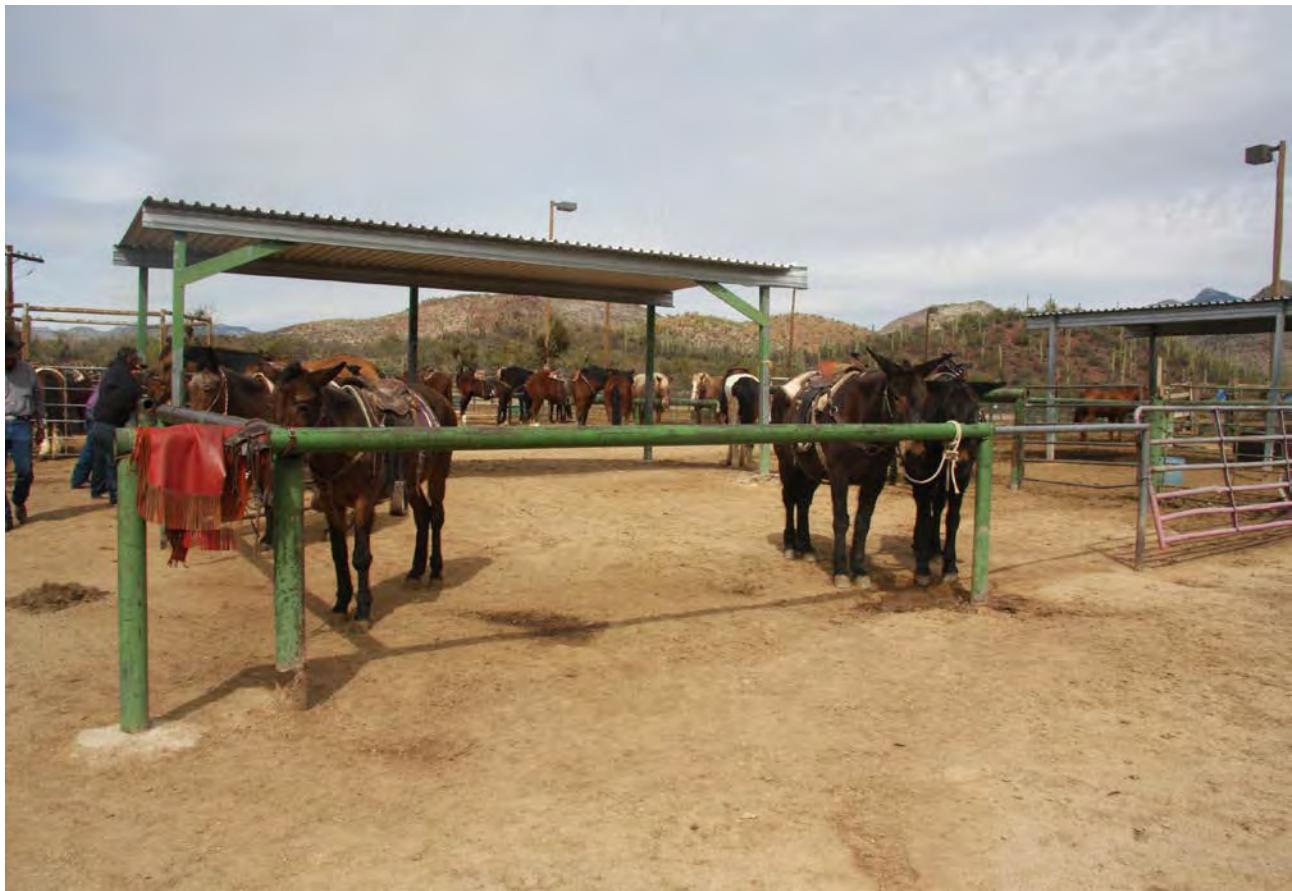
Facility:	<b>Colossal Cave Mountain Park</b>	Page Number	39
Building Name:	<b>Posta Quemada Shade Structure No. 1</b>	Photo By:	G.W. Bundrick

<b>Building Size:</b>	288 Square Feet
<b>Replacement Cost:</b>	\$ 14,400.00 Estimated at \$50.00 per square foot replacement cost.
<b>Building Materials:</b>	Steel frame with metal roof.
<b>Building Condition:</b>	Good
<b>Building Age:</b>	2002
<b>Photo Date</b>	February 24, 2014

*It would be helpful for identification if the Ramada's were numbered for easy reference.*

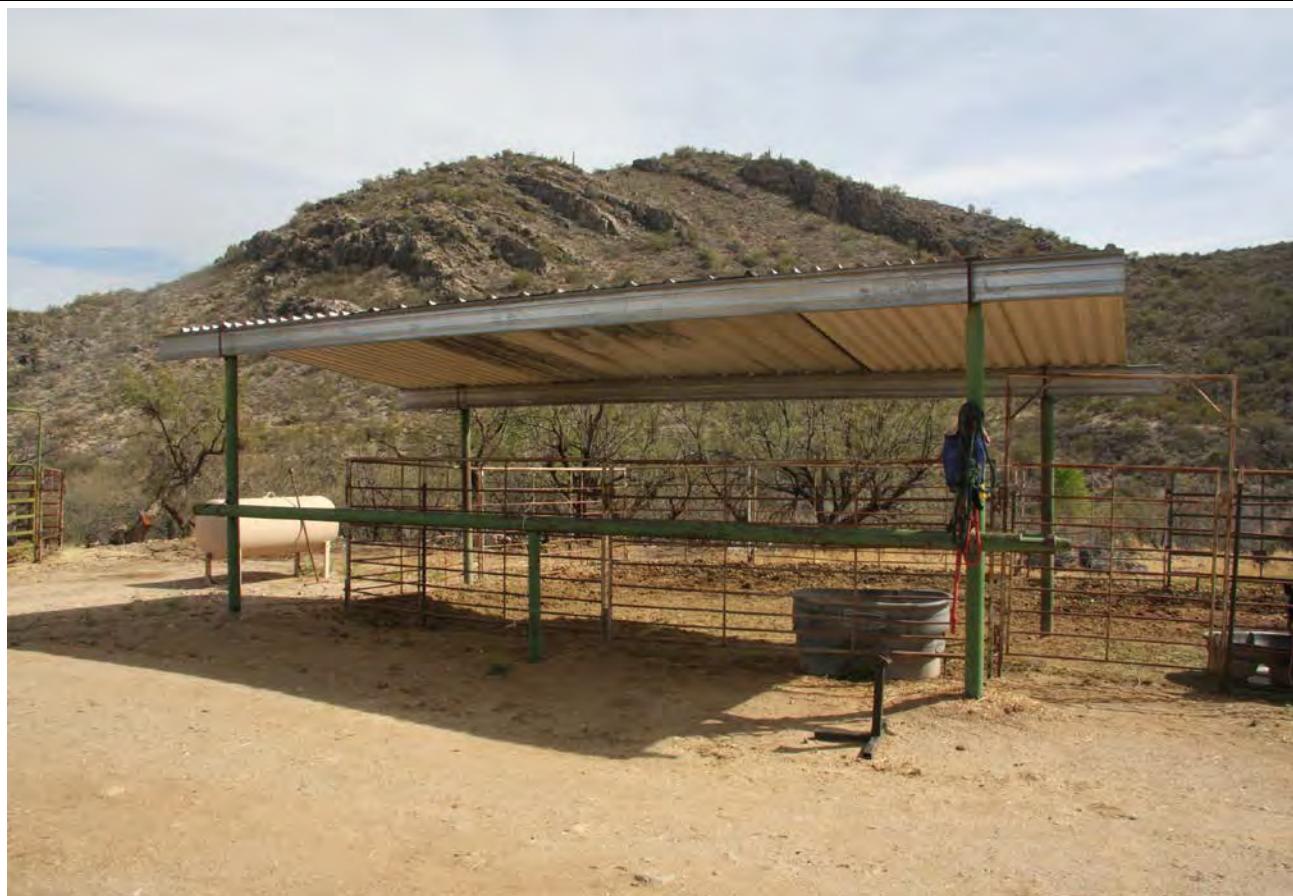
Facility:	Colossal Cave Mountain Park	Page Number	40
Building Name:	Posta Quemada Shade Structure No. 2	Photo By:	G.W. Bundrick

<b>Building Size:</b>	288 Square Feet
<b>Replacement Cost:</b>	\$ 14,400.00 Estimated at \$50.00 per square foot replacement cost.
<b>Building Materials:</b>	Steel Frame With Metal Roof
<b>Building Condition:</b>	Good
<b>Building Age:</b>	2002
<b>Photo Date:</b>	February 24, 2014

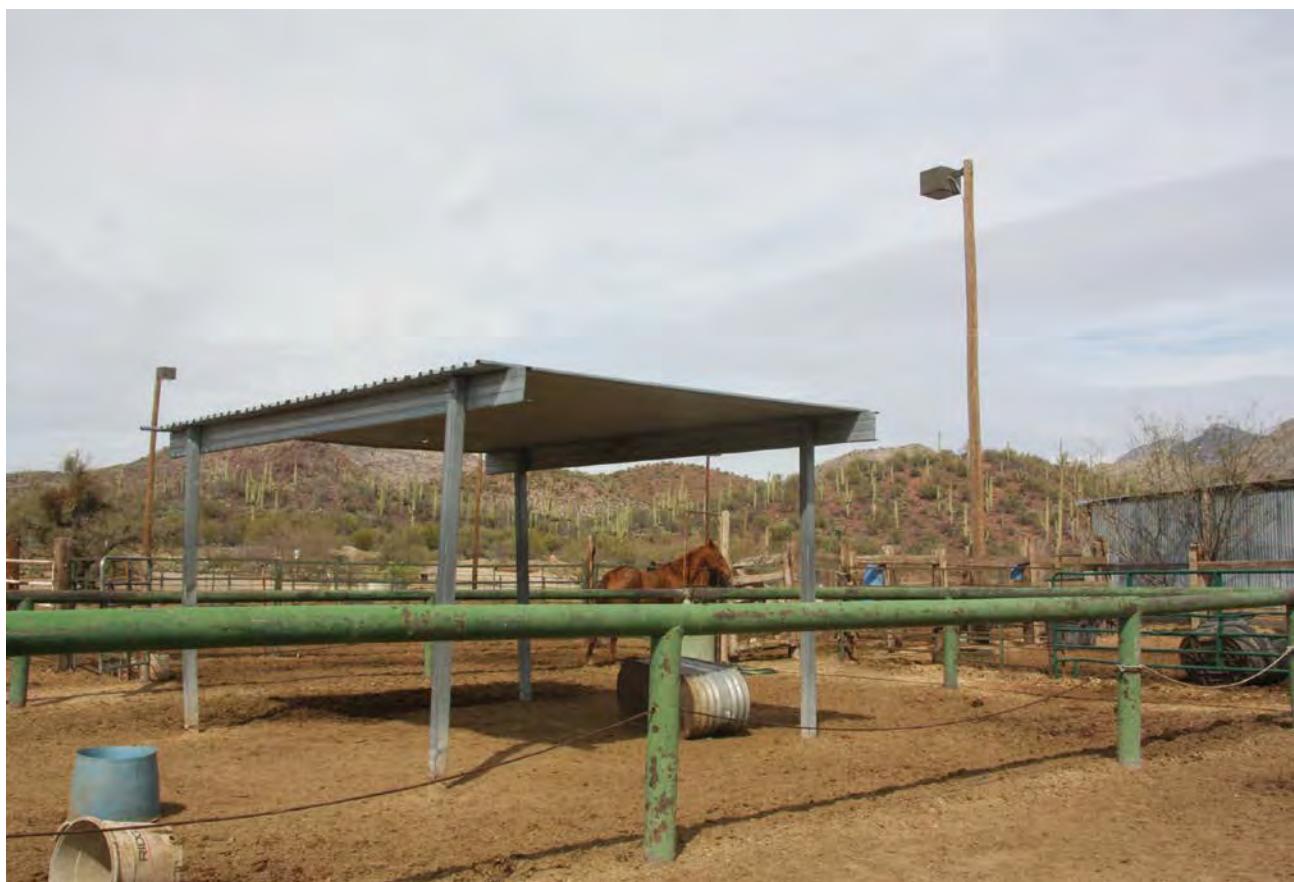
Facility:	<b>Colossal Cave Mountain Park</b>	Page Number	41
Building Name:	<b>Posta Quemada Shade Structure No. 3</b>	Photo By:	G.W. Bundrick

<b>Building Size:</b>	156 Square Feet
<b>Replacement Cost:</b>	\$ 7,800.00 Estimated at \$50.00 per square foot replacement cost.
<b>Building Materials:</b>	Steel Frame With Metal Roof
<b>Building Condition:</b>	Good
<b>Building Age:</b>	2002
<b>Photo Date</b>	February 24, 2014

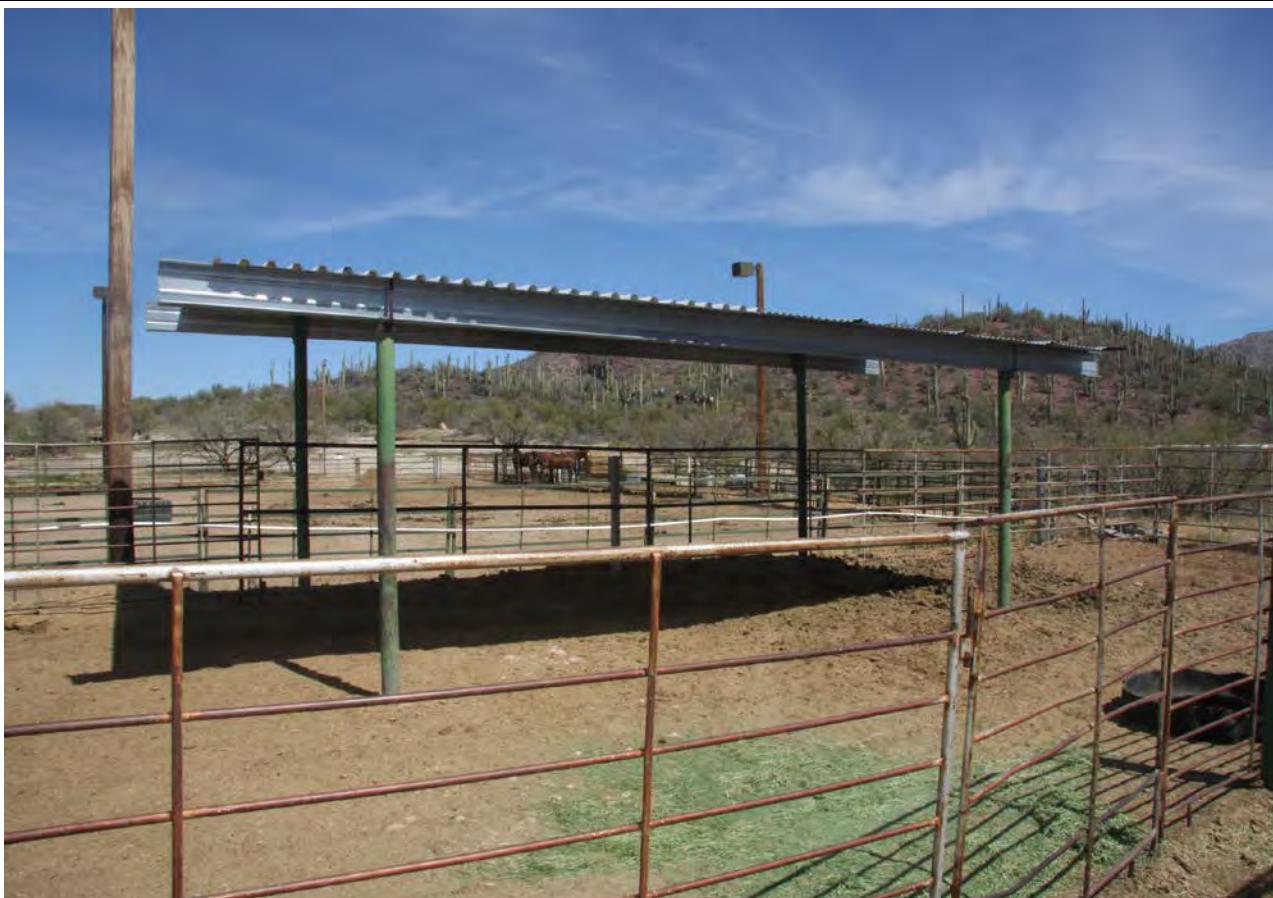
Facility:	Colossal Cave Mountain Park	Page Number	42
Building Name:	Posta Quemada Shade Structure No. 4	Photo By:	G.W. Bundrick

Building Size:	288 Square Feet
Replacement Cost:	\$ 14,400.00 Estimated at \$50.00 per square foot replacement cost.
Building Materials:	Steel Frame With Metal Roof
Building Condition:	Good
Building Age:	2002
Photo Date	February 24, 2014

*The support posts should be painted periodically for overall protection.*

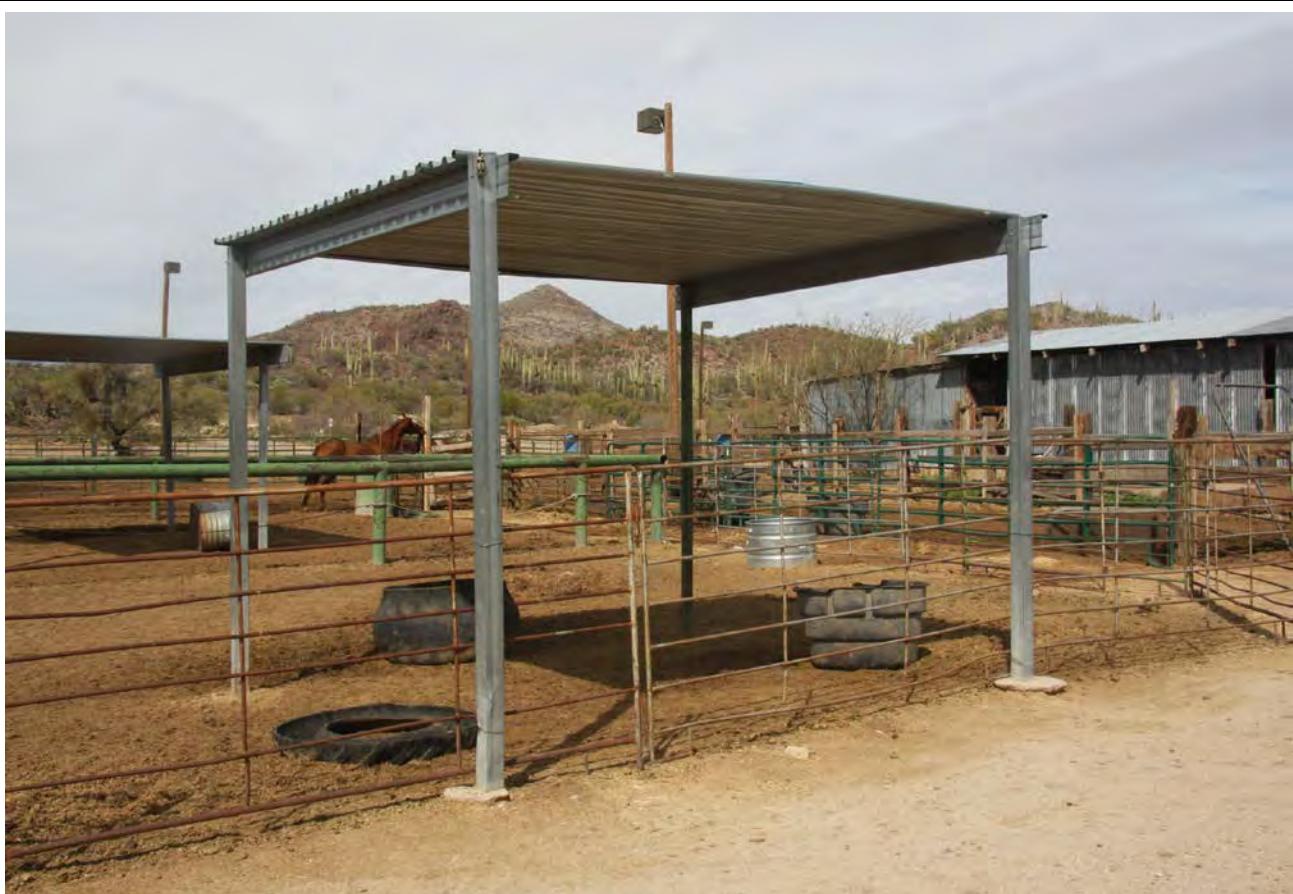
Facility:	Colossal Cave Mountain Park	Page Number	43
Building Name:	Posta Quemada Shade Ramada No.5	Photo By:	G.W. Bundrick

<b>Building Size:</b>	156 Square Feet
<b>Replacement Cost:</b>	\$ 7,800.00 <i>Estimated at \$50.00 per square foot replacement.</i>
<b>Building Materials:</b>	Steel Frame With Metal Roof
<b>Building Condition:</b>	Good
<b>Building Age:</b>	2002
<b>Photo Date:</b>	February 24, 2014

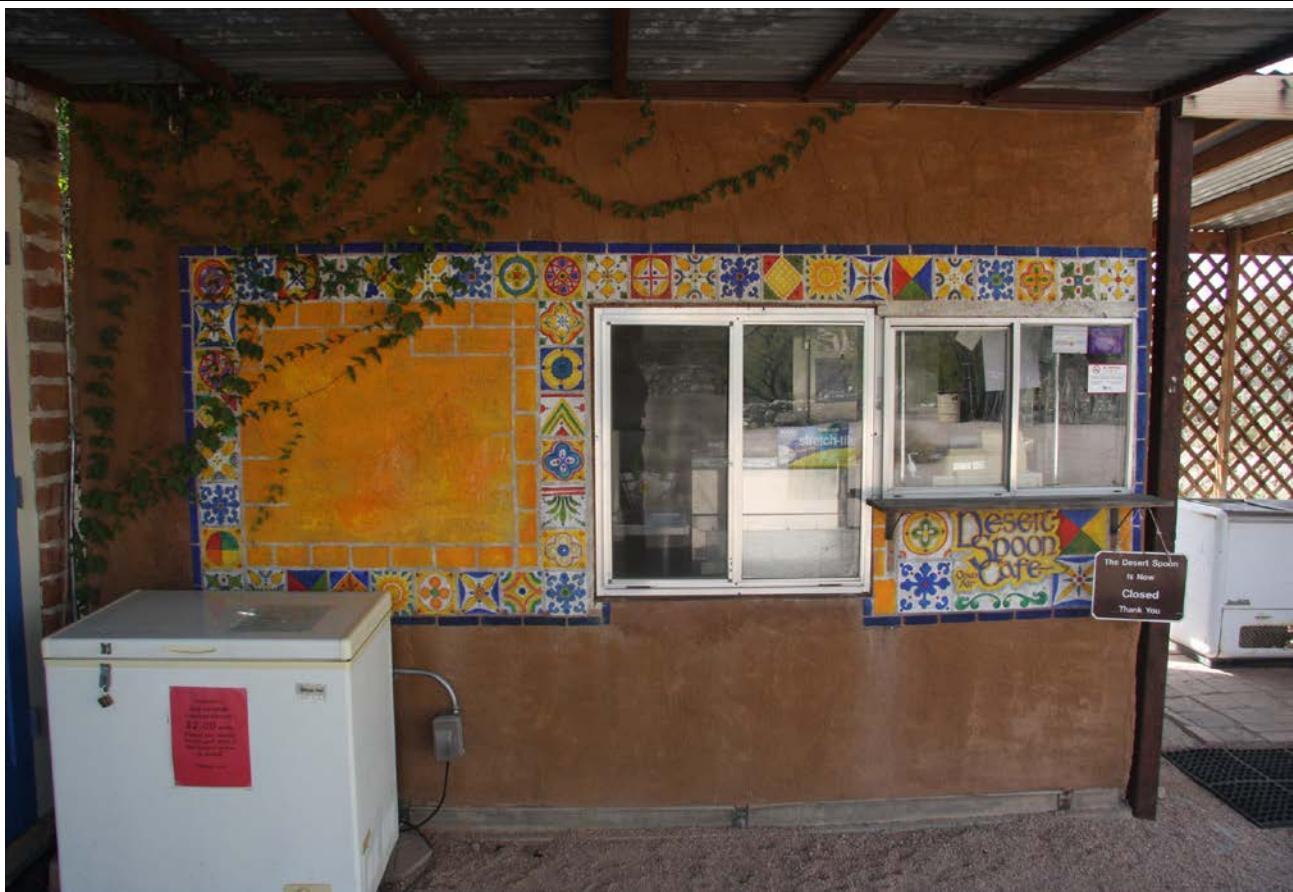
Facility:	Colossal Cave Mountain Park	Page Number	44
Building Name:	Posta Quemada Snack Bar	Photo By:	G.W. Bundrick

Building Size:	96 Square Feet
Replacement Cost:	\$ 12,000.00 Estimated at \$125.00 per square foot replacement cost.
Building Materials:	Wood Frame With Stucco Siding
Building Condition:	Good
Building Age:	1998
Photo Date:	February 24, 2014

<b>Recommendations:</b>
Some of the Vega's are in need to being oiled, the roof membrane is in need of being coated.
The entry way requires attention, the blocks currently being used present a tripping hazard.

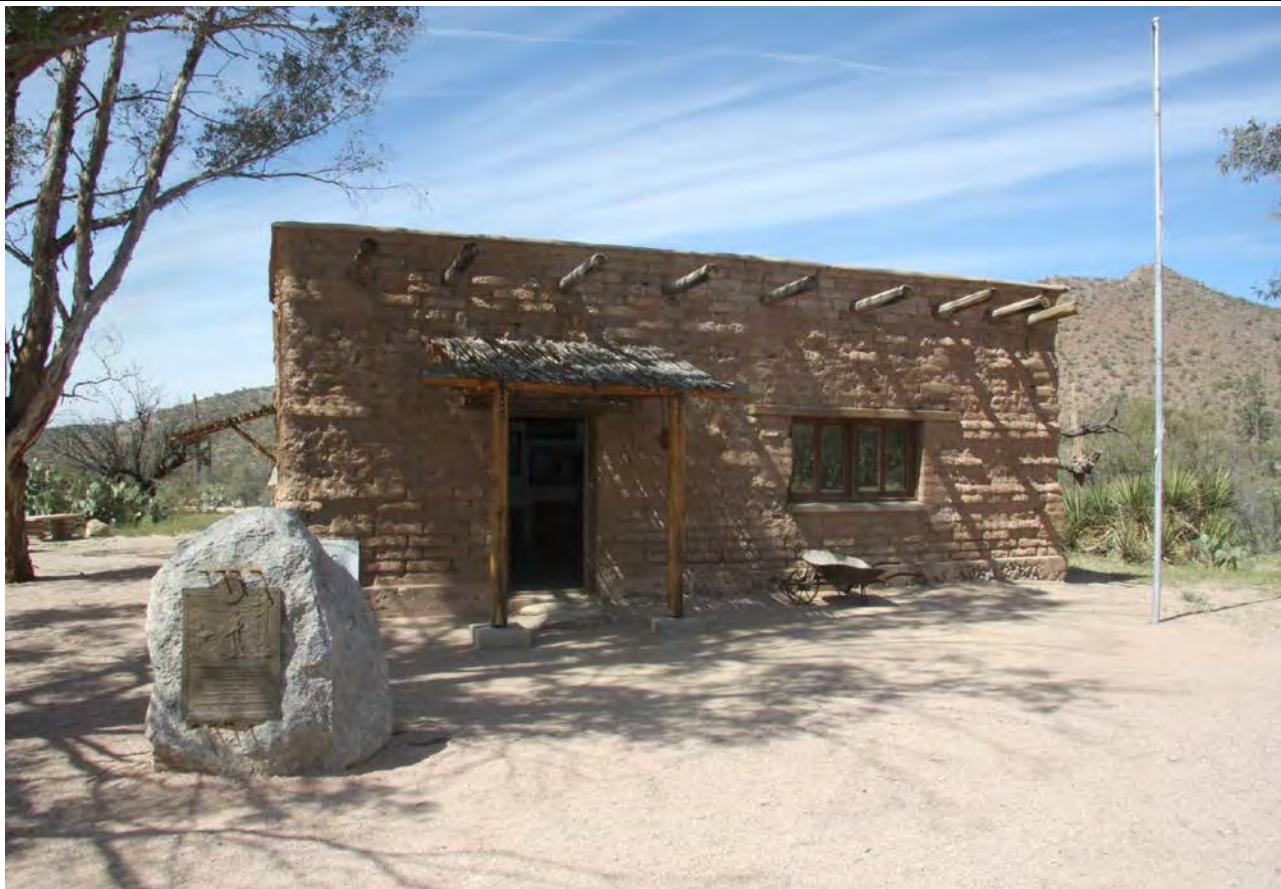
Building Size:	608 Square Foot
Replacement Cost:	\$ 121,600.00 Estimated at \$200.00 per square foot replacement cost.
Building Materials:	Native adobe
Building Condition:	Good
Building Age:	1935-1936-2004
Photo Date:	February 24, 2014

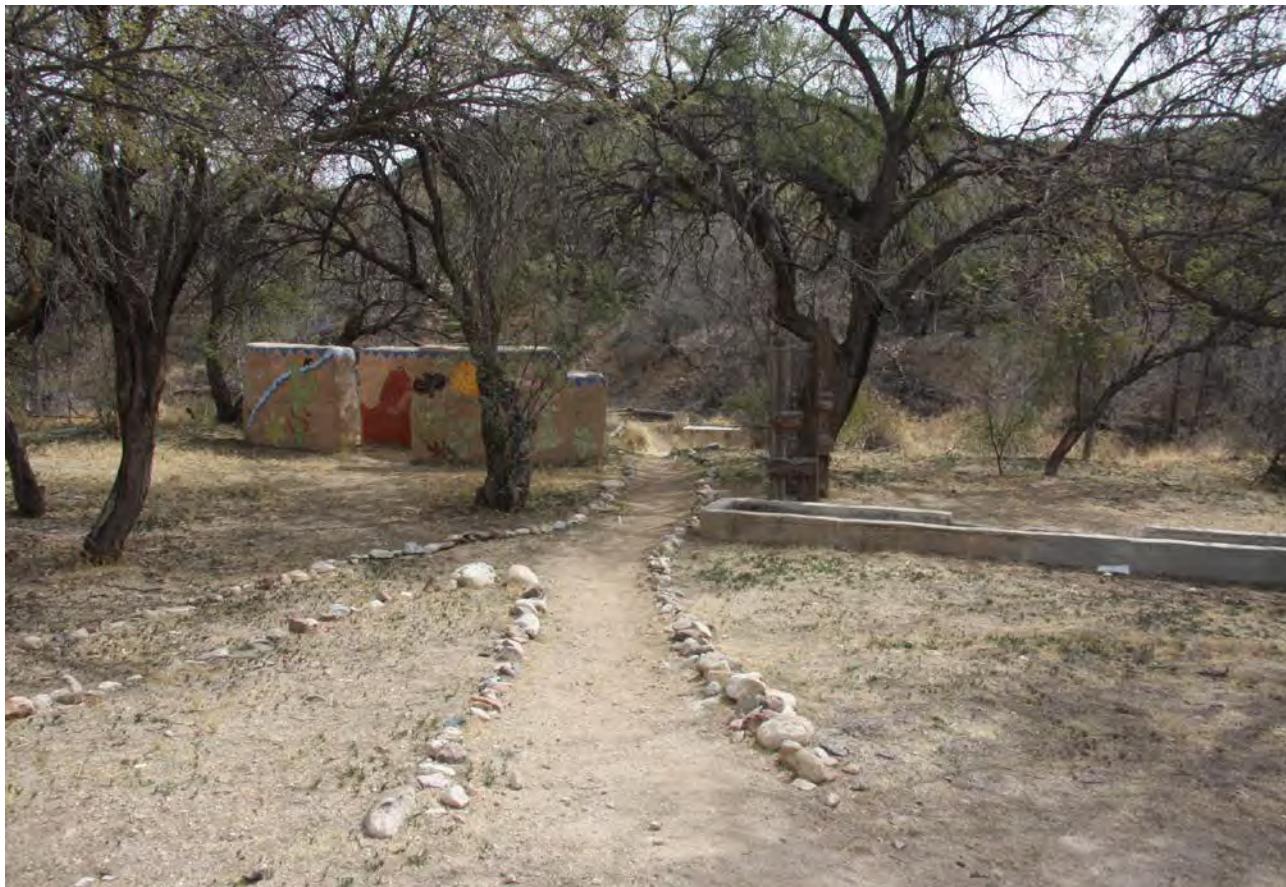
<b>Facility:</b>	<b>Colossal Cave Mountain Park</b>	<b>Page Number</b>	<b>46</b>
<b>Building Name:</b>	<b>Posta Quemada Story Teller Site</b>	<b>Photo By:</b>	<b>G.W. Bundrick</b>

<b>Building Size:</b>	34 Lineal Feet
<b>Replacement Cost:</b>	\$ 850.00 Estimated at \$25.00 per lineal foot replacement cost.
<b>Building Materials:</b>	CMU block with stucco finish
<b>Building Condition:</b>	Good
<b>Building Age:</b>	2003
<b>Photo Date</b>	February 24, 2014

<b>Remarks:</b>
The Story Teller Amphitheatre is no longer being used for budgetary reasons. The pole-logs that were once a part of the venue have rotted-out and were removed. The overall condition of the walls are still in good condition; however, they have no use at this time.

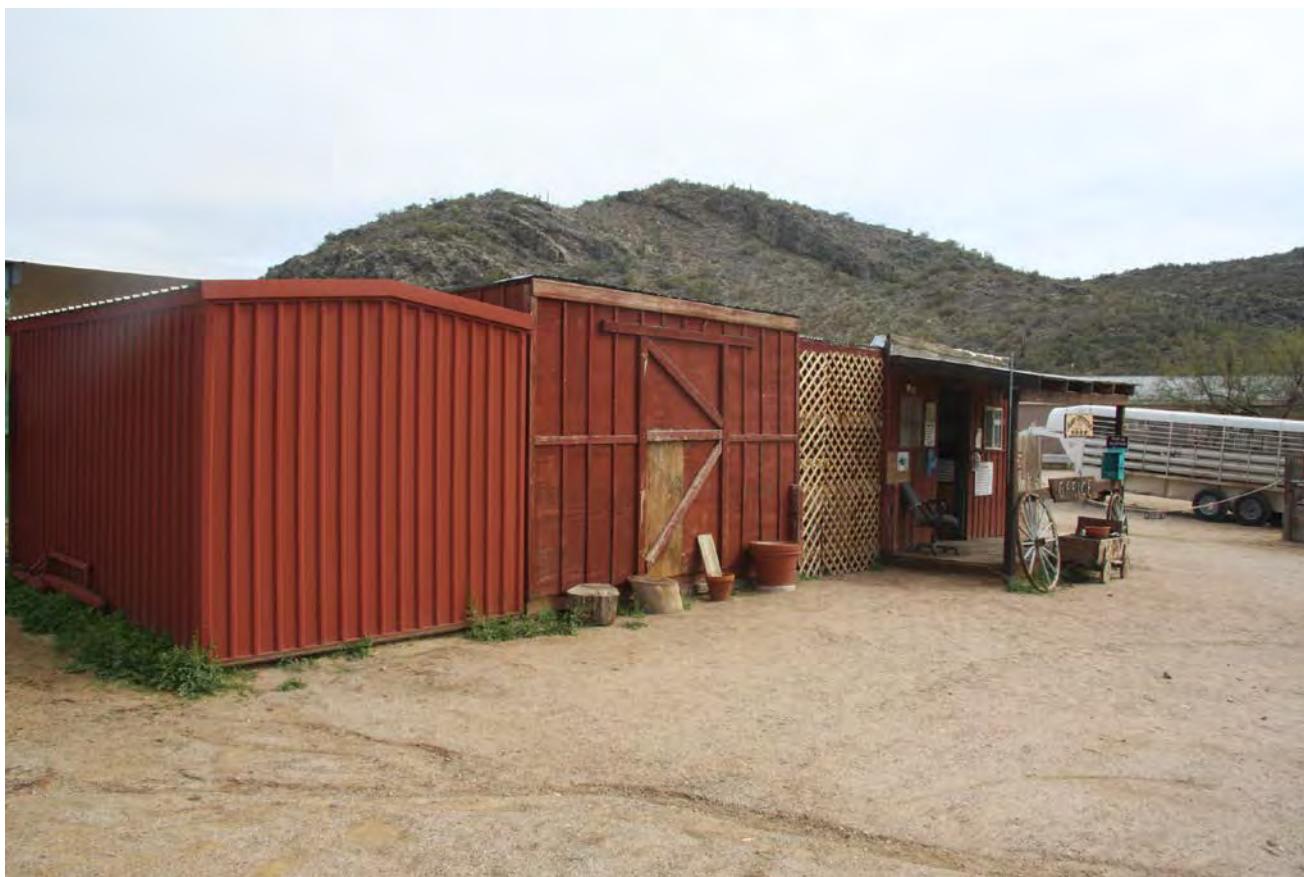
<b>Facility:</b>	<b>Colossal Cave Mountain Park</b>	<b>Page Number</b>	<b>48</b>
<b>Building Name:</b>	<b>Trail Rides Office</b>	<b>Photo By:</b>	<b>G.W. Bundrick</b>

<b>Building Size:</b>	150 square feet office space, 120 square feet tack shed.
<b>Replacement Cost:</b>	\$ 4,950.00 See estimate calculations listed below.
<b>Building Materials:</b>	Wood frame with plywood siding.
<b>Building Condition:</b>	Poor
<b>Building Age:</b>	2000
<b>Photo Date:</b>	February 24, 2014

<b>Remarks:</b>
The replacement estimates have been calculated as follows, the office replacement cost has been valued at \$25.00 per square foot; the tack shed has been estimated at \$10.00 per square foot.
The tack shed has been redone as recommended in order to improve the overall visual condition of the building. An additional portable storage building has been installed at the site for storage purposes.

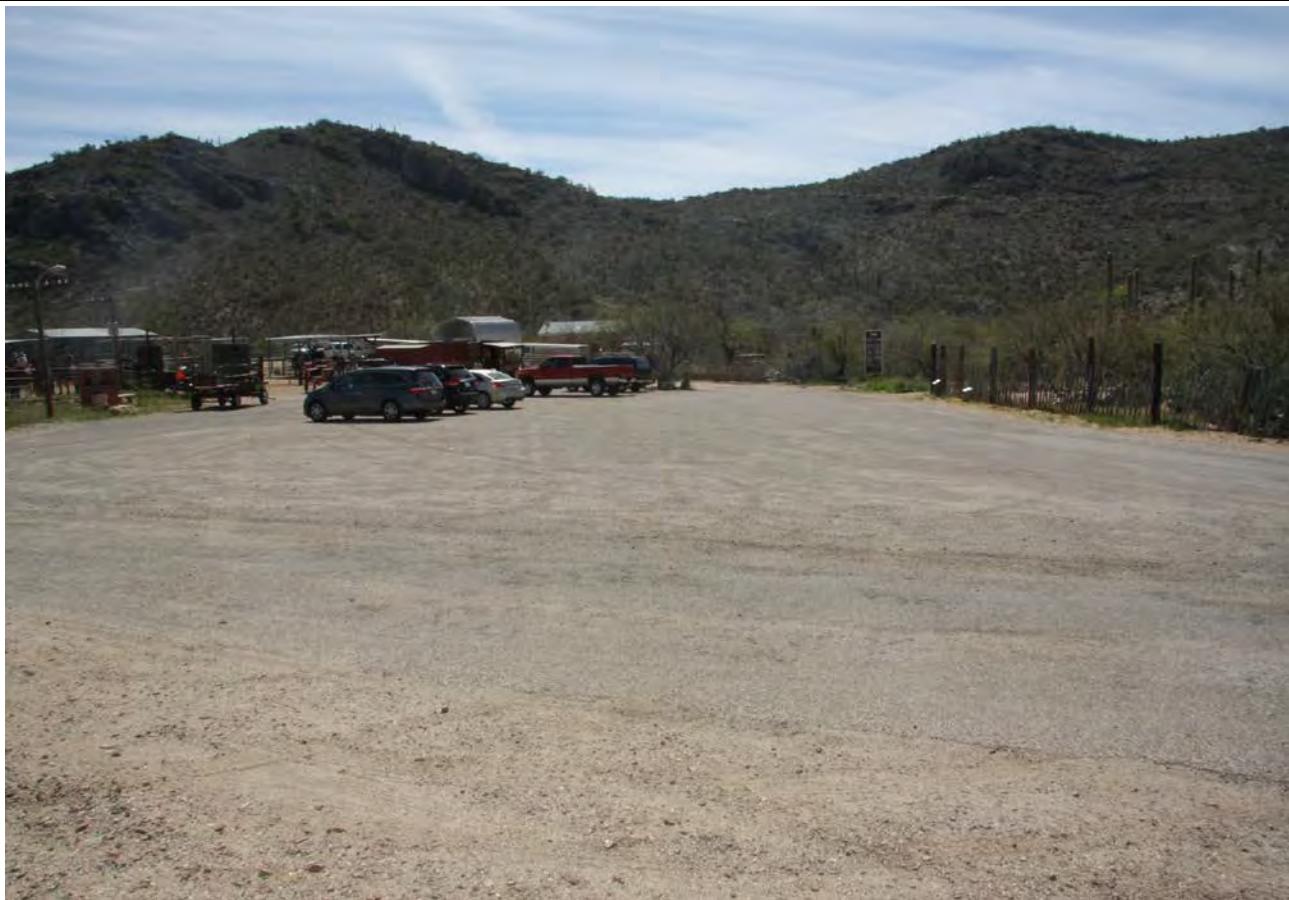
Building Size:	2,040 Square Yards
Replacement Cost:	\$ 16,320.00 Estimated at \$8.00 per square yard for a double shot of chip/seal
Building Materials:	Chip Seal over compacted native soil.
Building Condition:	Fair
Building Age:	1993
Photo Date	February 24, 2014

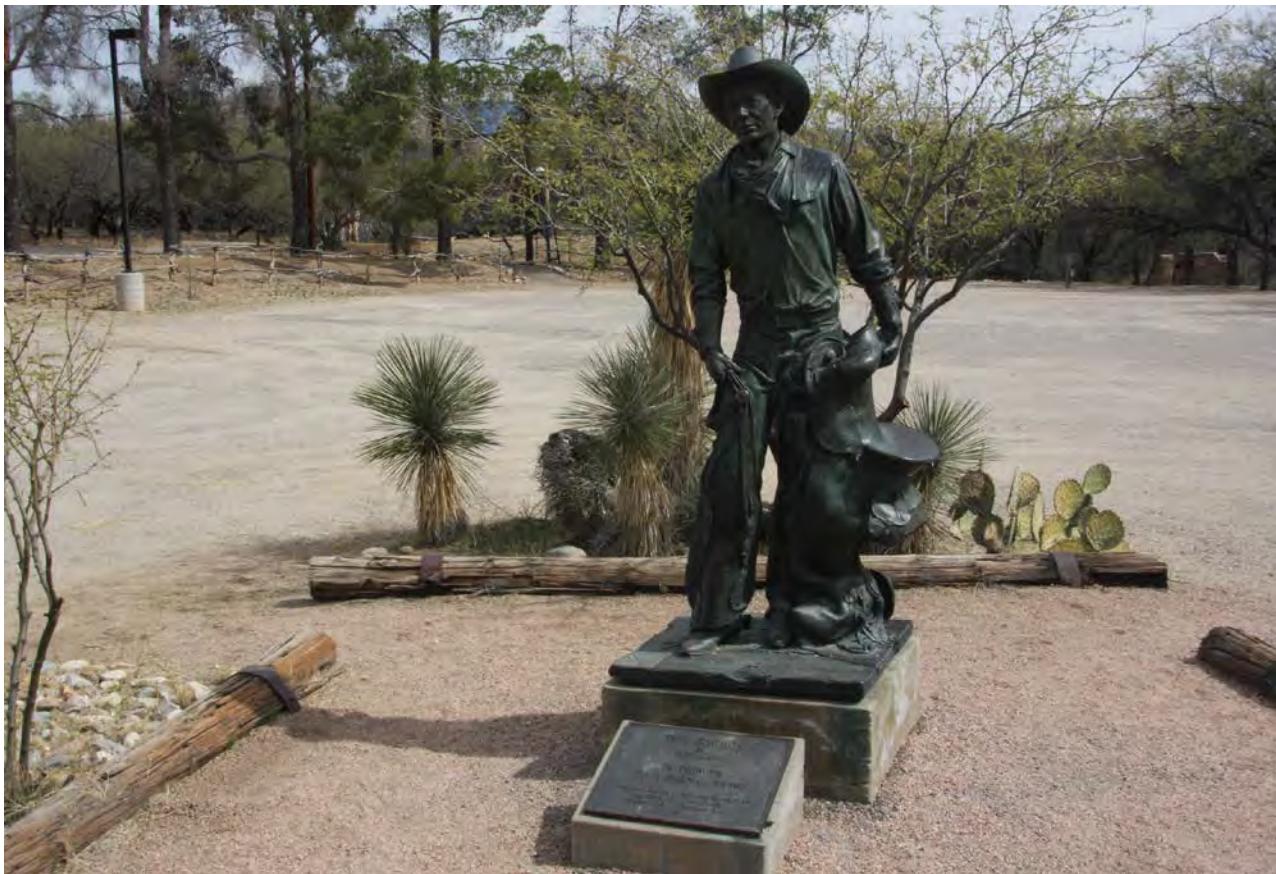
<b>Facility:</b>	<b>Colossal Cave Mountain Park</b>	<b>Page Number</b>	<b>50</b>
<b>Building Name:</b>	<b>Bronze Cowboy Statue</b>	<b>Photo By:</b>	<b>G.W. Bundrick</b>

<b>Building Size:</b>	6-foot bronze statue mounted on concrete footer.
<b>Replacement Cost:</b>	\$ 40,000.00 Estimated replacement value.
<b>Building Materials:</b>	Bronze figure hand-crafted.
<b>Building Condition:</b>	Good
<b>Building Age:</b>	1996
<b>Photo Date:</b>	February 24, 2014

<b>Remarks:</b>
The Bronze Statue is a beautiful piece of artwork that was donated to Colossal Cave Mountain Park by the Maierhausers.
The statue was handcrafted and the replacement value is only an estimate.
As recommended, the site has been cleaned-up and the overall appearance of the area is much better.

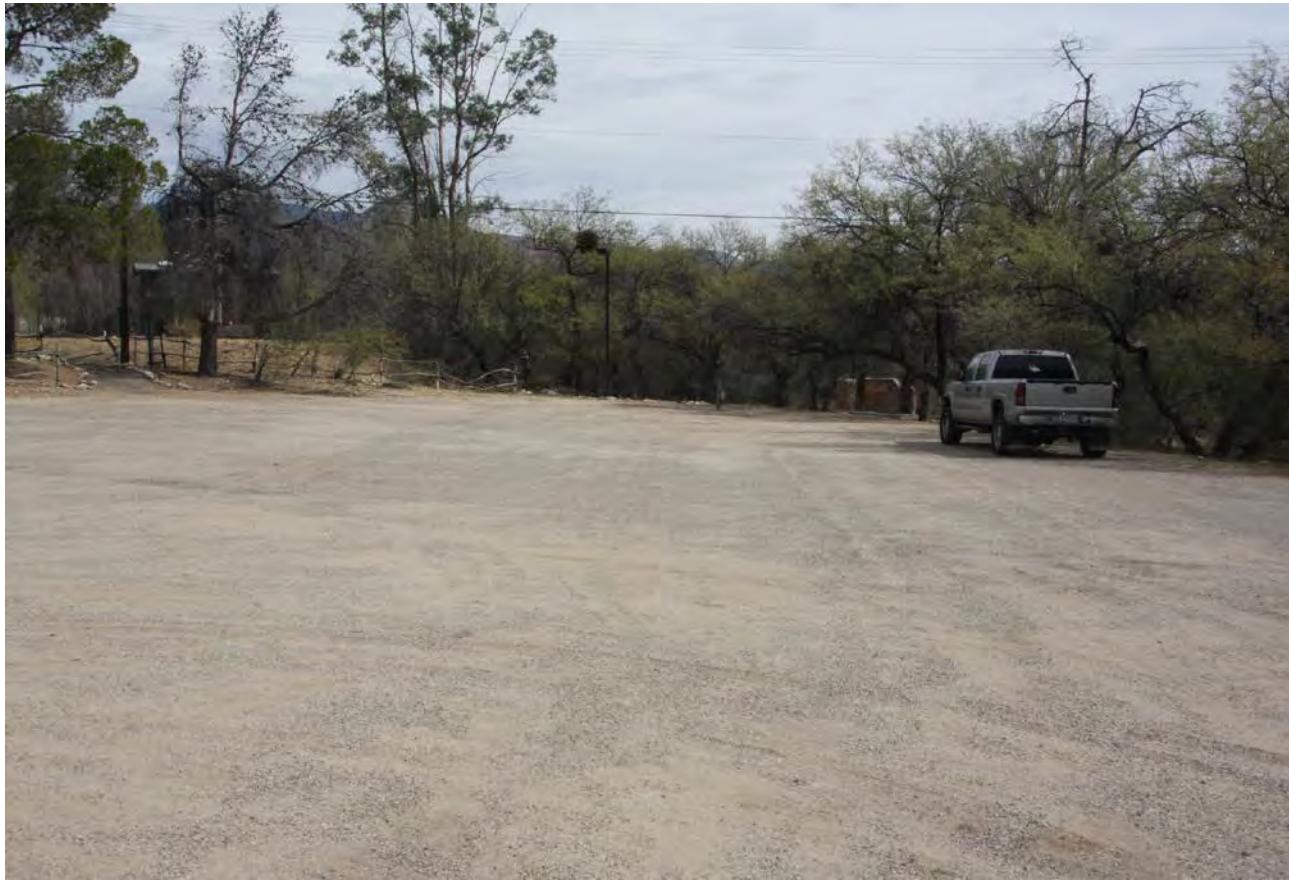
<b>Building Size:</b>	2,620 Square Yards
<b>Replacement Cost:</b>	\$ 20,960.00 Estimated at \$8.00 per yards of 2-shot chip/seal.
<b>Building Materials:</b>	Chip Seal over compacted earth.
<b>Building Condition:</b>	Good
<b>Building Age:</b>	1993
<b>Photo Date:</b>	February 24, 2014

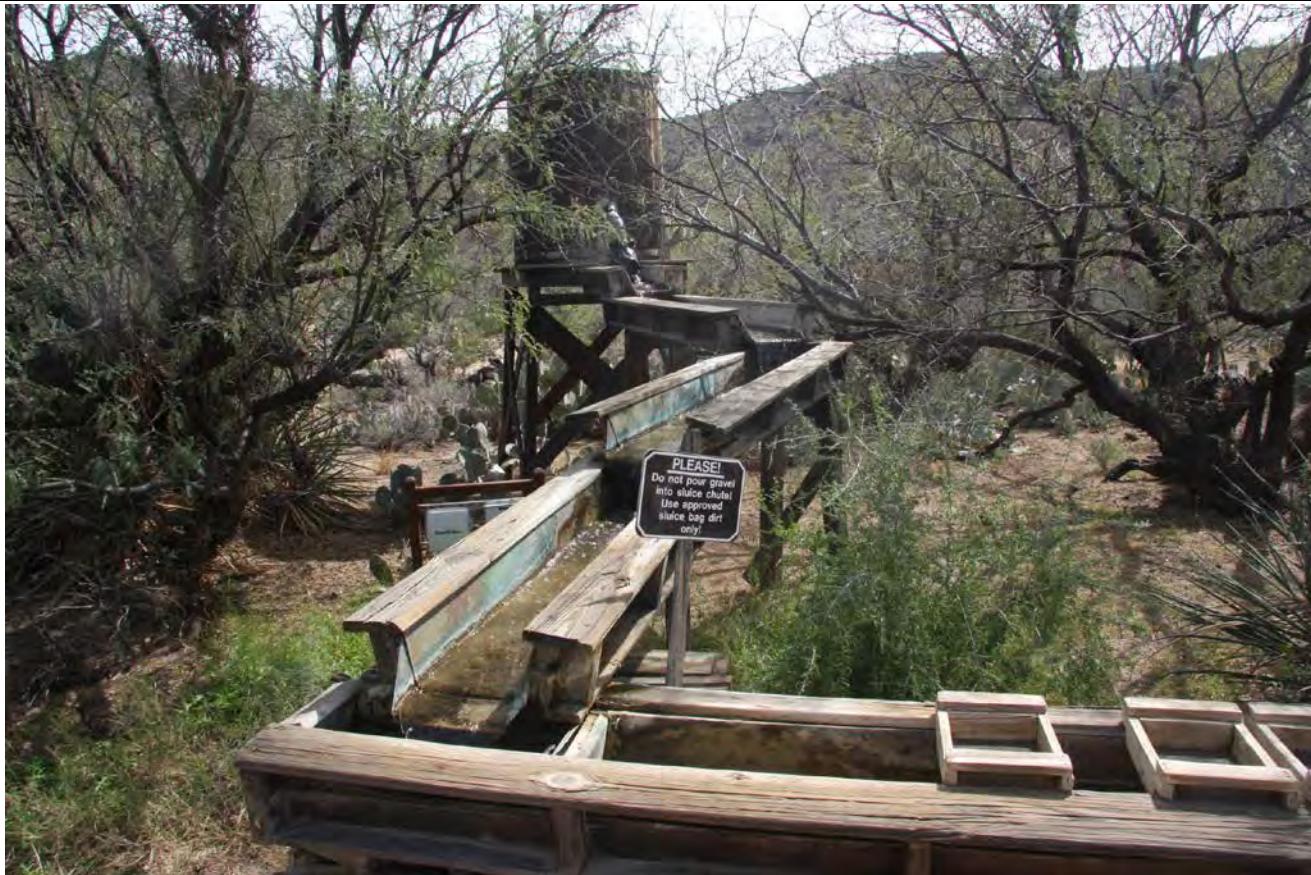
Facility:	Colossal Cave Mountain Park	Page Number	52
Building Name:	Posta Quemada Pan for Gold	Photo By:	G.W. Bundrick

Building Size:	60 Lineal Feet
Replacement Cost:	\$12,000.00 Actual replacement cost according to Martie Maierhauser.
Building Materials:	Wood/Copper
Building Condition:	Good
Building Age:	1999
Photo Date:	February 24, 2014

An evaluation should be made regarding the needed maintenance of the venue vs. the use and revenue income. Water leaks should be repaired.

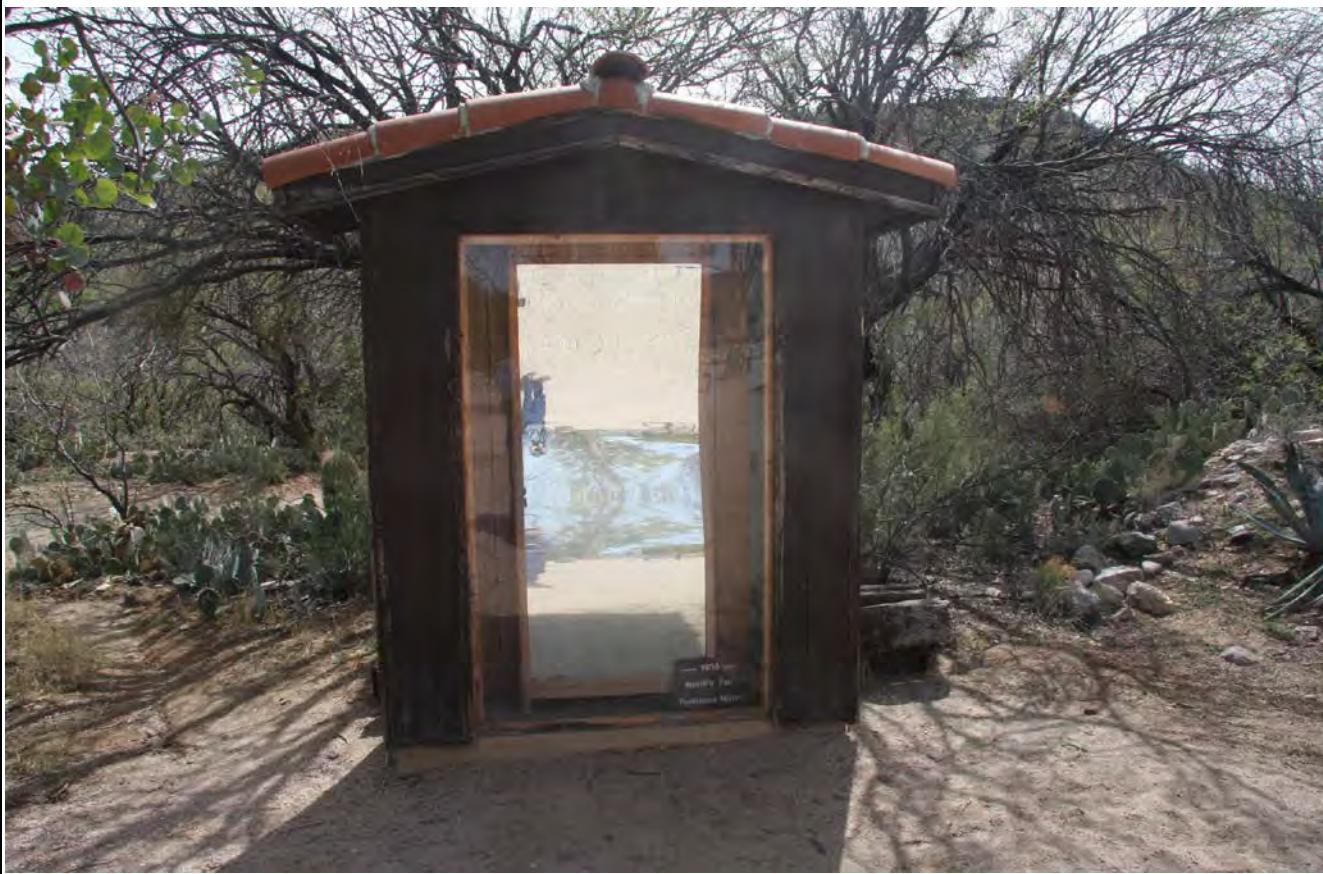
Facility:	Colossal Cave Mountain Park	Page Number	53
Building Name:	Posta Quemada Fun House Mirror	Photo By:	G.W. Bundrick

Building Size:	10-Square feet
Replacement Cost:	\$1,000.00    Estimated at \$100.00 per square foot replacement cost.
Building Materials:	Wood
Building Condition:	Very Good
Building Age:	2000
Photo Date:	February 24, 2014

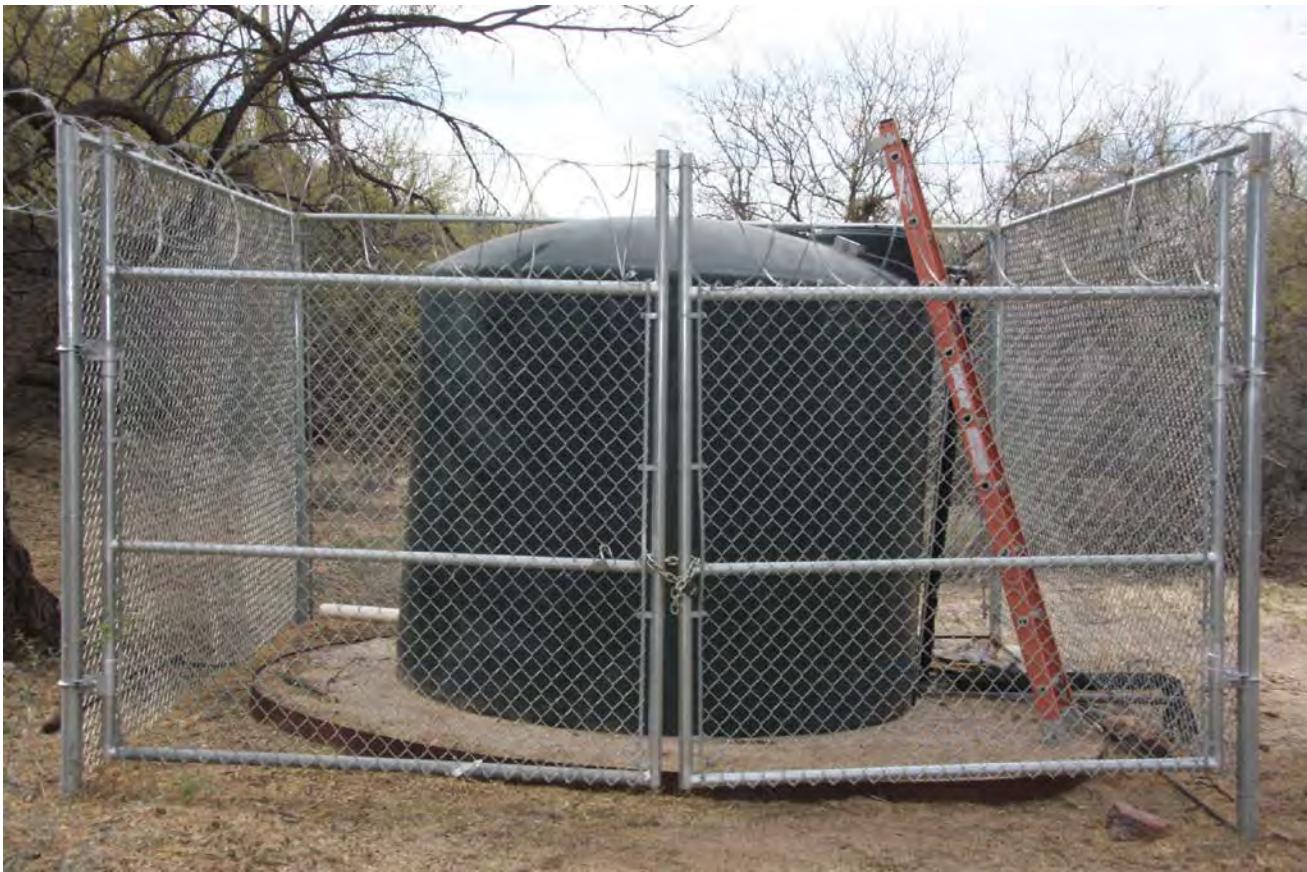
Building Size:	2,500-Gallon Tank
Replacement Cost:	\$10,000.00 Replacement cost is based on actual cost of tank and fencing.
Building Materials:	Polypropylene
Building Condition:	Excellent
Building Age:	2006
Photo Date:	February 24, 2014
