SITE ANALYSIS REPORT

DOLLAR GENERAL LOCATED AT 28890 SOUTH NOGALES HIGHWAY (I-19 FRONTAGE ROAD)

TUCSON, ARIZONA 85645

November 8, 2017

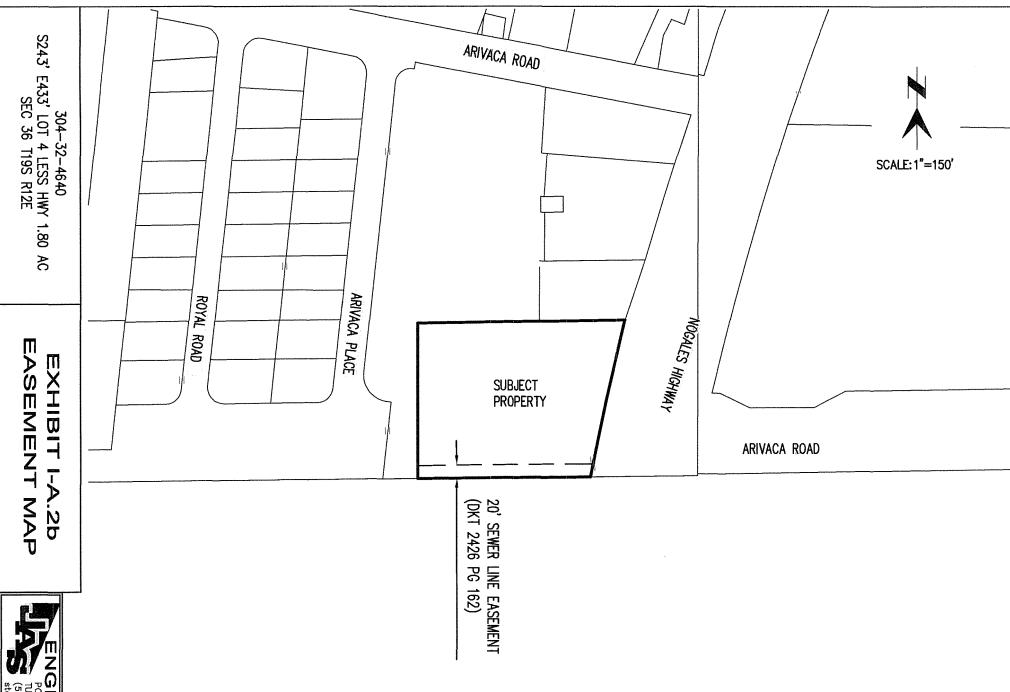
EXHIBIT I-A.2c4e
COMPREHENSIVE
PLAN MAP

- a. The 1.64 acre rezoning district is currently undeveloped.
- b. There is a 20-foot sewer easement along the south boundary as can be seen on Exhibit I-A.2b.
- c. Comprehensive Plan.
 - The site is located within the Upper Santa Cruz planning area as shown on the Pima County Comprehensive Plan.
 - The Plan designation for the subject property is Neighborhood Activity Center (NAC).
 - The property is not subject to a Special Area Policy.
 - Exhibit I-A.2c, 4e shows the planned land use for the site and nearby area.

e. Comprehensive Plan designations are included on Exhibit I-A.2c, 4e.

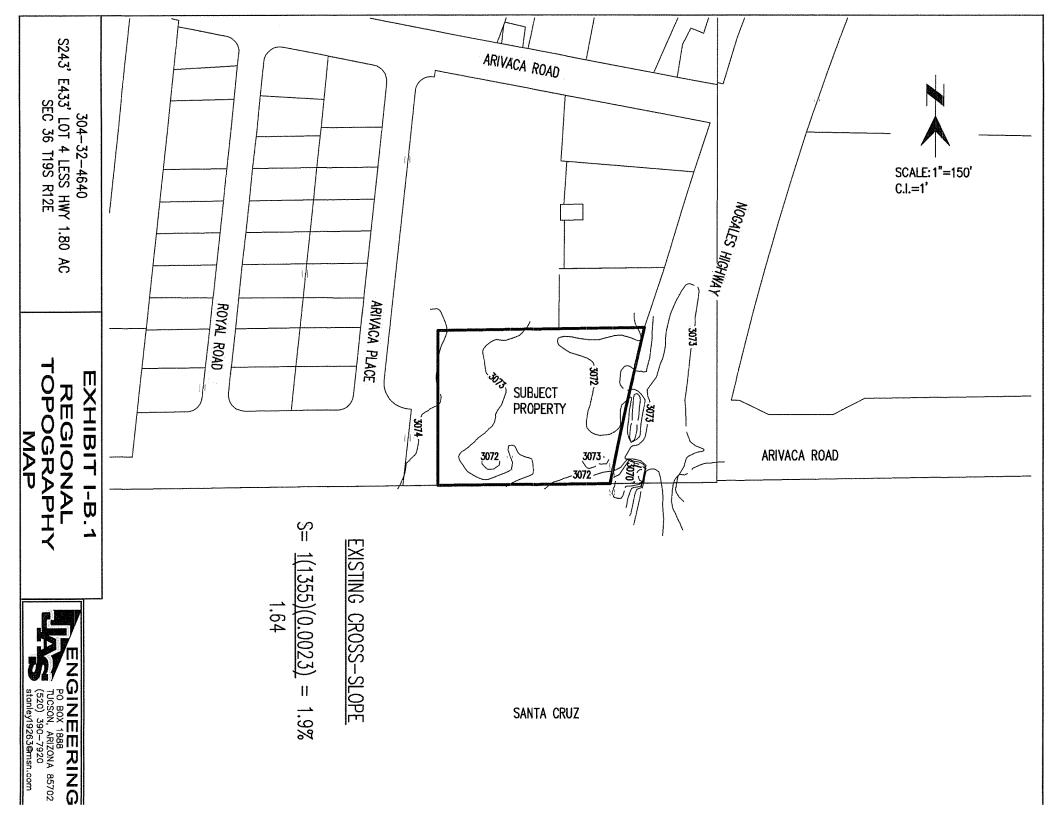
The topographic characteristics of the property are described below and are depicted on Exhibit I-B.1:

- a. There are no restricted peaks or ridges on the property.
- b. There are no rock outcrops on the property.
- c. There are not any natural slopes that are 15% on the property.
- d. There is no significant topographic feature on the property.
- e. There is no existing onsite grading.

The pre-developed average cross-slope is 1.9%. This percentage was derived from the following formula: (1355 ft x 1 ft x 0.0023)/1.64 = 1.9%.

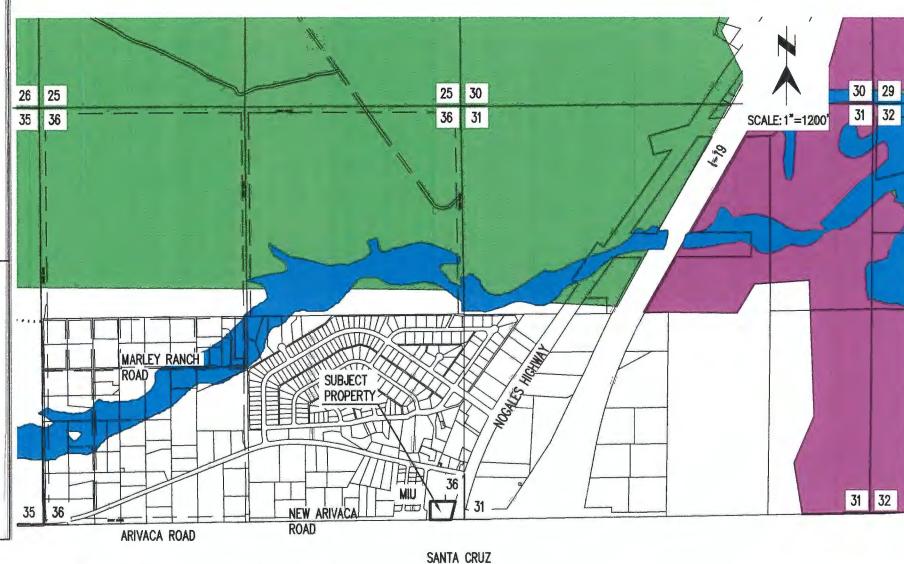
EXHIBIT I-D.1

- 1. Conservation Land System (CLS) Exhibit I-D.1 outlines Important Riparian and Biological Core Management Areas in a regional context. There is not a Special Species Management Area within the region depicted. The Important Riparian Area shown on the exhibit is not within the site boundaries.
- 2. The site is not within or adjacent to one of the six Critical Landscape Connections.

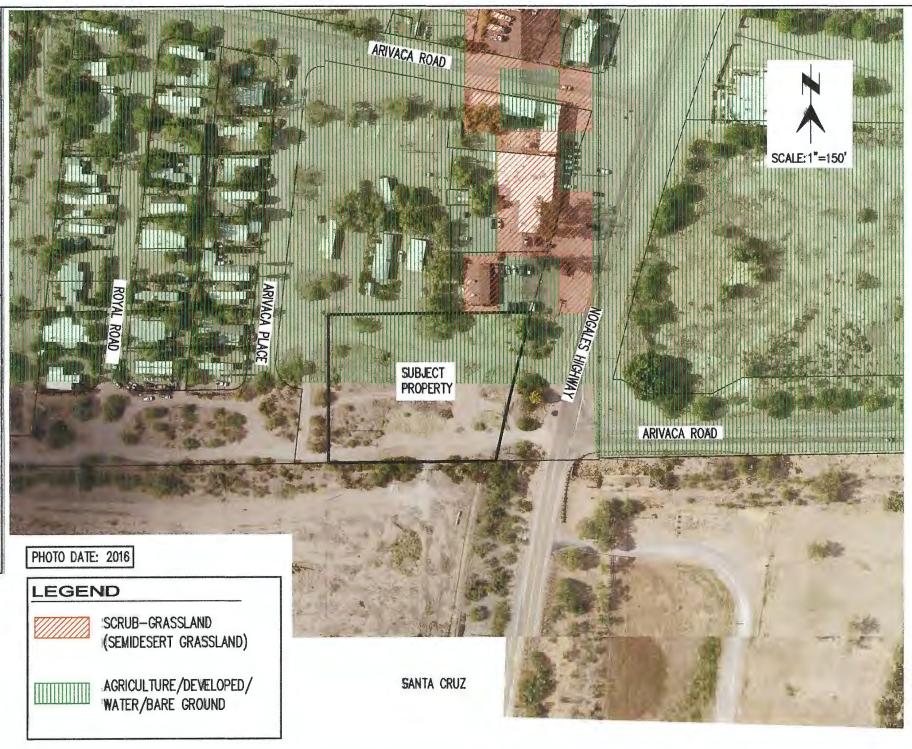
EXHIBIT I-D.10 VEGETATIVE COMMUNITIES MAP

- 9. There are no areas within the site boundaries where vegetation is important for scenic value, screening and/or buffering, and soil stabilization.
- 10. Exhibit I-D.10 is a vegetative communities map. Half of the site is located within the Agriculture/Developed/Water/Bare Ground area.

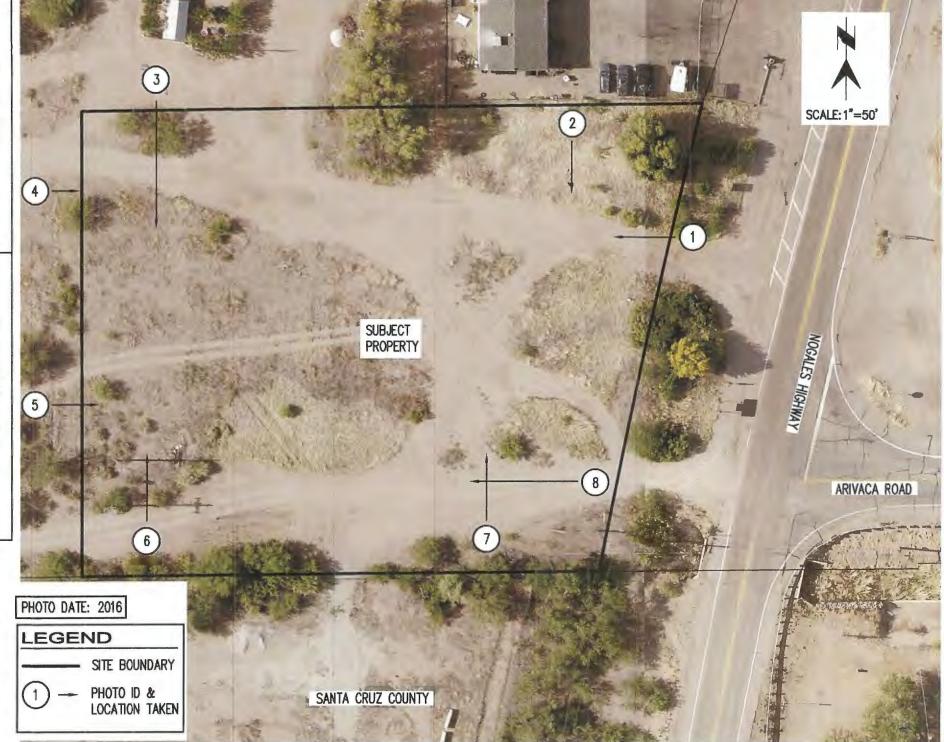
EXHIBIT I-E.2 SITE PHOTO KEY MAP

- 1. The site is not being developed under the Cluster Development Option of the Zoning Code.
- 2. Exhibit I-E.2 is a Site Photo Key Map that shows the photo location a series of 8 photos. Immediately following are the 8 pictures of the site and nearby area.

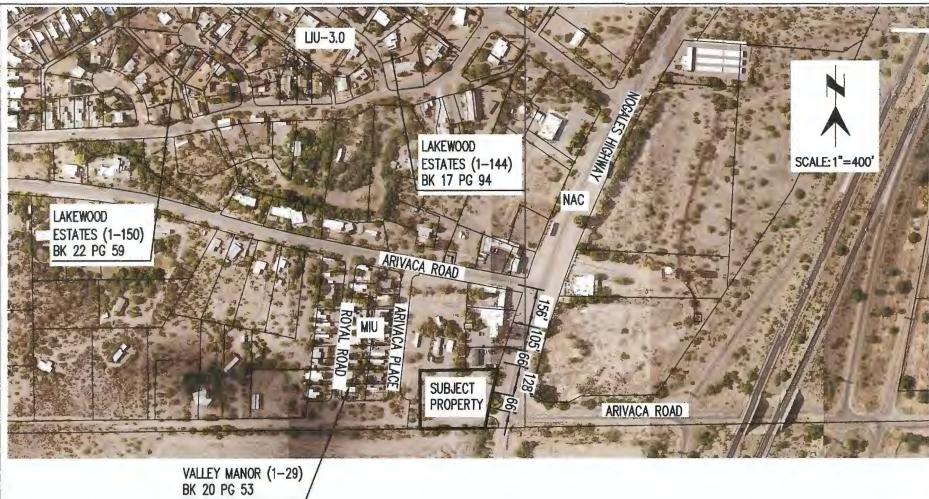
EXHIBIT I-F.2 DRIVEWAY/ INTERSECTION MAP

- g. There are not any existing bicycle routes adjacent to the project site.
 - h. There are not any scheduled roadway projects.
- 2. Exhibit I-F.2 is a Driveway/Intersection Map that shows distances from the site to existing driveways and intersections.

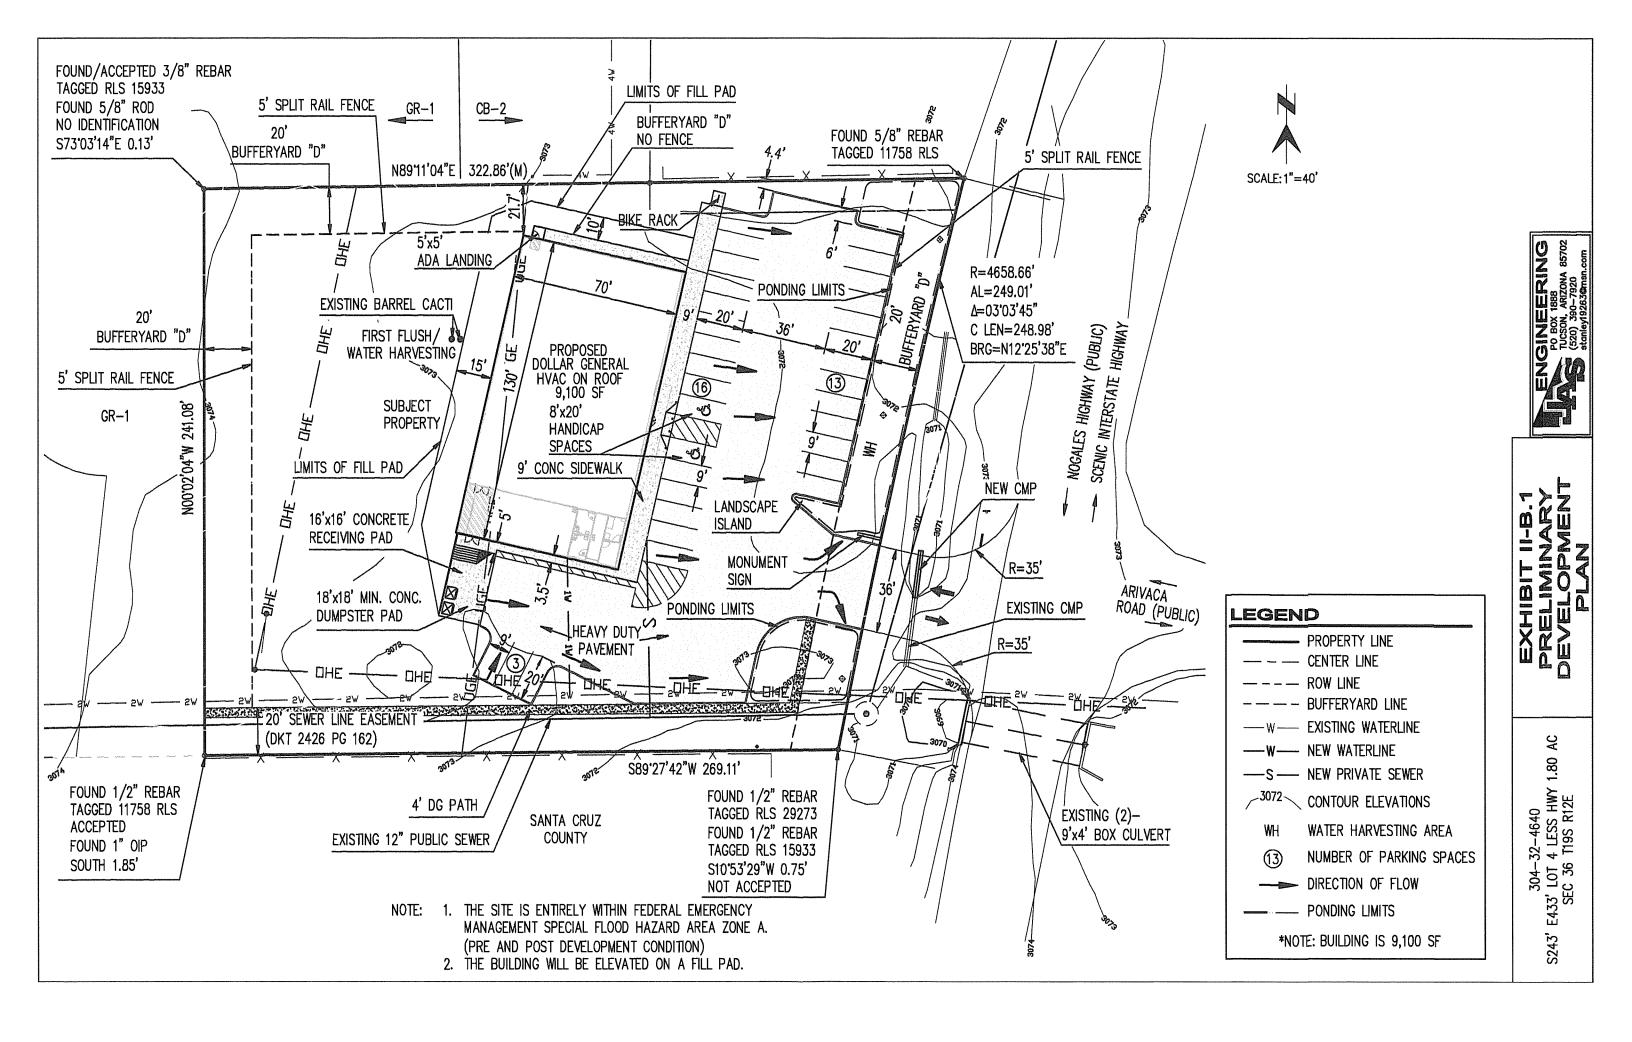
EXHIBIT I-K COMPOSITE MAP

Exhibit I-K is a composite map that shows physical constraints and areas that require special evaluation. The following characteristics were addressed and shown if they pertain to the project site:

- a. There are no restricted peaks and ridges.
- b. There are not any rock outcrops or talus slopes.
- c. Site topography is shown, there are not any slopes 15% or greater located on the property.

- a. There is a 100-year floodplain with discharges greater than 100 cfs on the project site.
- b. The site is within a sheet flow area. Part of the site is subject to sheet flow depths less than 6 inches while the remaining portion is subject to sheet flow depths of 12 inches.
- c. There is a federally mapped Zone A floodplain as delineated on FIRM panel 04019C4355L with effective date June 16, 2011
- d. There are no regulated Riparian Habitat Classifications.
- e. There are no areas of lakes, ponds, springs, wetlands, or sources of perennial surface water

- a. There are not any saguaro cacti onsite.
- b. There are not any ironwood trees onsite.
- b. There is no Pima Pineapple cactus onsite.
- c. There is not any Needle Spined Pineapple cactus onsite.
- d. There are no areas of significant or important vegetation onsite.
