Title: Approval of a Riparian Habitat Mitigation In-Lieu Fee Proposal Located at 1440 North Tanque Verde Loop (District 4)

SUBJECT: Approval of a Riparian Habitat Mitigation In-Lieu Fee Proposal Located at 1440 North Tanque Verde Loop, Located within Important Riparian Area with Underlying Hydromesoriparian Habitat (District 4)

RIPARIAN HABITAT MITIGATION PLAN
 Floodplain Use Permit number: 16-22TRP

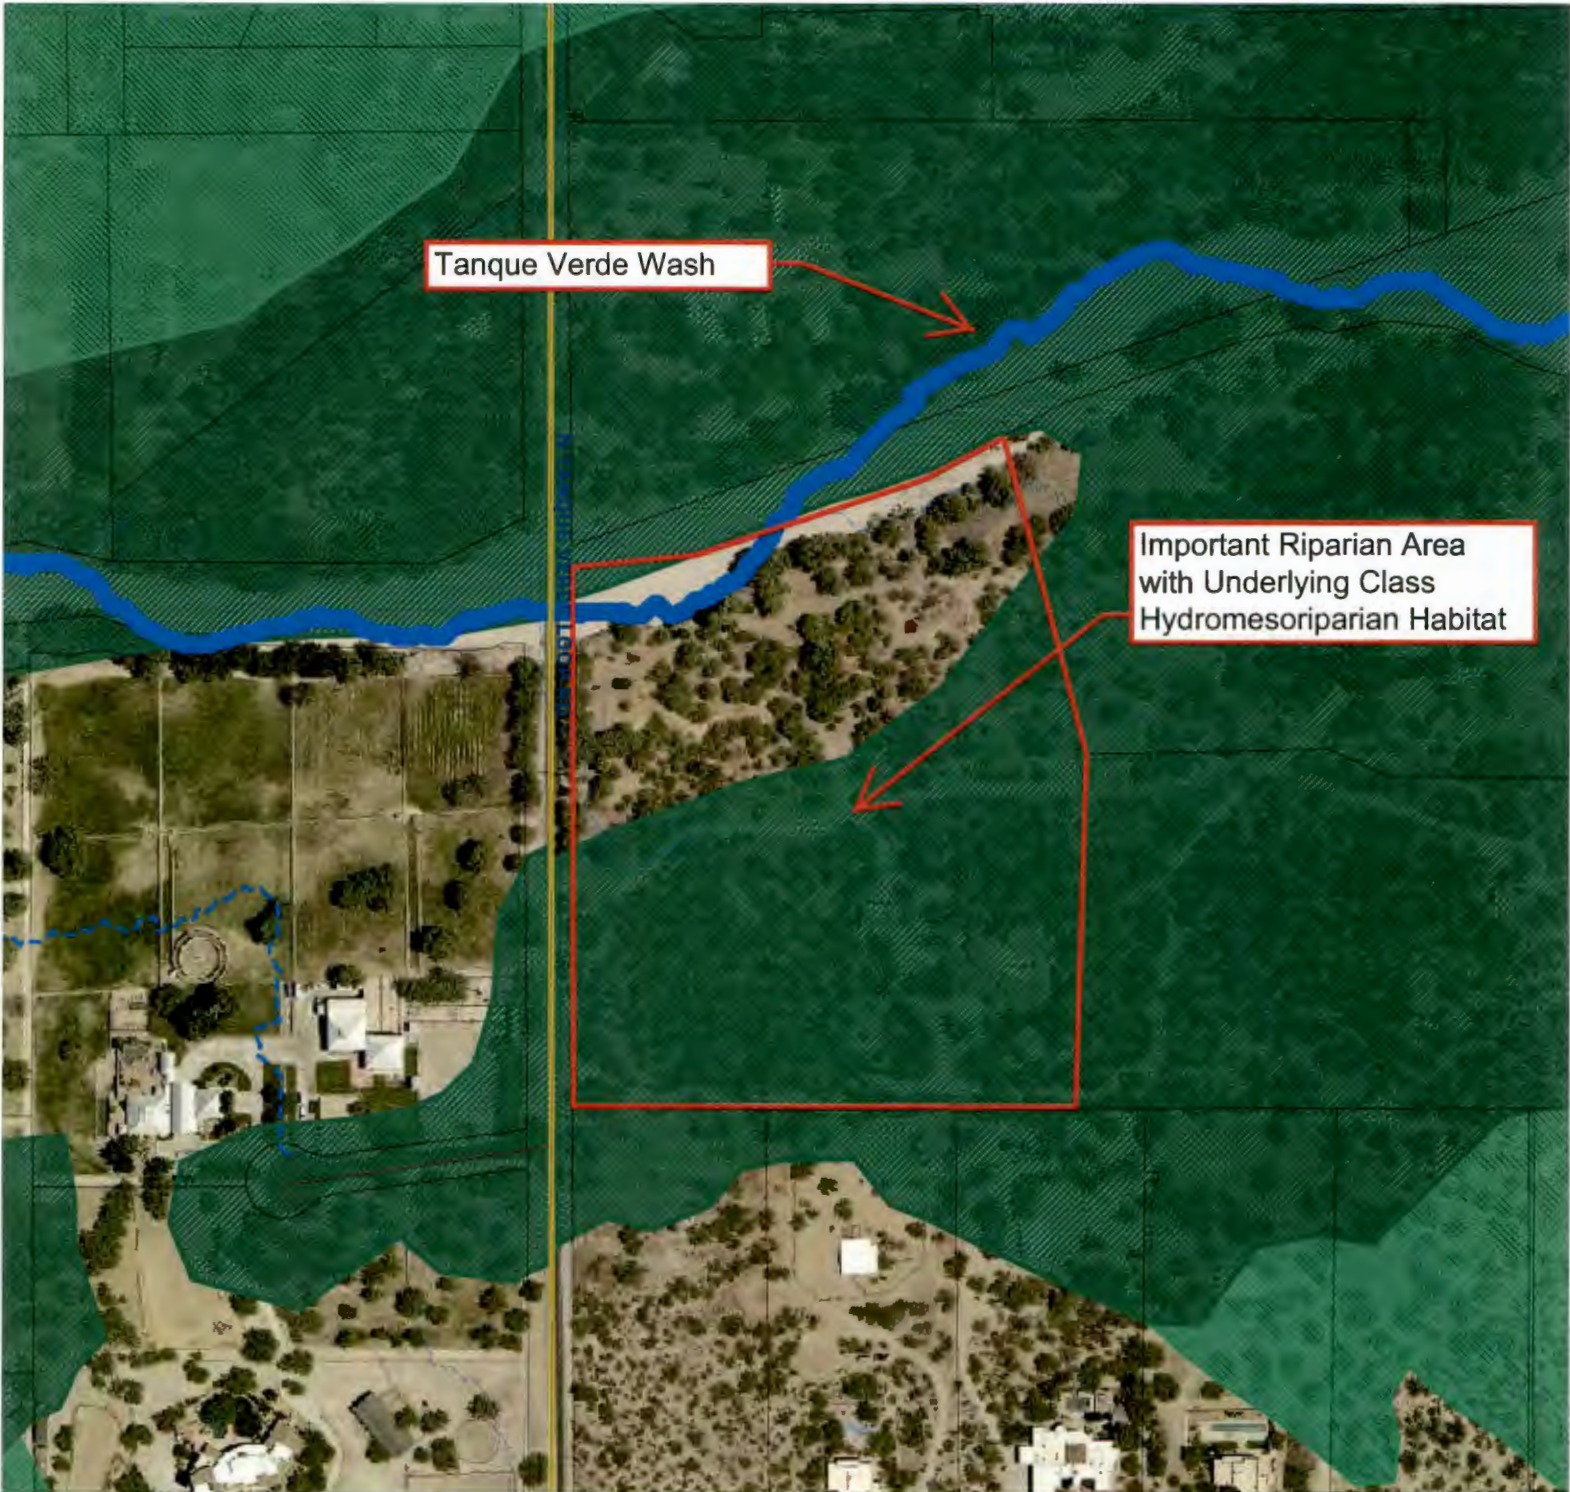
Exhibit B

Important Riparian Area
with Underlying Class
Hydromesoriparian Habitat

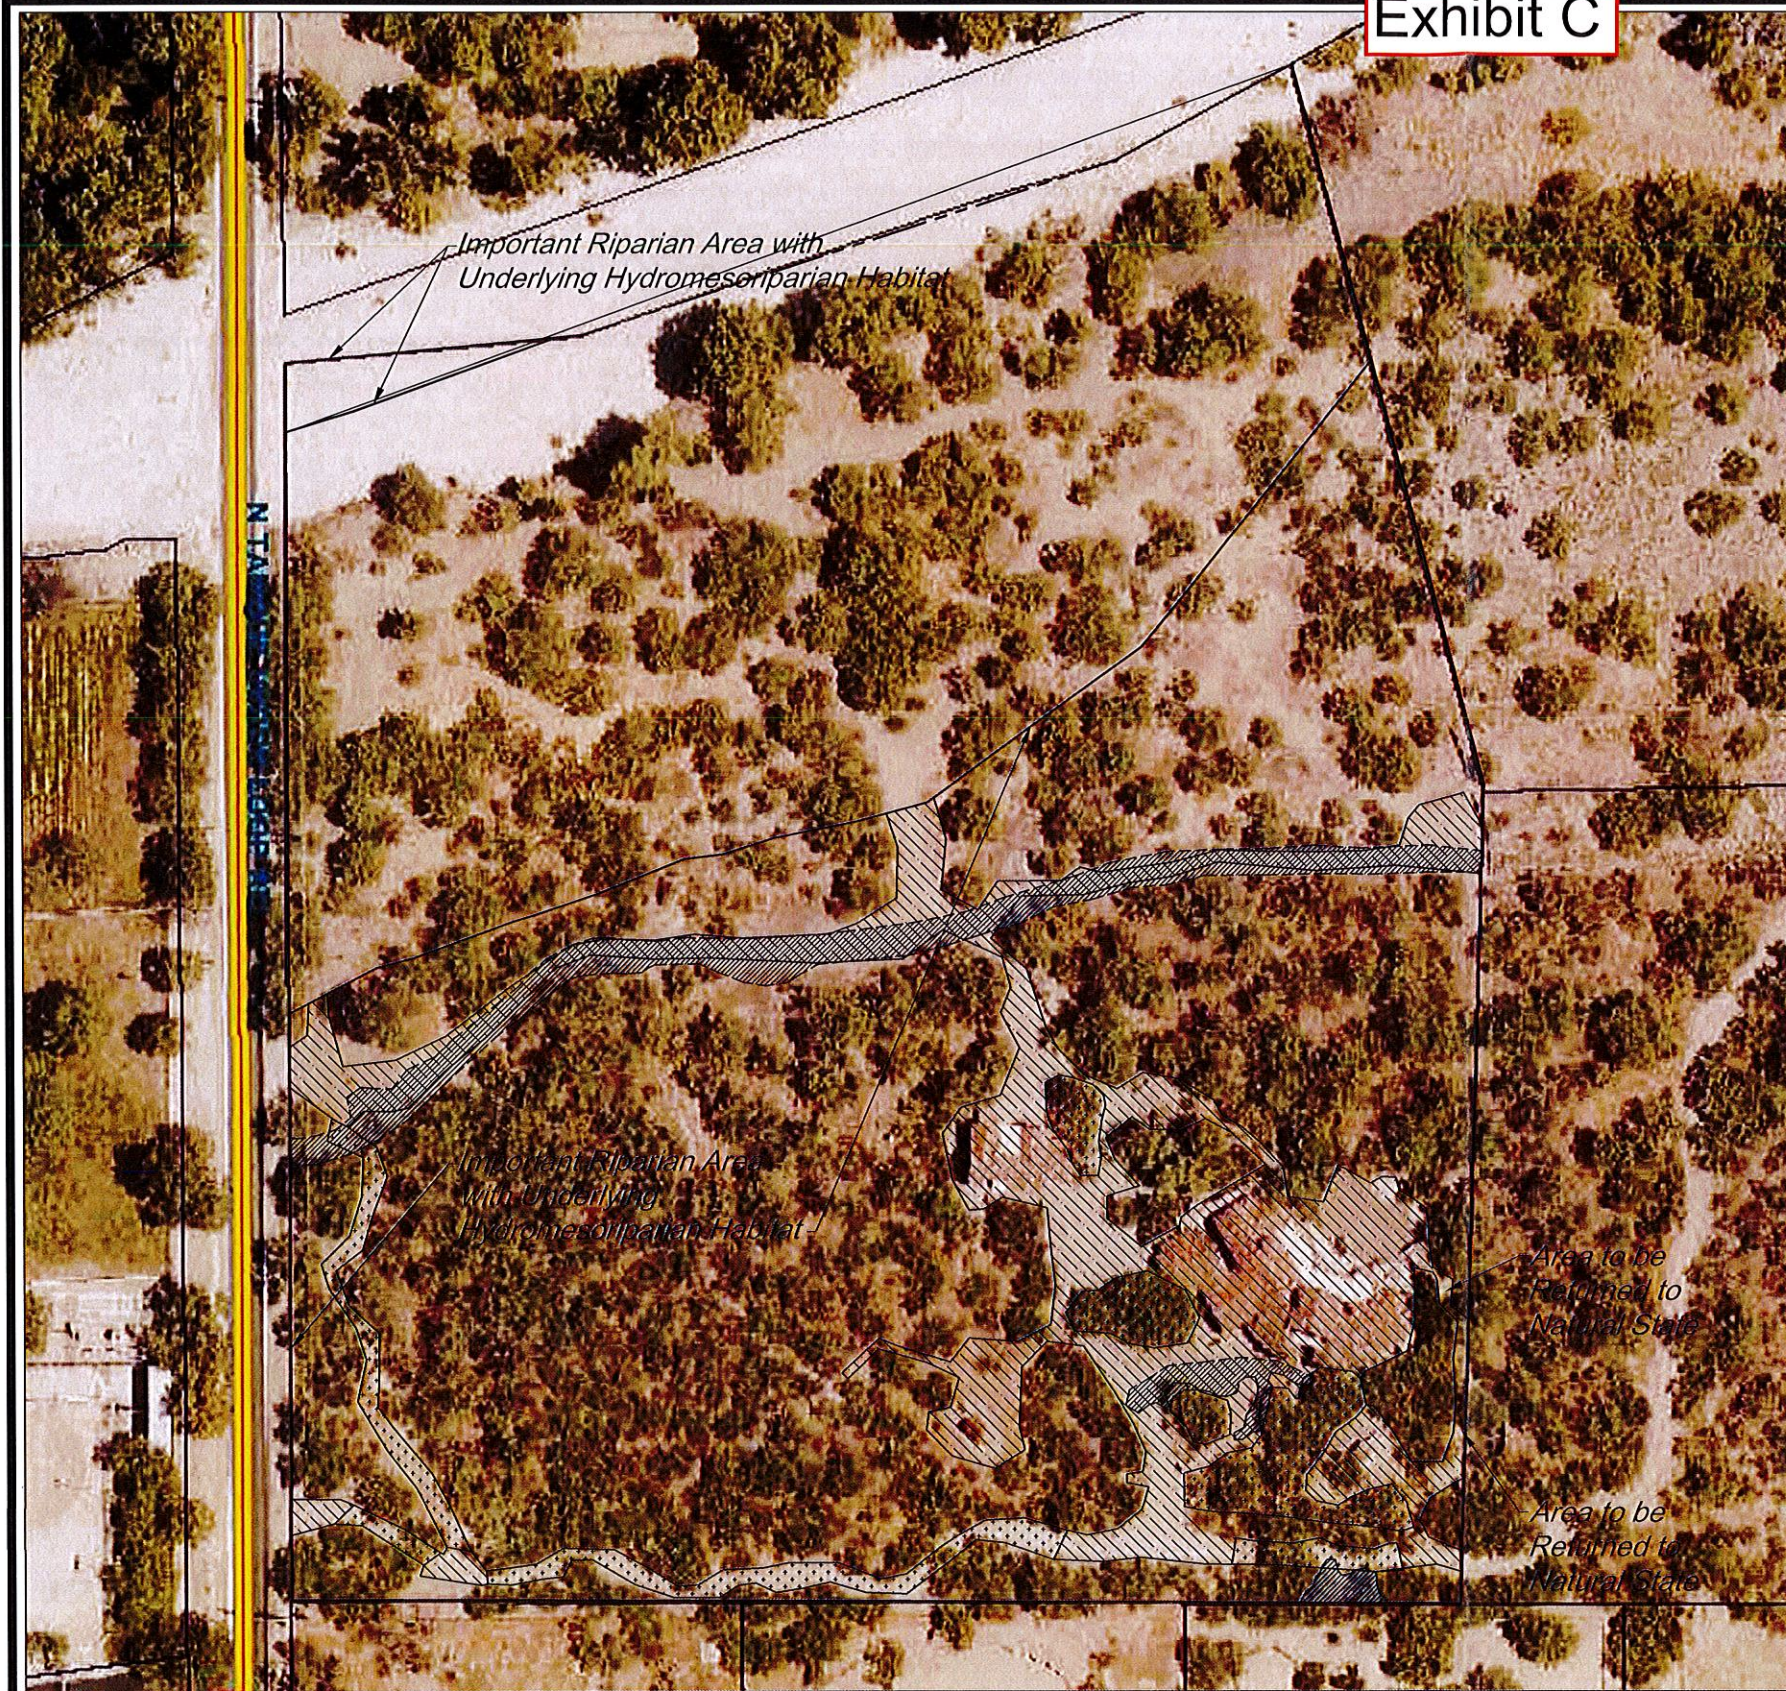
MAP # 1:
 CURRENT & PARTIAL DISTURBANCE BASED ON 2016 AERIAL

The adjusted full current disturbance represents disturbance of 5.9% of the riparian area on the property.

This site contains Important Riparian Area with Underlying Hydromesoriparian Habitat	
Total Regulated Riparian Habitat On-Site	341,832 sf (7.85 ac)
Total Area of Current Full Disturbed Riparian Habitat	56,006 sf (1.29 ac)
Less Area of Pre-Ordinance Disturbed Habitat	(15,590 sf)
Less Area of Disturbance Previously Mitigated	(20,100 sf)
Total Area of Adjusted Full Current Disturbance	20,316 sf (0.47 ac)
Trees Required for Full Dist = $1.5 \times 90 \times 0.47 =$	63 Trees
Shrubs Required for Full Dist = $1.5 \times 20 \times 0.47 =$	14 Shrubs
Total Partial Disturbance (Shrubs Only)	19,307 sf (0.44 ac)
Shrubs Required for Partial Dist = $1.5 \times 20 \times 0.44 =$	13 Shrubs
Total # of Trees Required = 63 Trees	
Total Trees Provided on Site	0 Trees
Total Trees Provided by in lieu fee	63 Trees
Total # of Shrubs Required = 27 Shrubs	
Total Shrubs Provided on Site	52 Shrubs
Total Shrubs Provided by in lieu fee	0 Shrubs

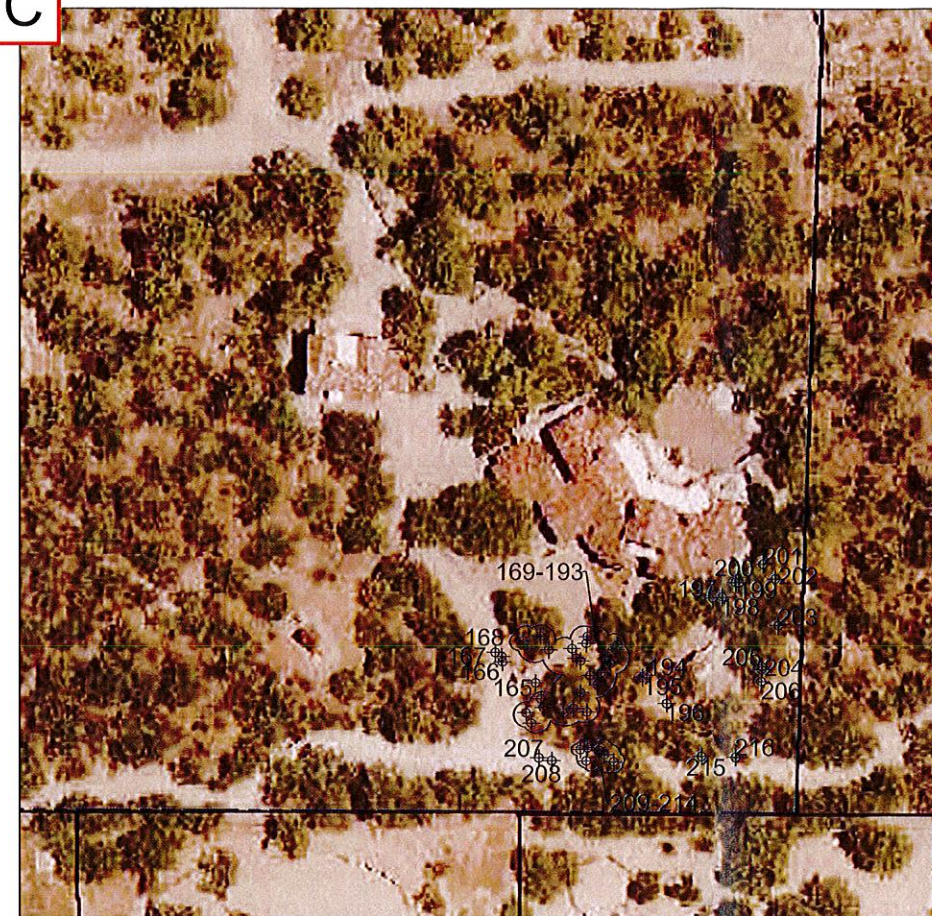
MAP # 3:
VEGETATION POINTS & INVENTORY

ID NO.	DESCRIPTION
165	Larrea tridentata - Creosote Bush
166	Larrea tridentata - Creosote Bush
167	Larrea tridentata - Creosote Bush
168	Larrea tridentata - Creosote Bush
169	Celtis pallida - Desert Hackberry
170	Celtis pallida - Desert Hackberry
171	Celtis pallida - Desert Hackberry
172	Larrea tridentata - Creosote Bush
173	Larrea tridentata - Creosote Bush
174	Larrea tridentata - Creosote Bush
175	Larrea tridentata - Creosote Bush
176	Larrea tridentata - Creosote Bush
177	Larrea tridentata - Creosote Bush
178	Larrea tridentata - Creosote Bush
179	Larrea tridentata - Creosote Bush
180	Larrea tridentata - Creosote Bush
181	Larrea tridentata - Creosote Bush
182	Celtis pallida - Desert Hackberry
183	Celtis pallida - Desert Hackberry
184	Larrea tridentata - Creosote Bush
185	Larrea tridentata - Creosote Bush
186	Larrea tridentata - Creosote Bush
187	Condalia globosa - Condalia
188	Larrea tridentata - Creosote Bush
189	Larrea tridentata - Creosote Bush
