LA CHOLLA AND ORACLE JAYNES STATION REZONING DOCUMENT | PIMA COUNTY JULY 2016 CASE NO. P16RZ00001

La Cholla and Oracle Jaynes Station Rezone

Pima County, Arizona La Cholla Boulevard and Oracle Jaynes Station Road

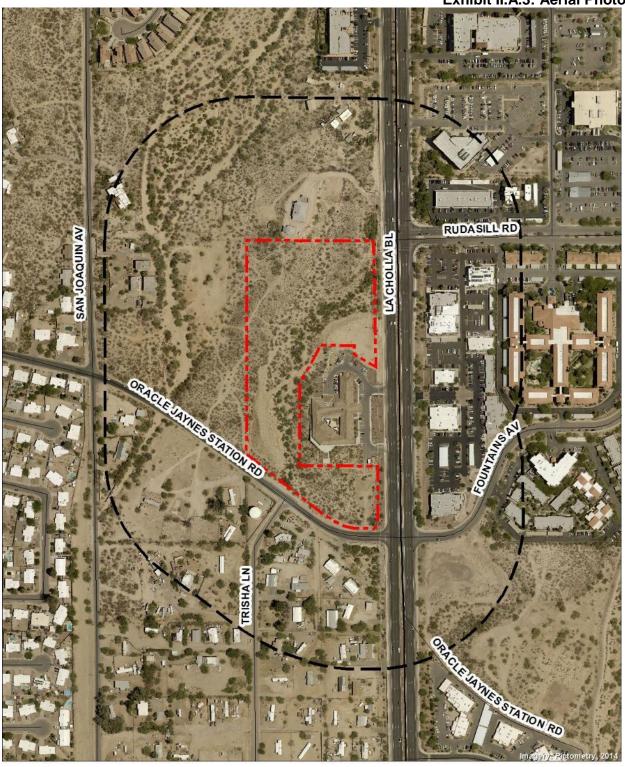
Exhibit II.A.3: Aerial Photo displays a 2014 Pictometry aerial image of the subject property with a 600-Foot radius surrounding the site.

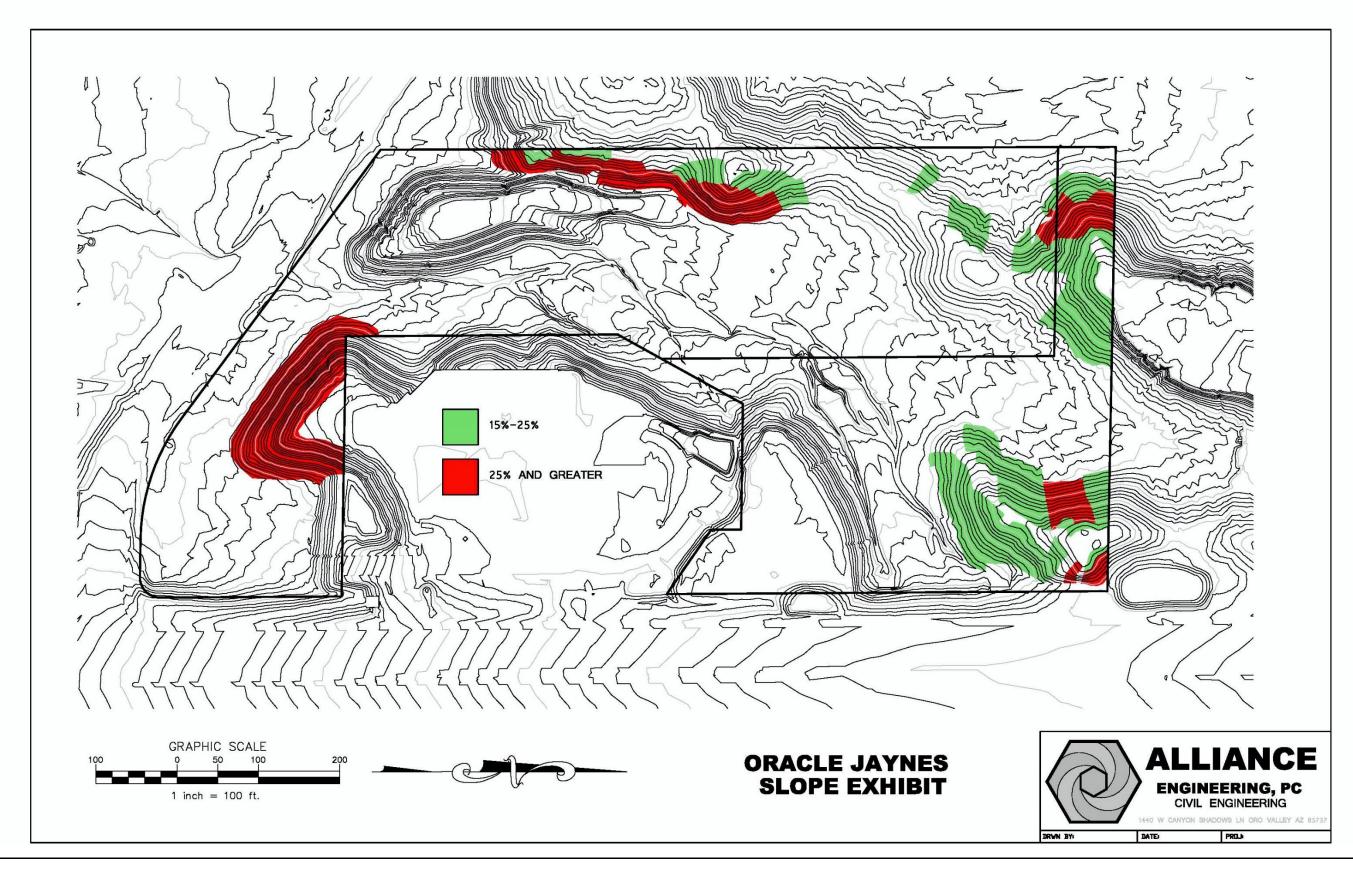
Exhibit II.B.1: Topography

Elevation ranges from 2,270 feet at the southern edge of the property adjacent to Oracle Jaynes Station Road to 2,316 feet at the northern edge of the property.

Interval (I) = 2'
Total length of contours in feet (L) = 26,360Area in acres (A) = 10.3

ACS = 11.8%

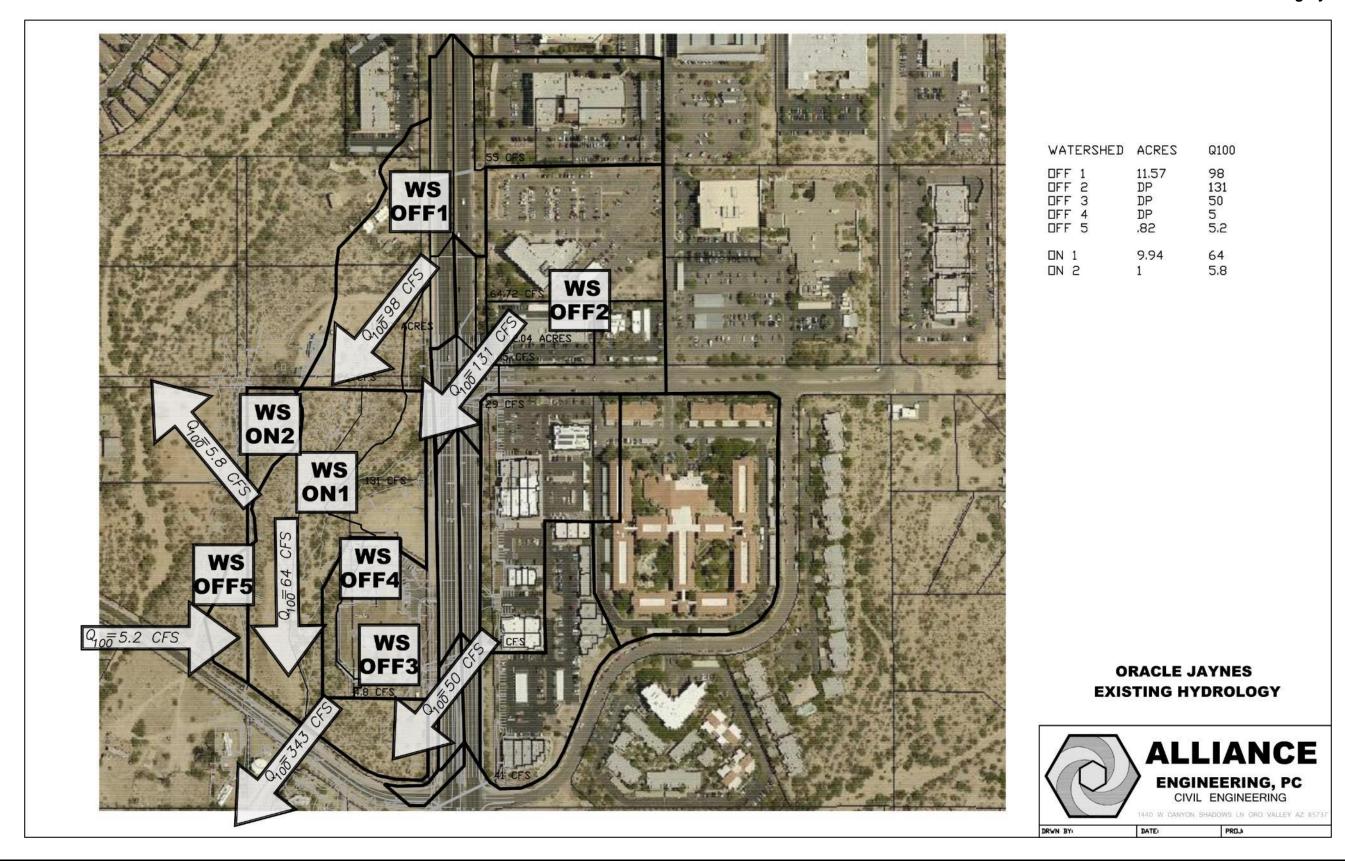
Exhibit II.C.1: Existing Hydrology

There are multiple, small off-site watersheds impacting this parcel. Offsite watershed 1 (OFF1) depicted on Exhibit II.C.1 to the north is a combination of drainage from La Cholla Boulevard, discharge from a developed commercial site, and one single family home lot. This area is 11.57 acres and has a total 100 year discharge of 98 cfs. On the east portion of the site, Offsite watershed 2 (OFF2), Offsite watershed 3 (OFF3), and Offsite watershed 4 (OFF4) all impact the parcel. Offsite watershed 2 (OFF2) is a combination of discharge from the La Cholla Boulevard roadway and a developed commercial site, and impacts the parcel from the east and a pipe from the north. OFF2 is a combination of commercial development and discharge from La Cholla Boulevard. Q100 was derived from previous development plans and the total 100 year discharge is 131 cfs. OFF3 impacts the parcel from the adjacent memory care site (5 cfs) and from across La Cholla Boulevard from the fountains at La Cholla Medical Park (45 cfs) with a total 100 year discharge is 50 cfs. Offsite watershed 4 (OFF4) impacts the parcel from the adjacent memory care site (5 cfs), which was extracted from the Tucson Memory Care development plan. The total 100 year discharge for OFF4 is 5 cfs. Offsite watershed 5 (OFF5) impacts the parcel from the west and is an undeveloped hill that discharges to the west boundary with a total 100 year discharge of 5.2 cfs. All discharge created by the parcel and the pass through discharge is concentrated at the south boundary at Oracle Jaynes Station Road and has a total 100 year discharge of 343 cfs.

All discharges have been mapped on *Exhibit II.C.1: Existing Hydrology*. Some information was taken directly from approved development plans as well as PC-Hydro sheets calculating discharges.

100-year storm event peak discharge rates for all points of concentration along the project boundaries were computed using PC-Hydro. The location of the concentration point, drainage areas and 100-year peak discharge rates are provided on *Exhibit II.C.1*.

Multiple culverts discharge into the parcel along the east boundary as well as from the Memory Care facility. Offsite watershed locations have been shown on *Exhibit II.C.1*.

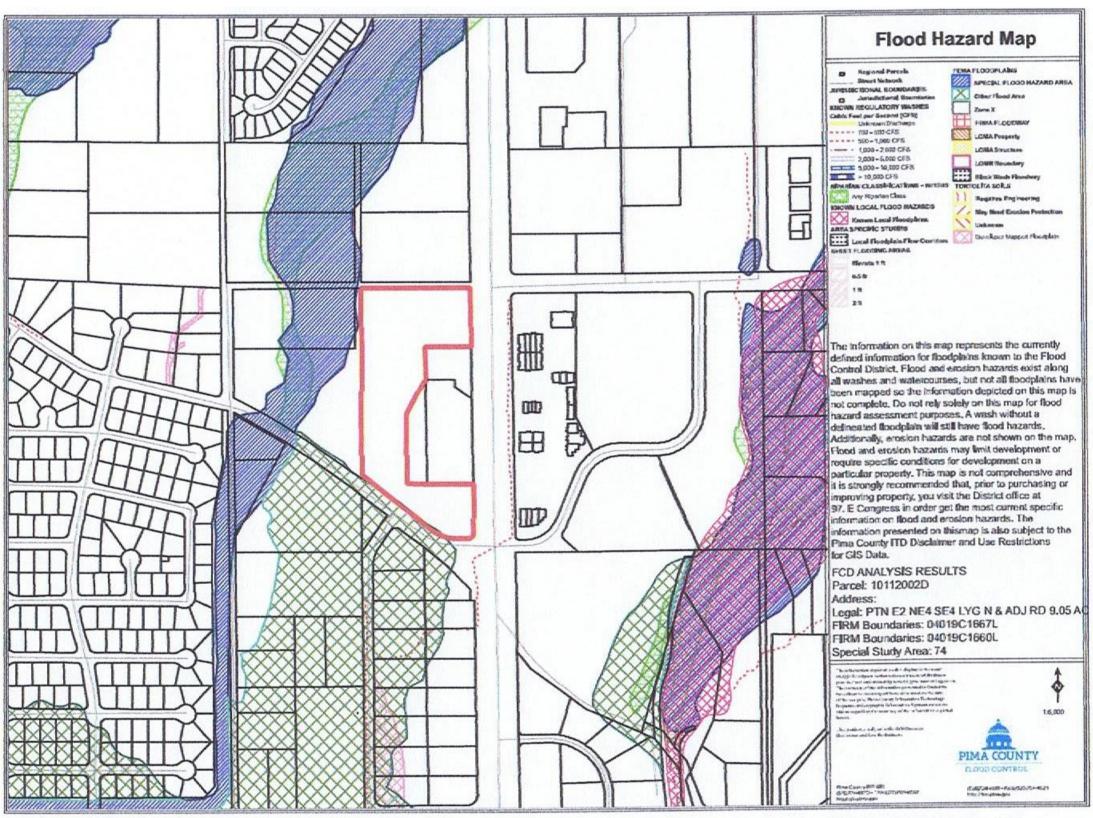
Exhibit II.C.2: Flood Hazard Map was generated from Pima County Regional Flood Control and demonstrates that the site contains no FEMA delineated floodplains.
